**ADDENDUM 2**

**Contract: 23-C-00013; Morris Bridge Filter Building Improvements**

**COMPREHENSIVE PRE-DEMOLITION SURVEY REPORT FOR:  
MORRIS BRIDGE WATER PUMPING FACILITY**

**JULY 26, 2022**

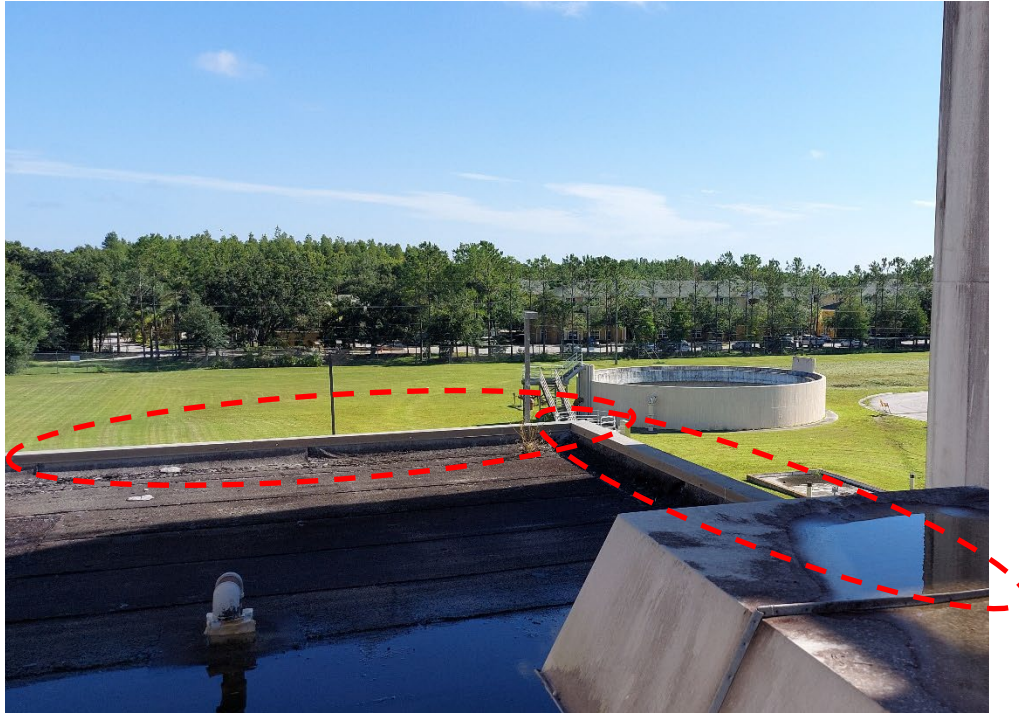
Photo 1 – ACM black asphalt roofing perimeter flashing on Structure 9

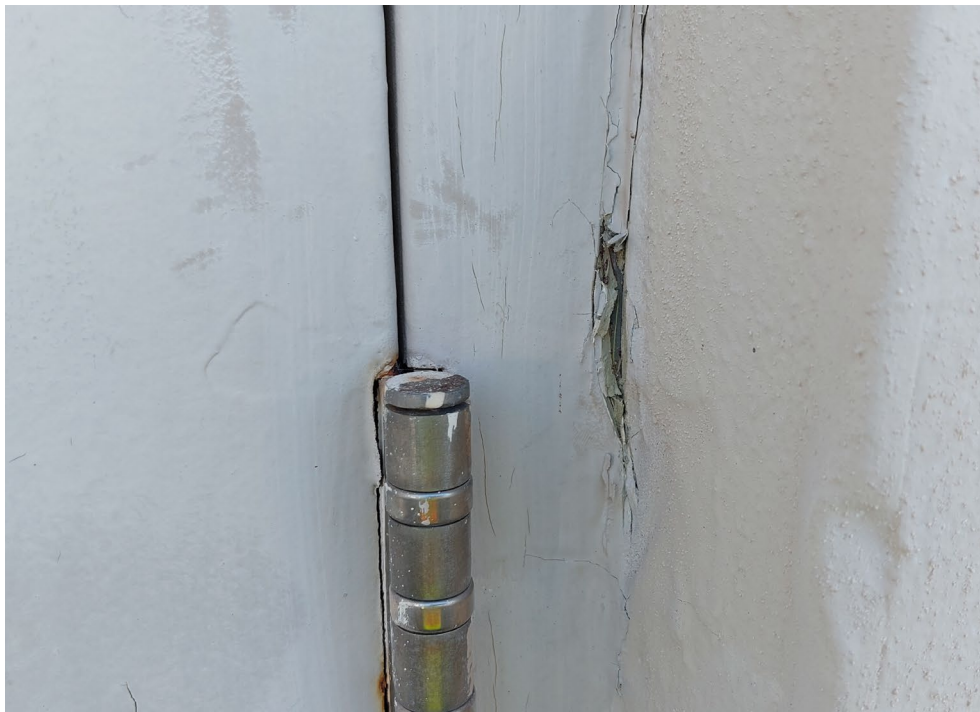
Photo 2 – ACM grey exterior doorway caulking on Structure 12

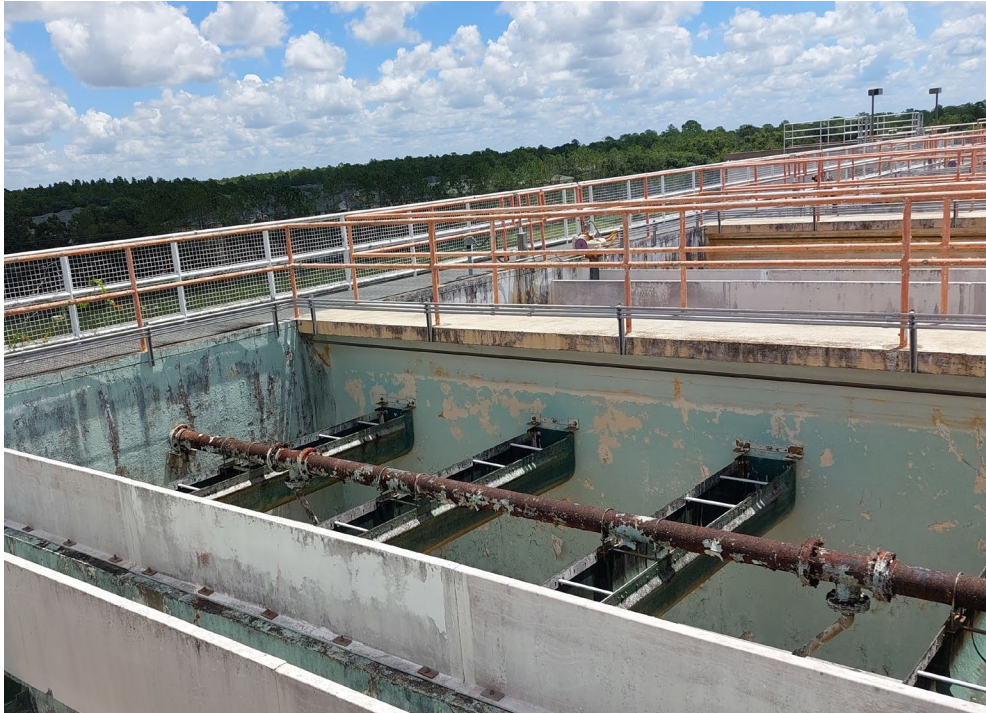
Photo 5 – LBP orange metal handrails on roof of Structure 6

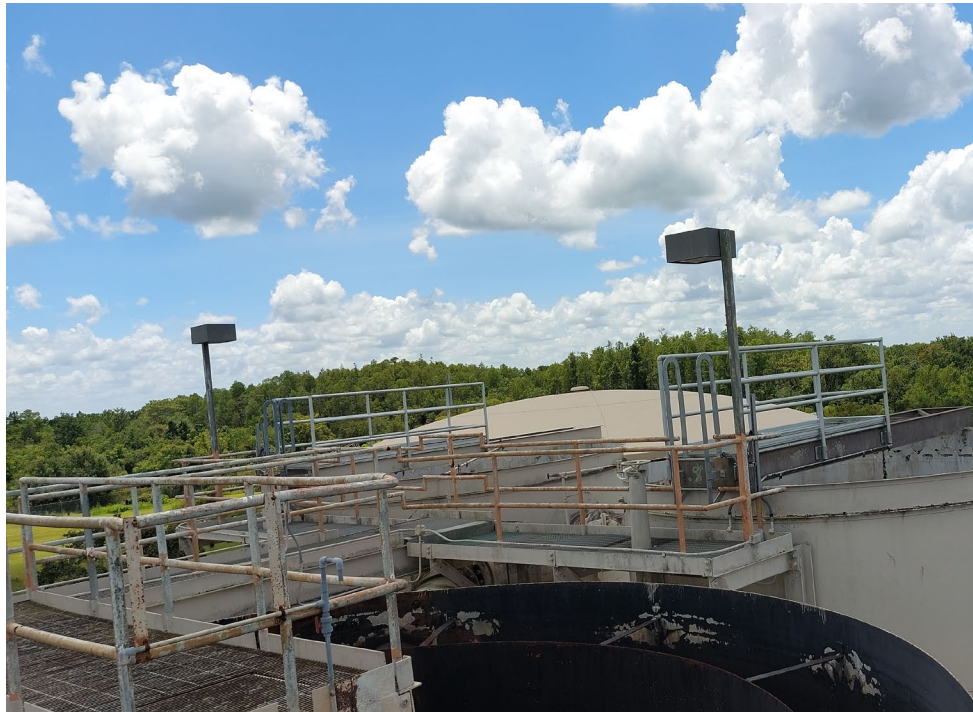
Photo 6 – LBP orange metal handrails on top of Structure 7

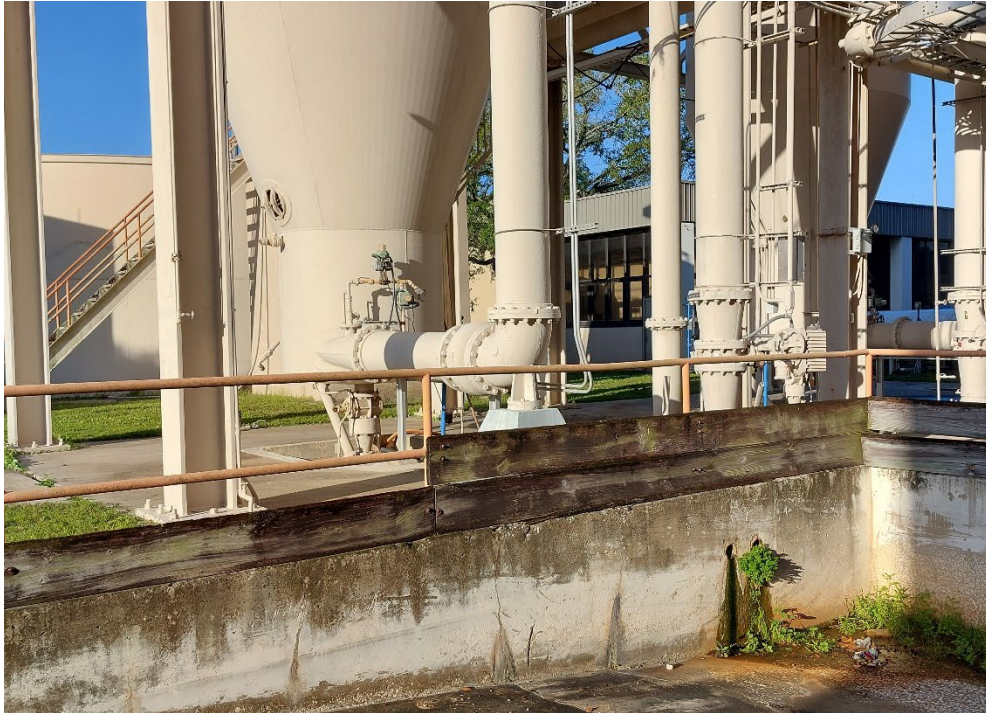
Photo 7 – LBP orange metal handrails around Structures 8a & 8b

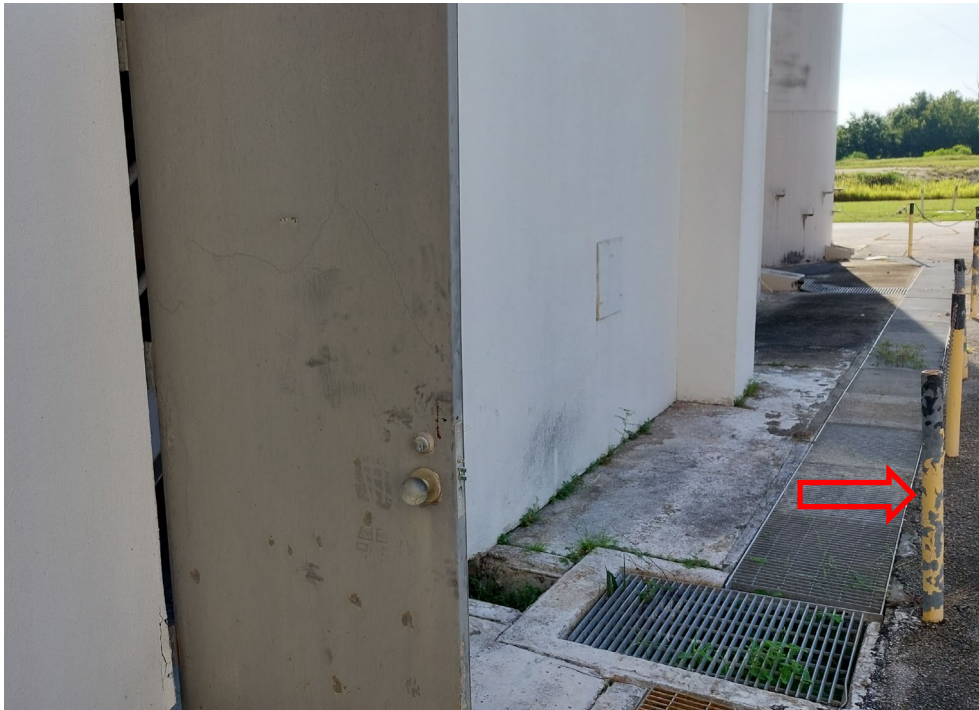
Photo 8 – Yellow metal parking bollards of Structure 9

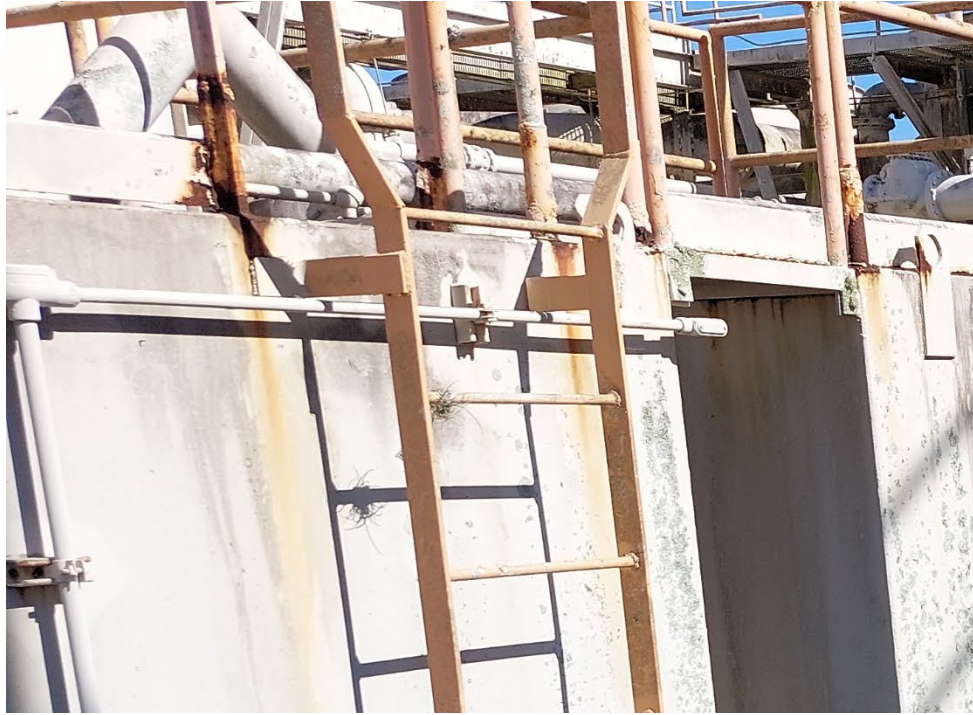
Photo 9 – LBP orange metal handrails on roof of Structure 9

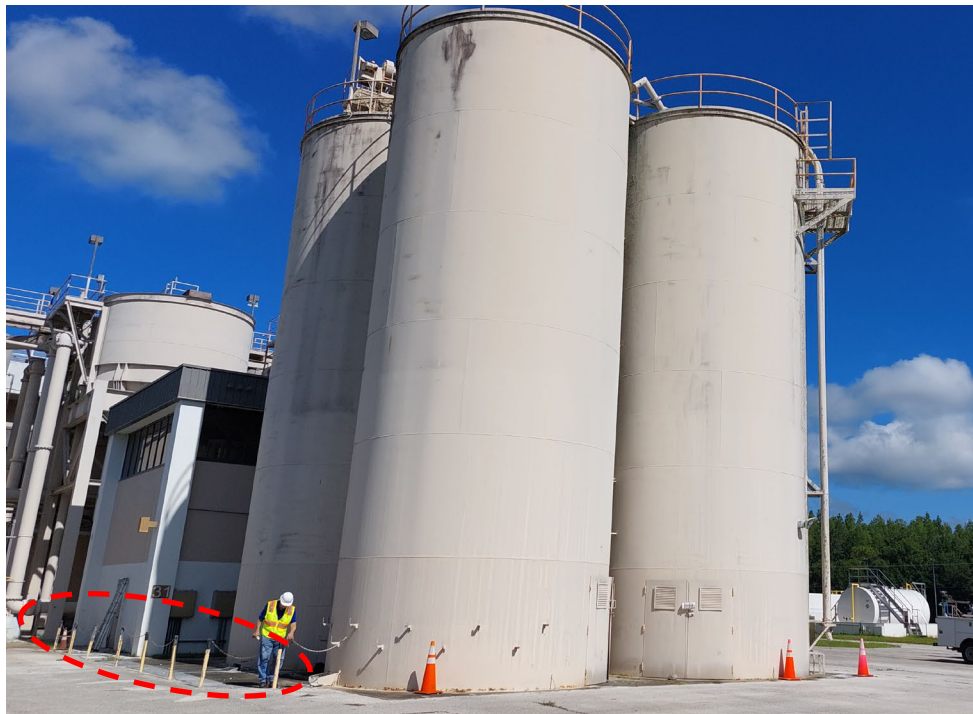
Photo 10 – LBP yellow on metal parking bollards of Structure 10

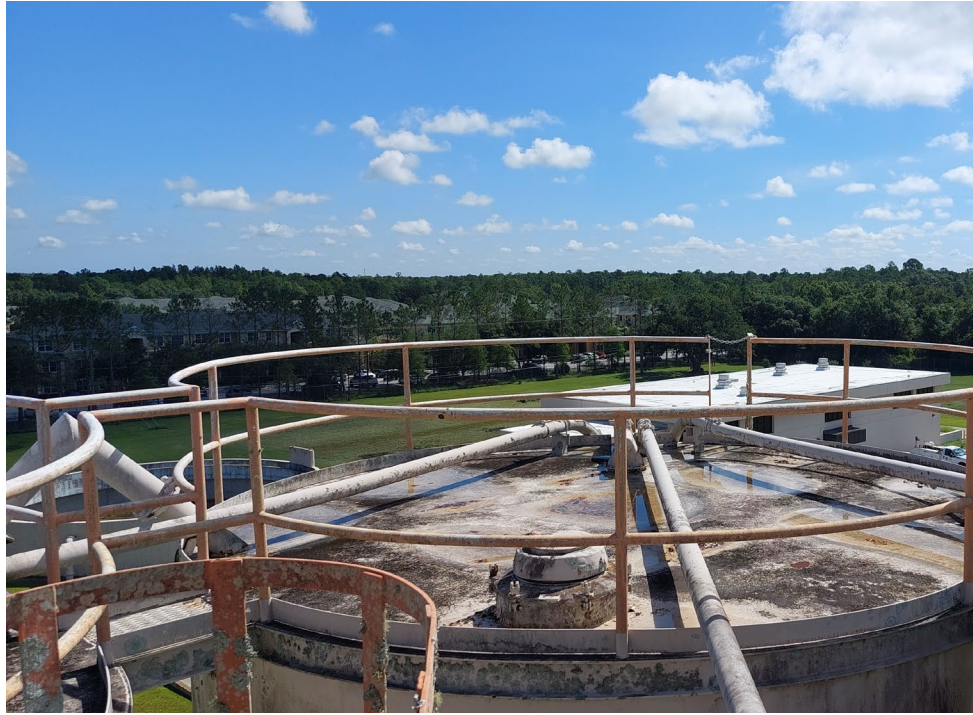
Photo 11 – LBP orange metal handrails on top of tanks/silos of Structure 10

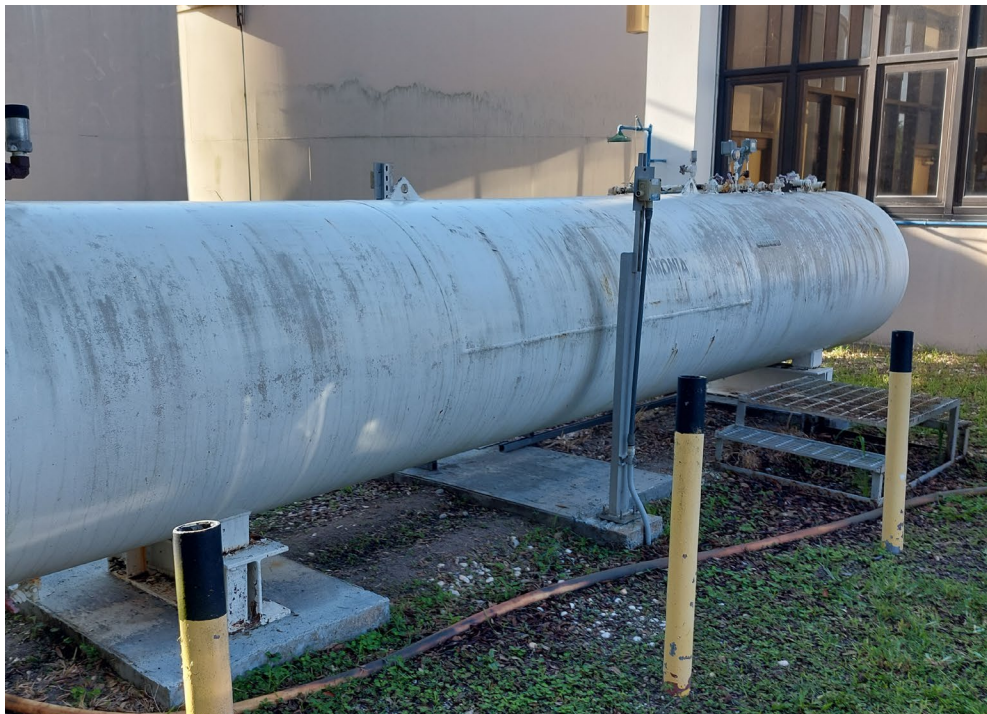
Photo 12 – LBP yellow metal parking bollards around Structure 11

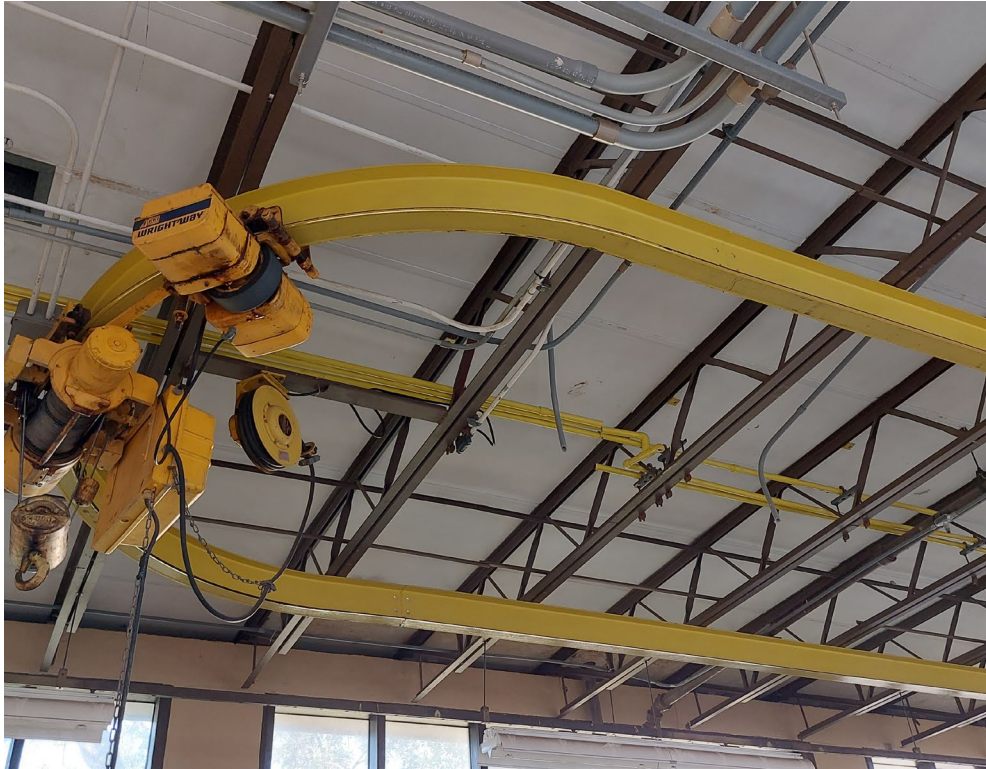
Photo 13 – LBP yellow metal crane/hoist inside Structure 12

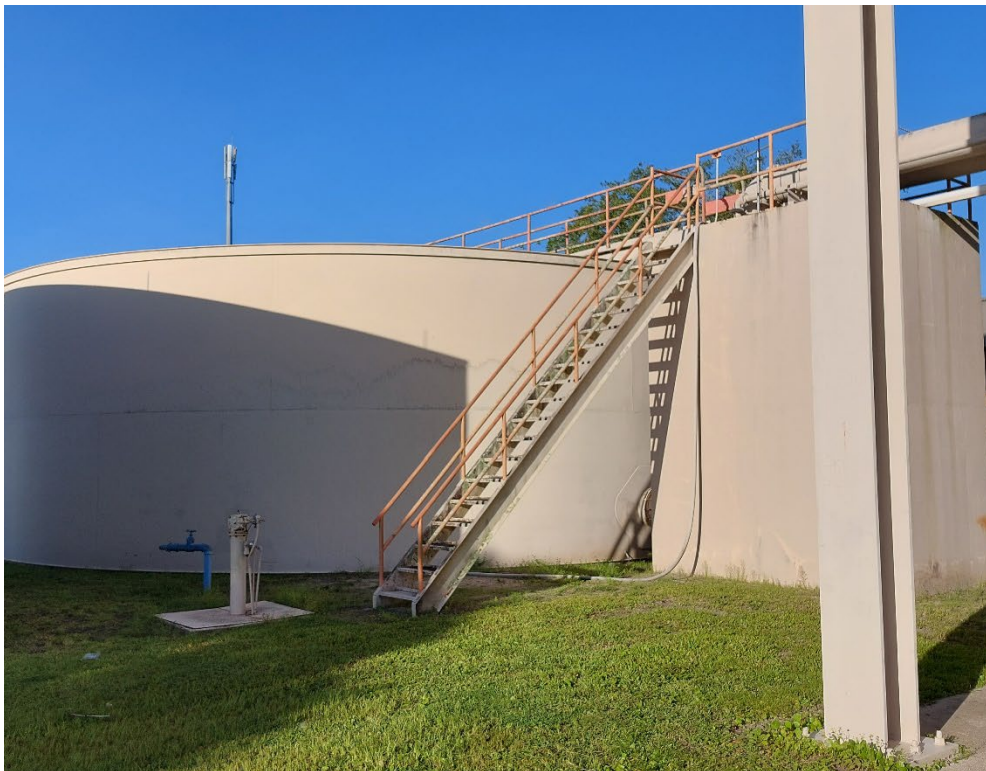
Photo 14 – LBP orange handrails on top of Structures 13 & 14

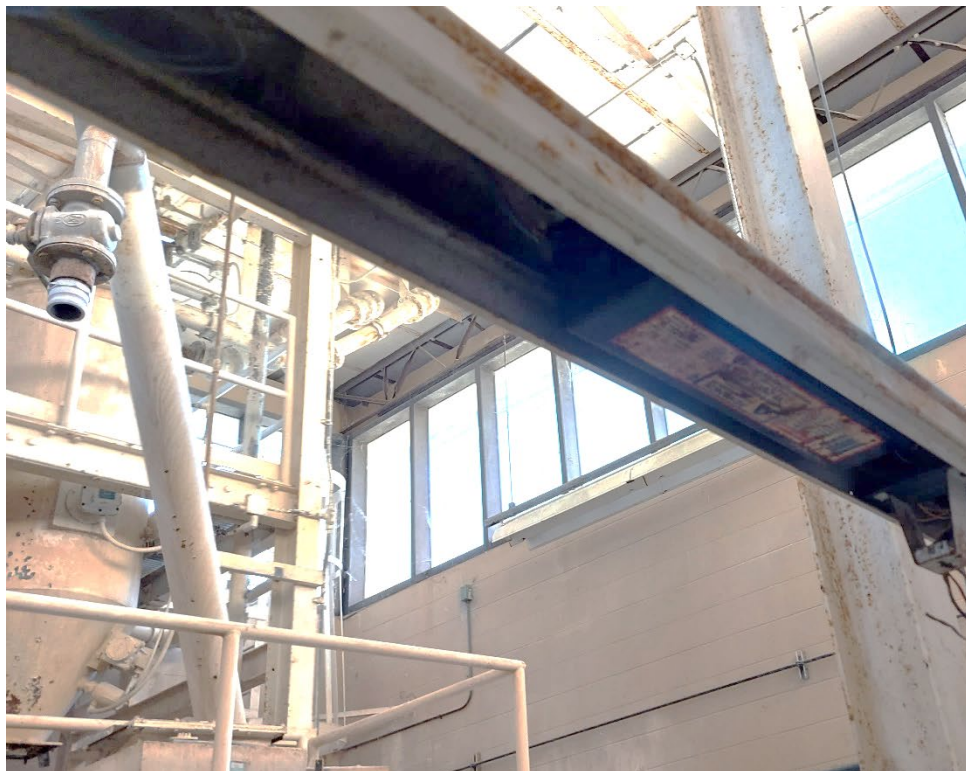
Photo 16 – Fluorescent light fixture with eight-foot bulbs (bulbs on ground)

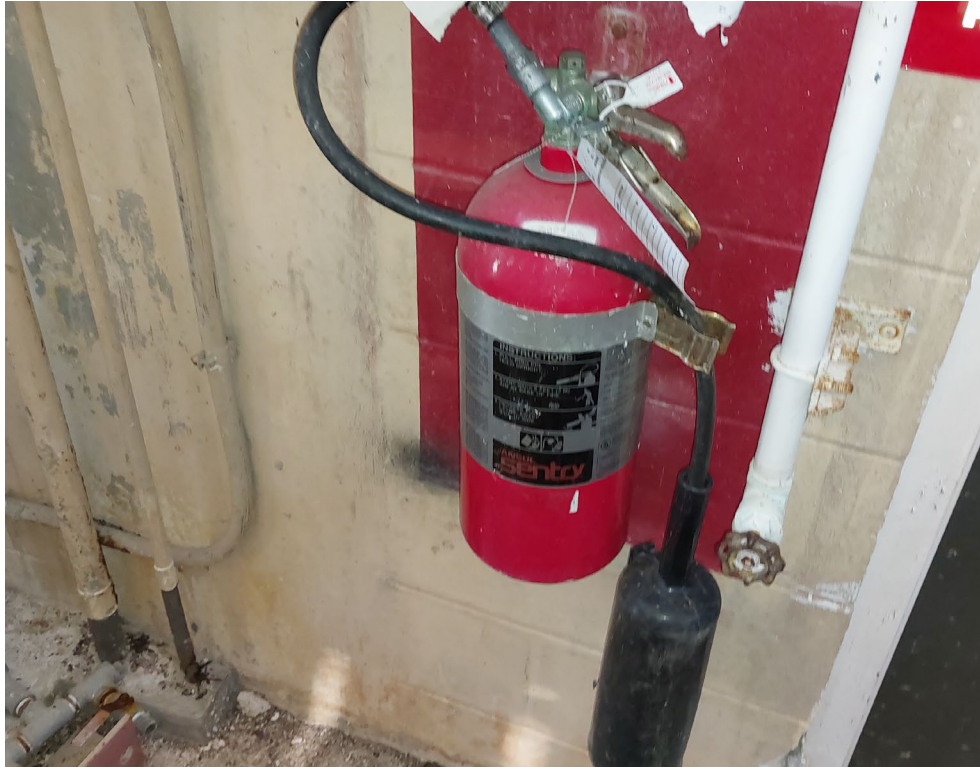
Photo 17 – wall mounted fire extinguisher

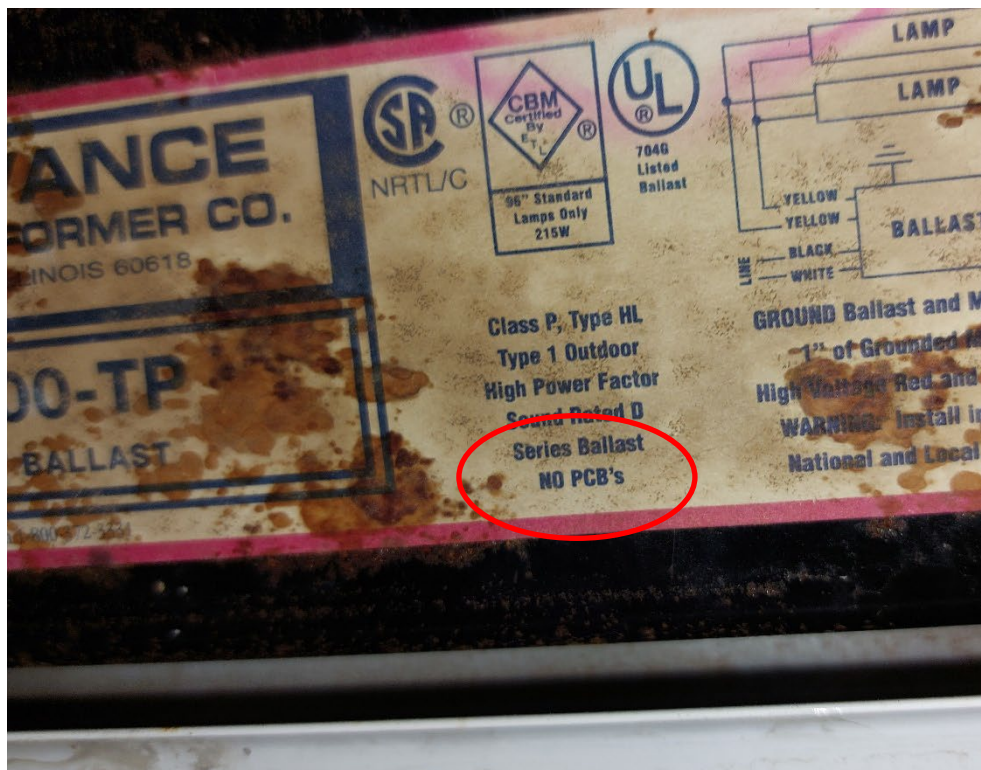
Note: all lighting ballasts observed with “No PCB” labeling ([Photo 18](#))

Photo 18 – “No PCB” labeling on all lighting ballasts observed

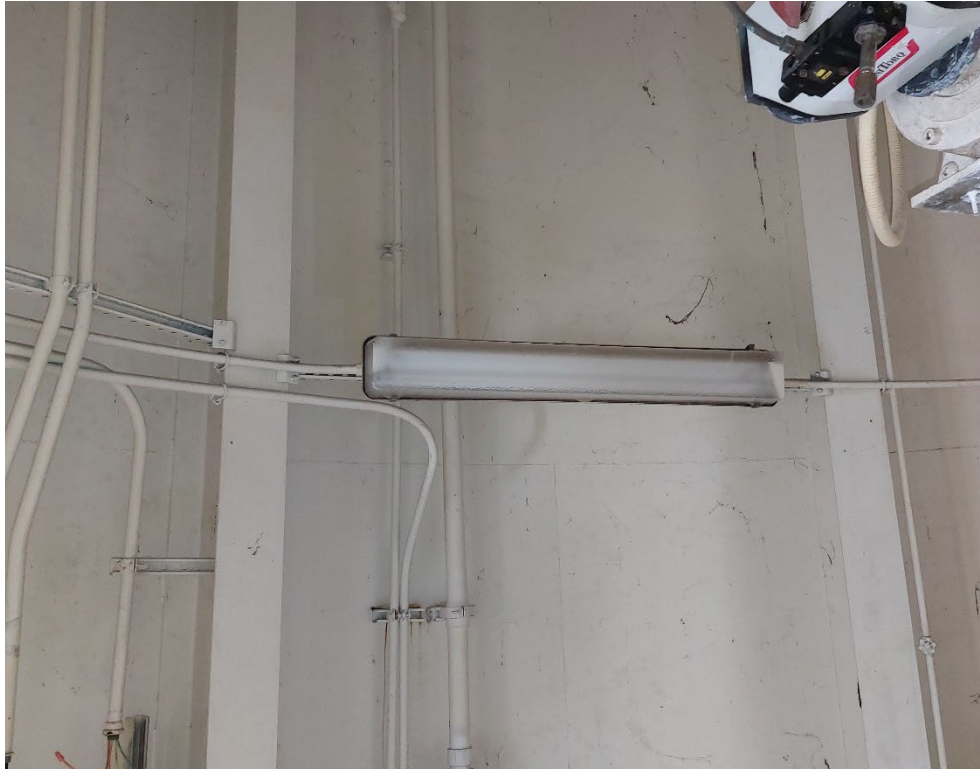
Photo 19 – Fluorescent light fixture with four-foot bulb

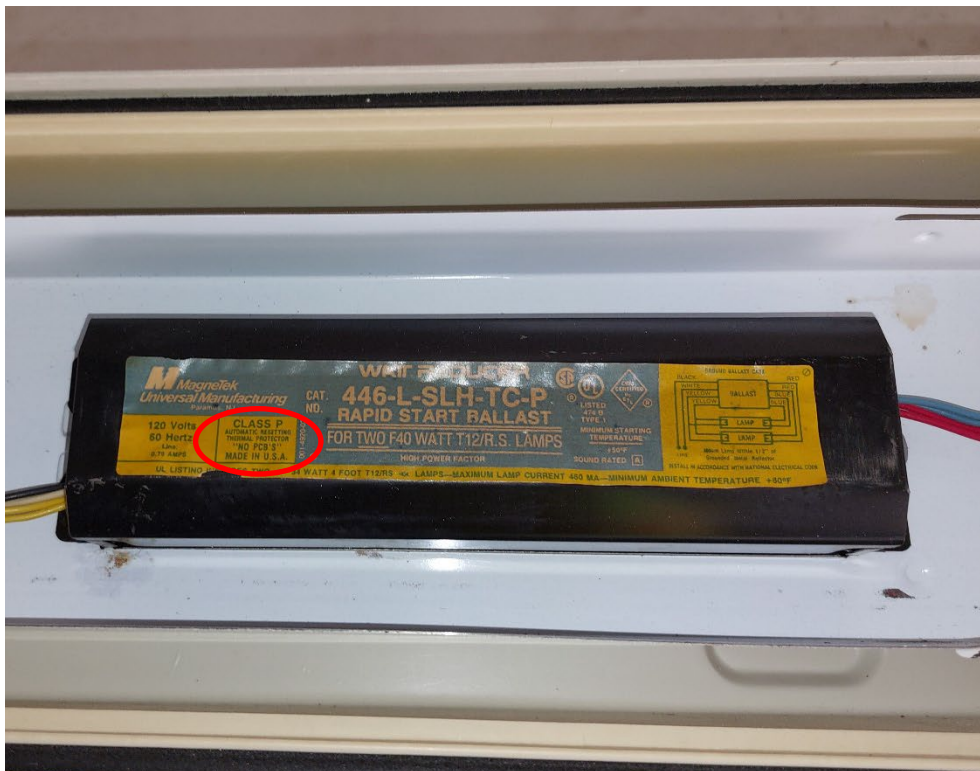
Note: all lighting ballasts observed with “No PCB” labeling ([Photo 20](#))

Photo 20 – “No PCB” labeling on all lighting ballasts observed

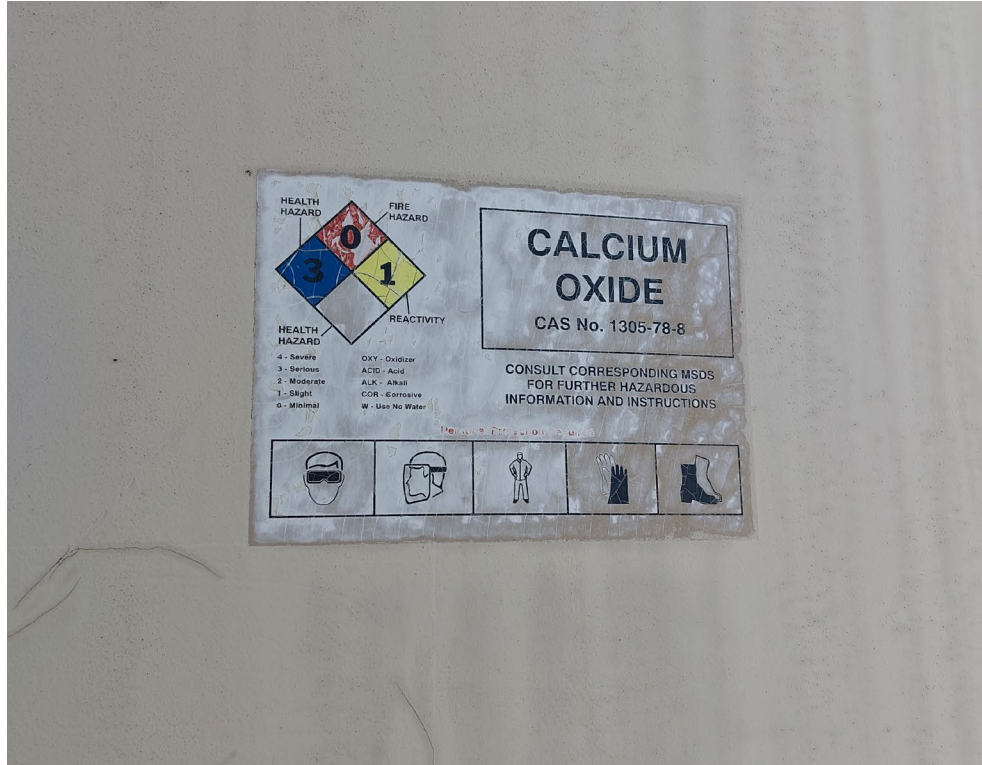
Photo 21 – Safety placard on tank/silo identified content as Calcium Oxide

Unknown contents inside tanks/silos should be evaluated for content or confirmed to be empty prior to demolition activities. If content is observed inside the silos/tanks, appropriate disposal should be conducted by a licensed waste hauler/landfill prior to demolition activities.

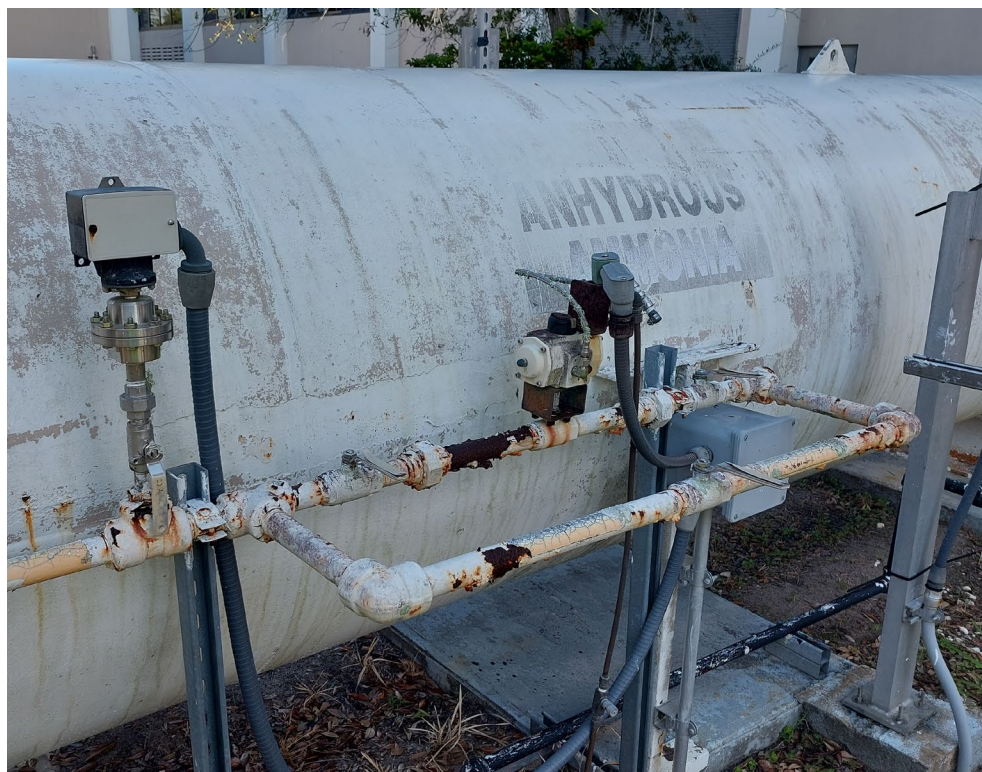
Photo 22 – “Chlorine Tank” labeled “Anhydrous Ammonia” in field
