ADDENDUM 2
Via E-Mail
DATE: April 26, 2024

Contract: 23-C-00013; Morris Bridge Filter Building Improvements ReBid

**COMPREHENSIVE PRE-DEMOLITION SURVEY REPORT FOR:
MORRIS BRIDGE WATER PUMPING FACILITY**

PROJECT NO. 22009-0142

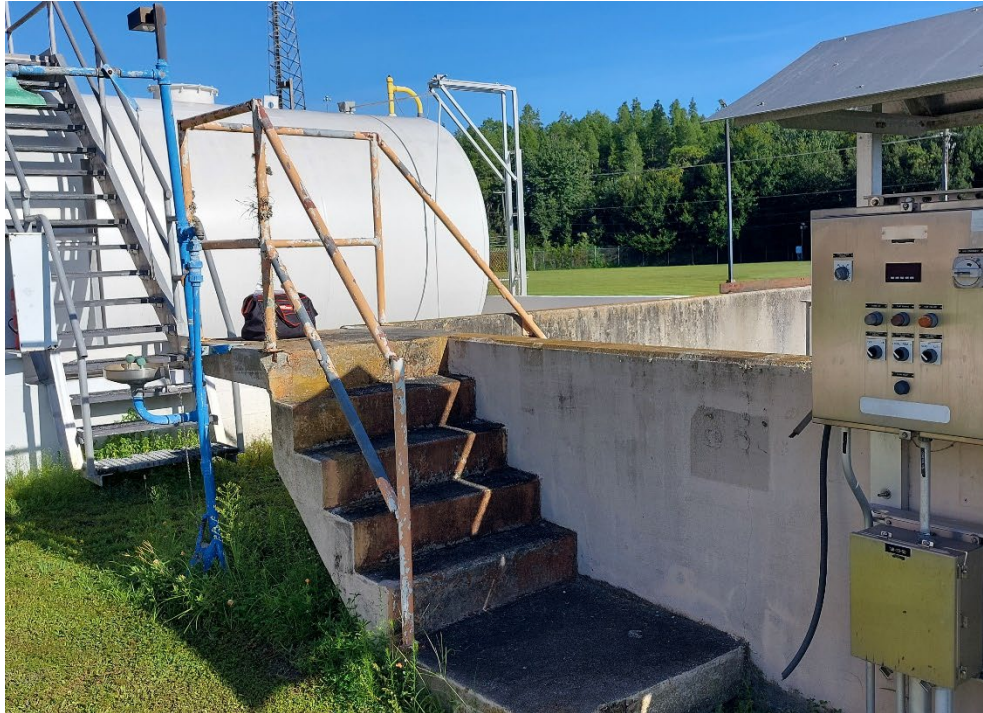
Photo 3 – LBP orange metal handrail on Structure 3

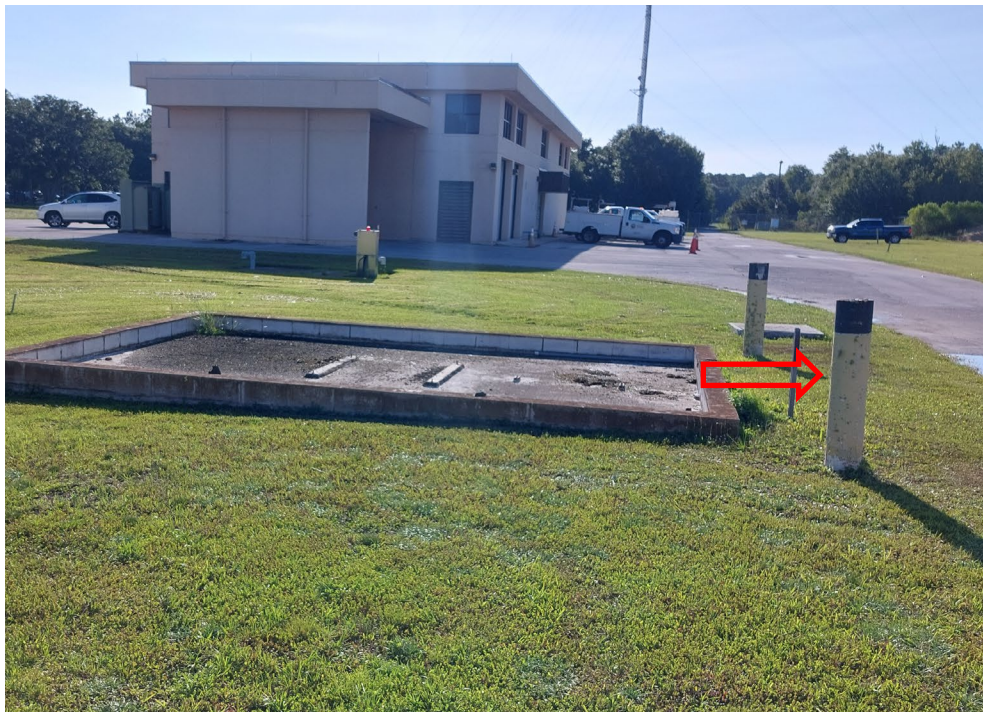
Photo 4 – LBP yellow metal parking bollards on Structure 5

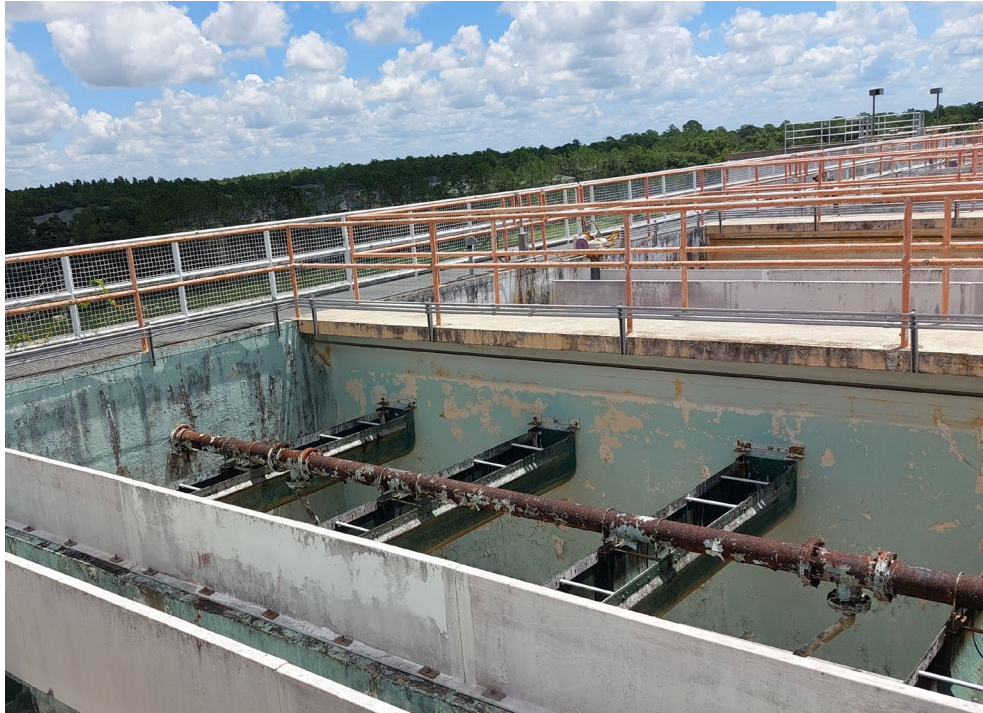
Photo 5 – LBP orange metal handrails on roof of Structure 6

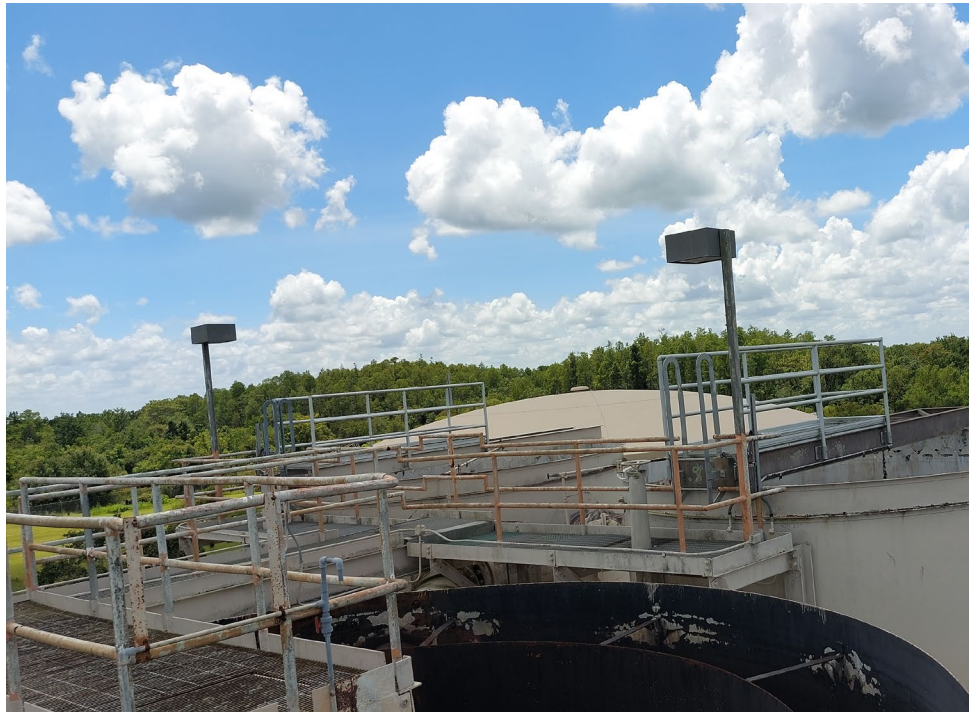
Photo 6 – LBP orange metal handrails on top of Structure 7

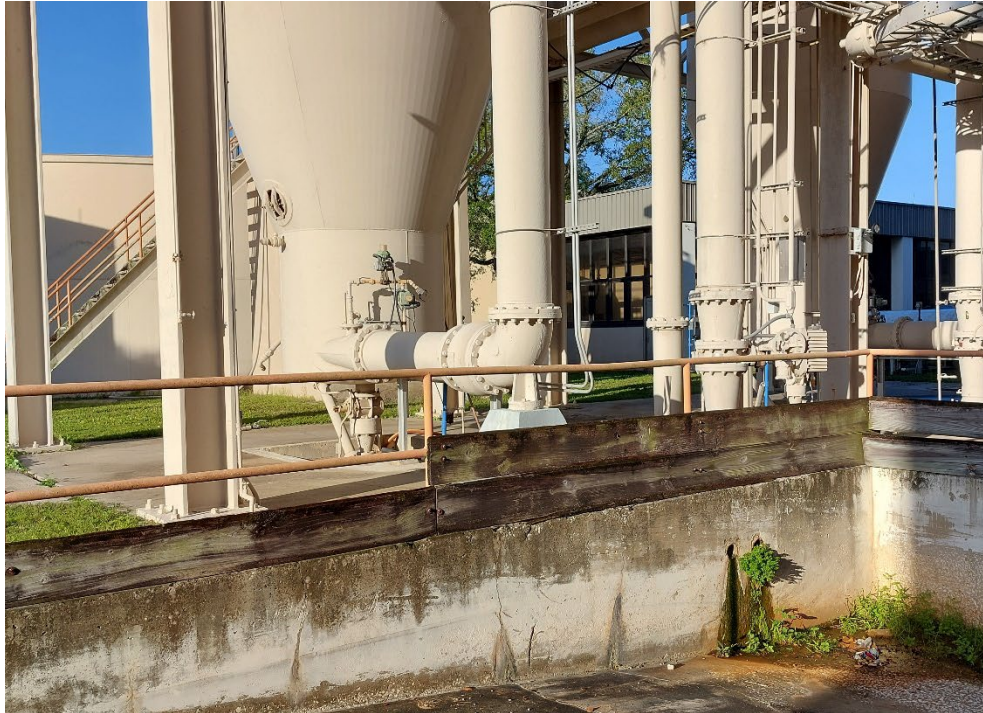
Photo 7 – LBP orange metal handrails around Structures 8a & 8b

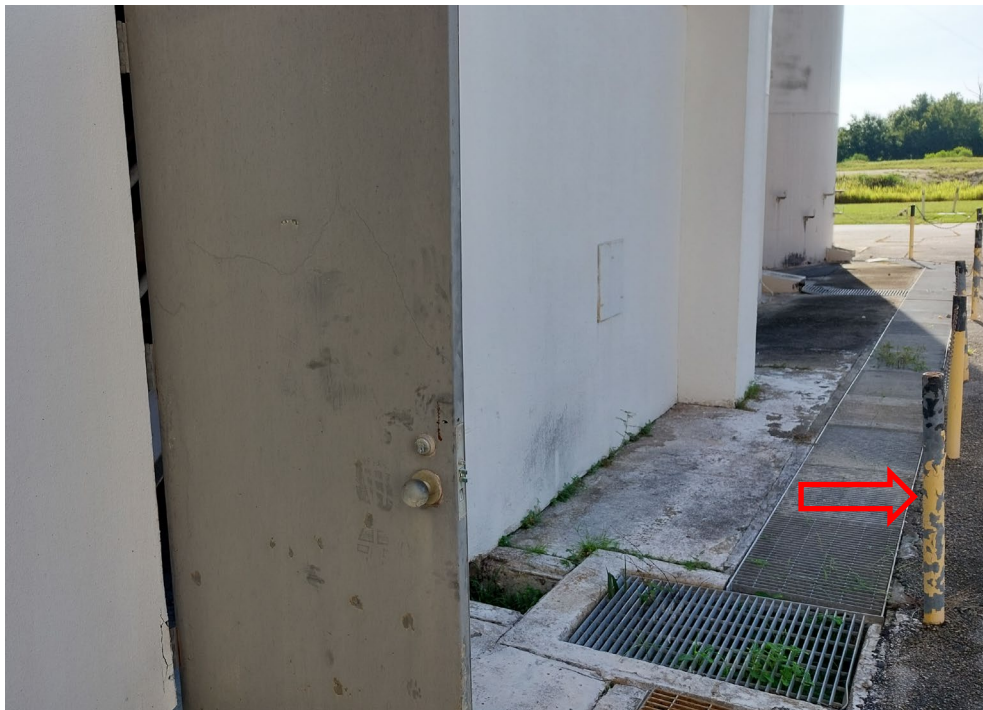
Photo 8 – Yellow metal parking bollards of Structure 9

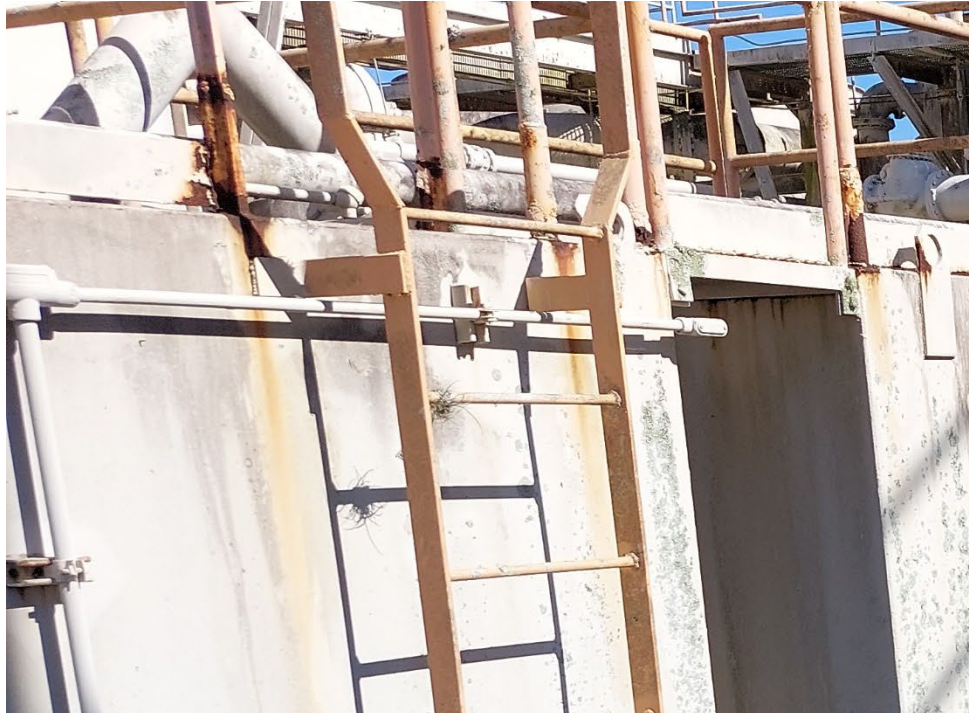
Photo 9 – LBP orange metal handrails on roof of Structure 9

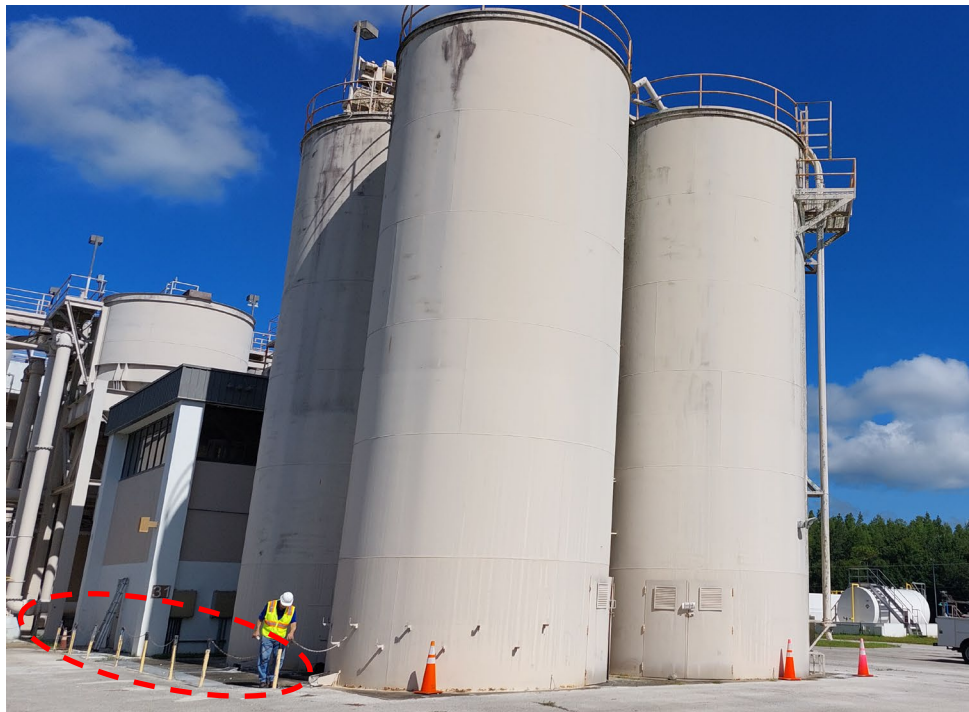
Photo 10 – LBP yellow on metal parking bollards of Structure 10

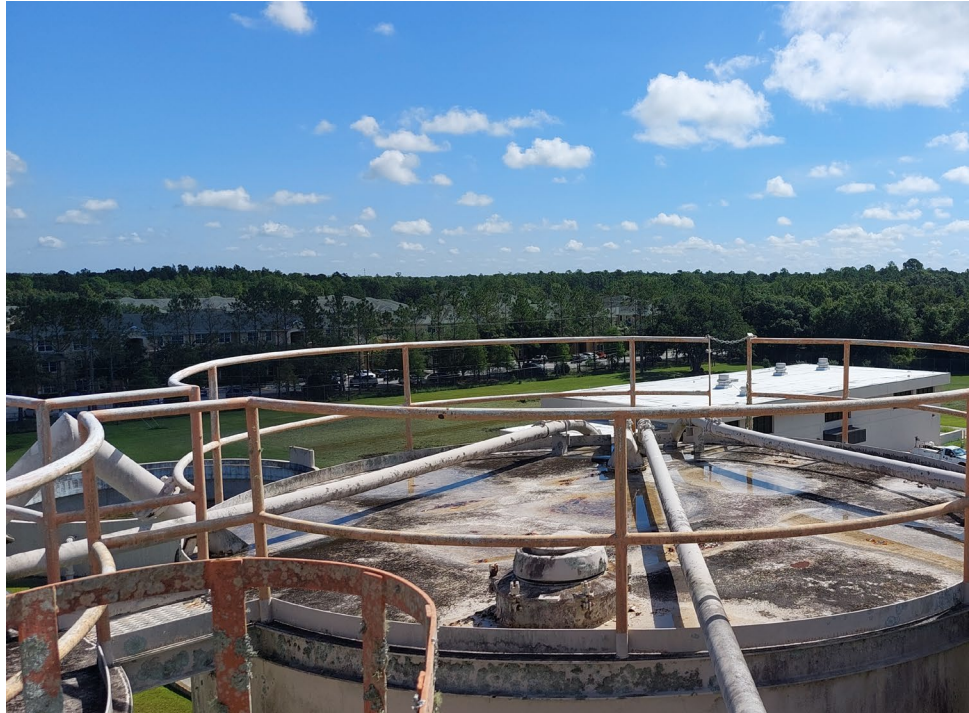
Photo 11 – LBP orange metal handrails on top of tanks/silos of Structure 10

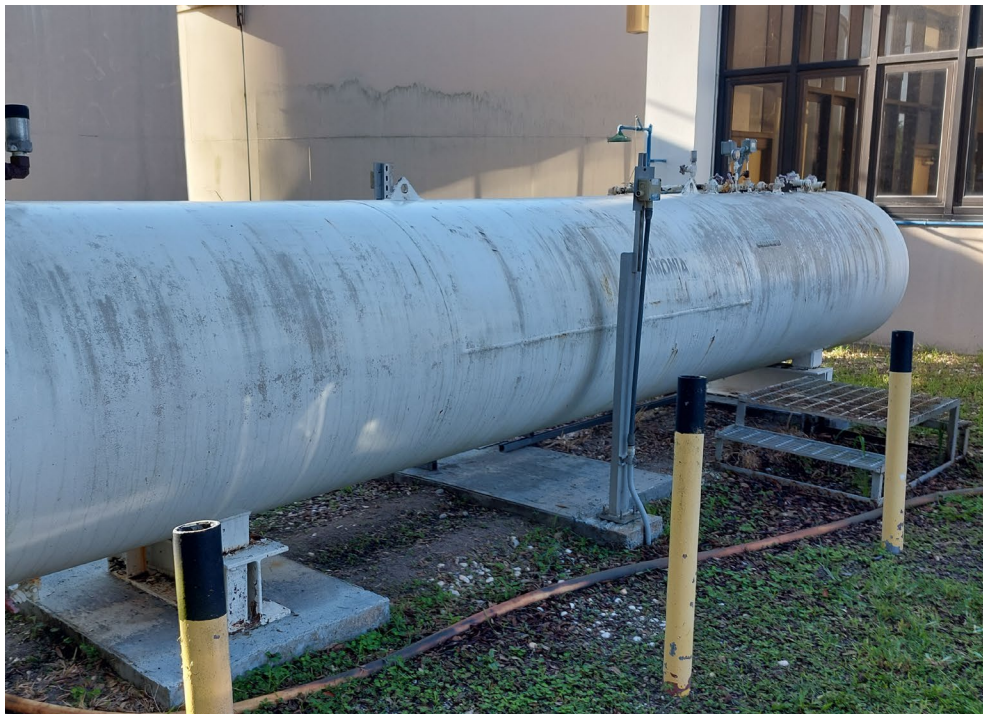
Photo 12 – LBP yellow metal parking bollards around Structure 11

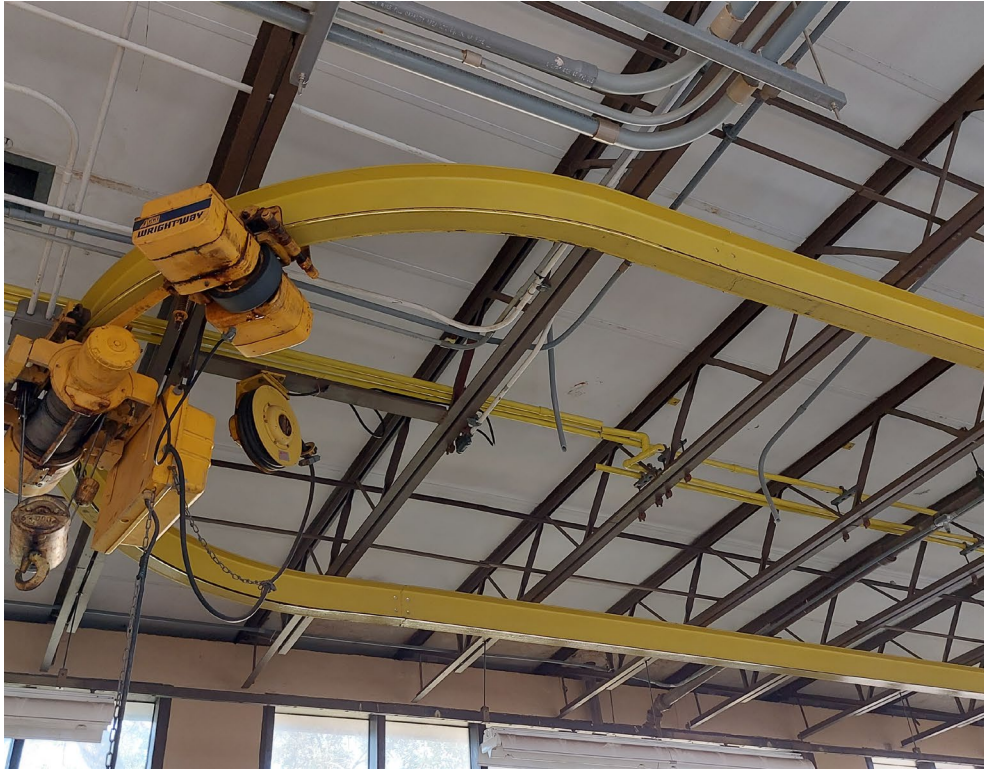
Photo 13 – LBP yellow metal crane/hoist inside Structure 12

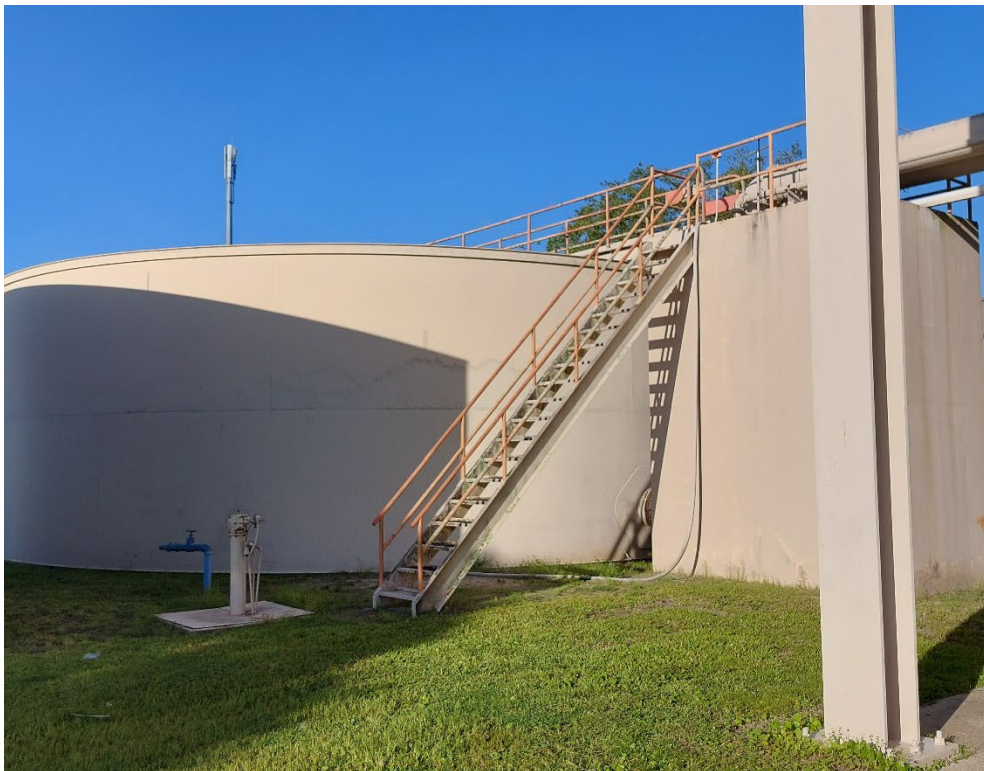
Photo 14 – LBP orange handrails on top of Structures 13 & 14

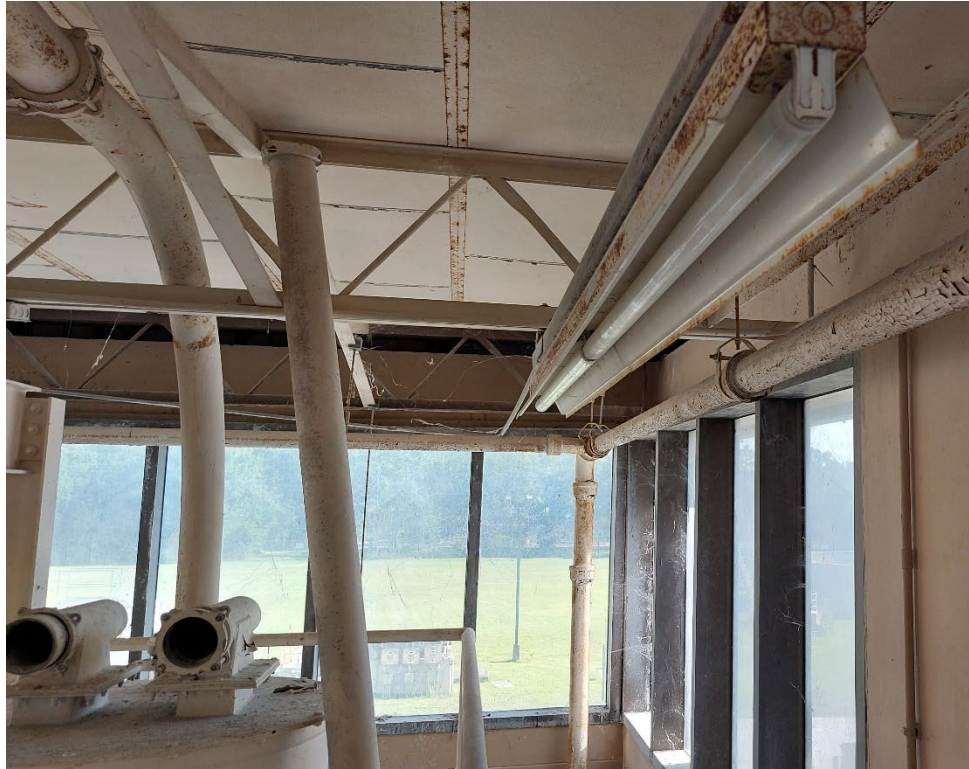
Photo 15 – Fluorescent light fixture with four-foot bulb

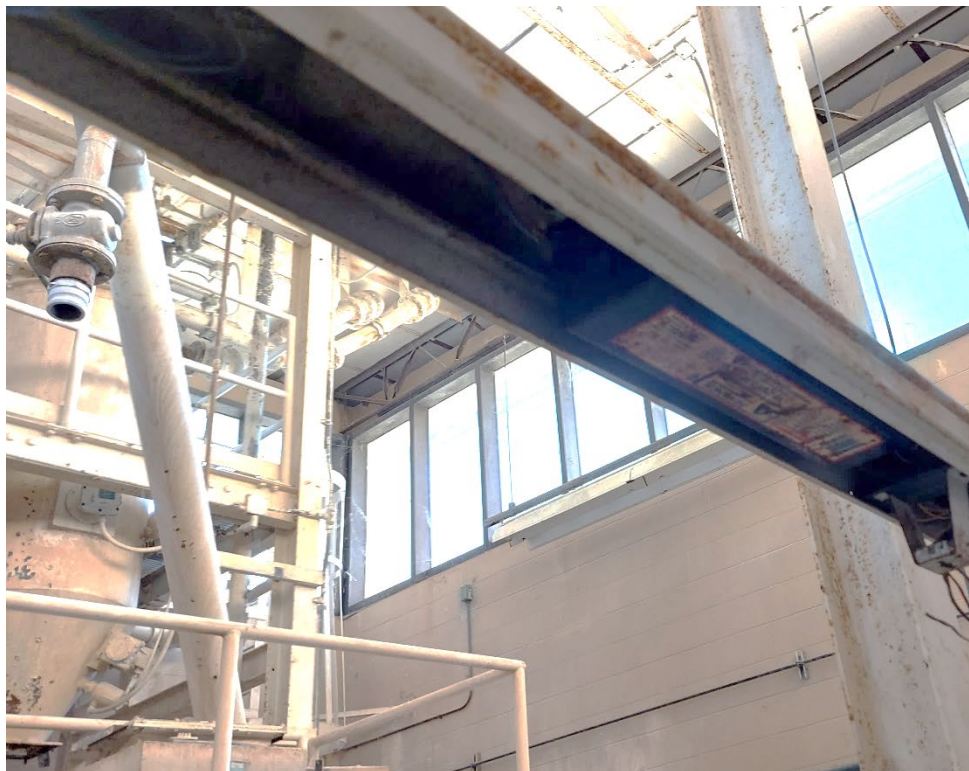
Photo 16 – Fluorescent light fixture with eight-foot bulbs (bulbs on ground)

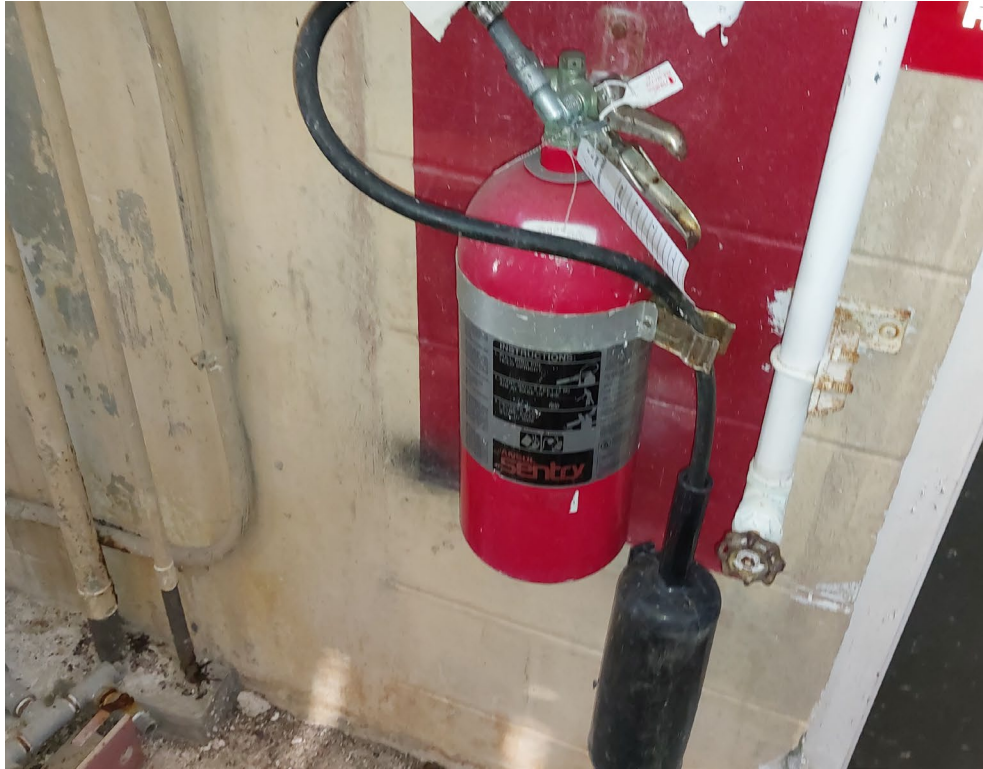
Photo 17 – wall mounted fire extinguisher

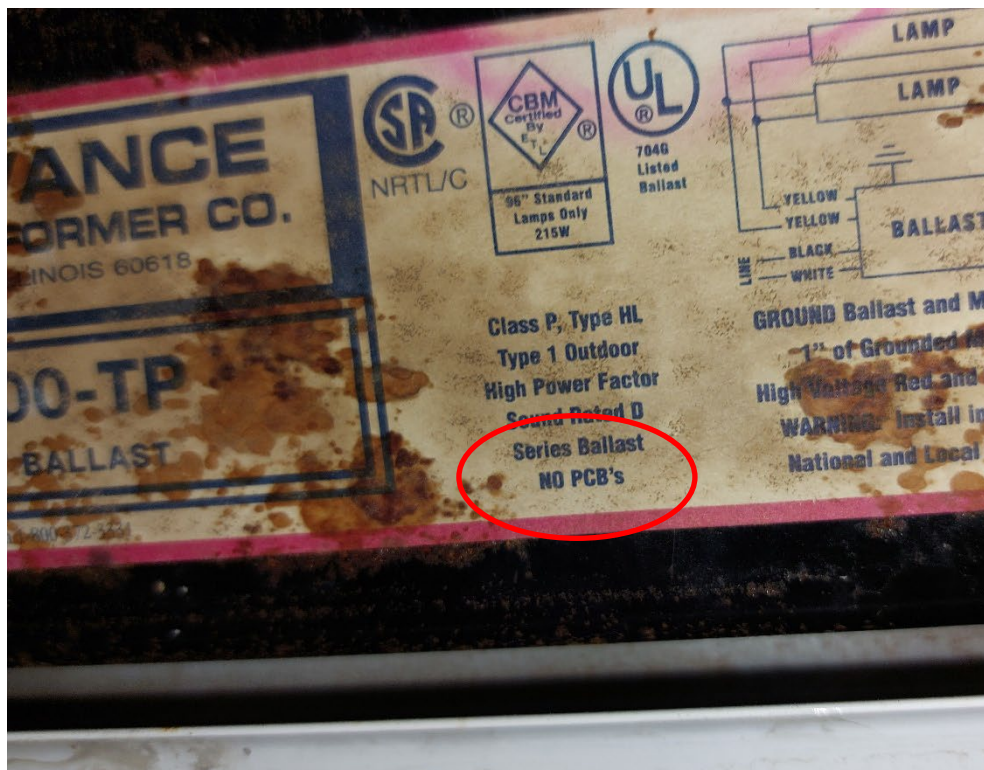
Note: all lighting ballasts observed with “No PCB” labeling ([Photo 18](#))

Photo 18 – “No PCB” labeling on all lighting ballasts observed

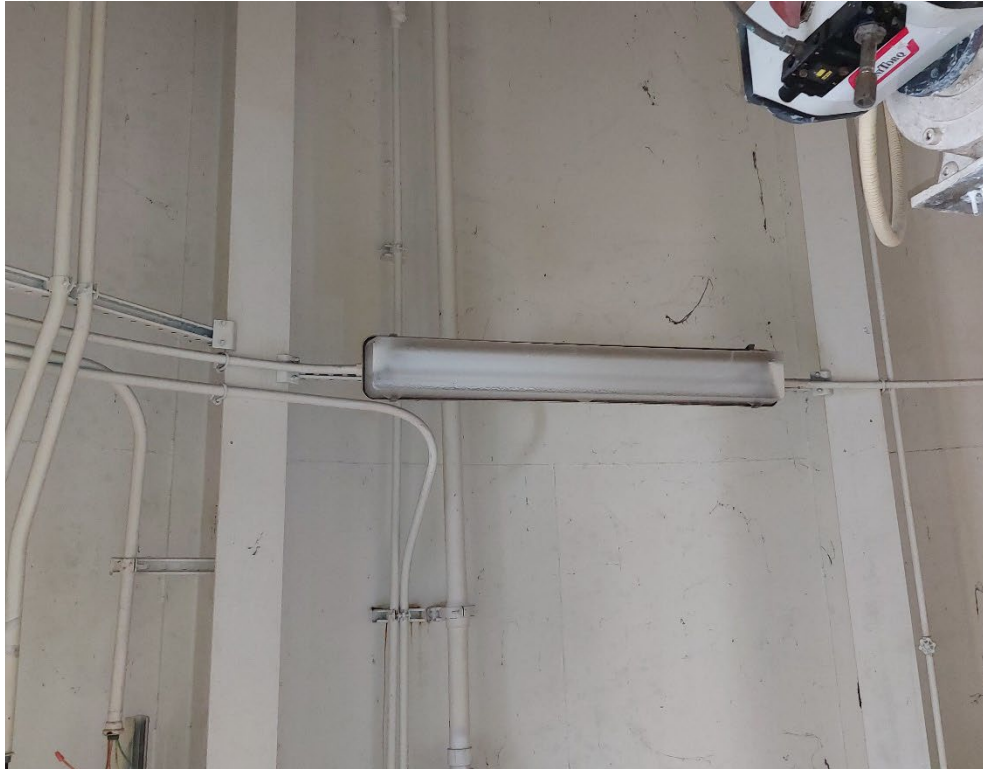
Photo 19 – Fluorescent light fixture with four-foot bulb

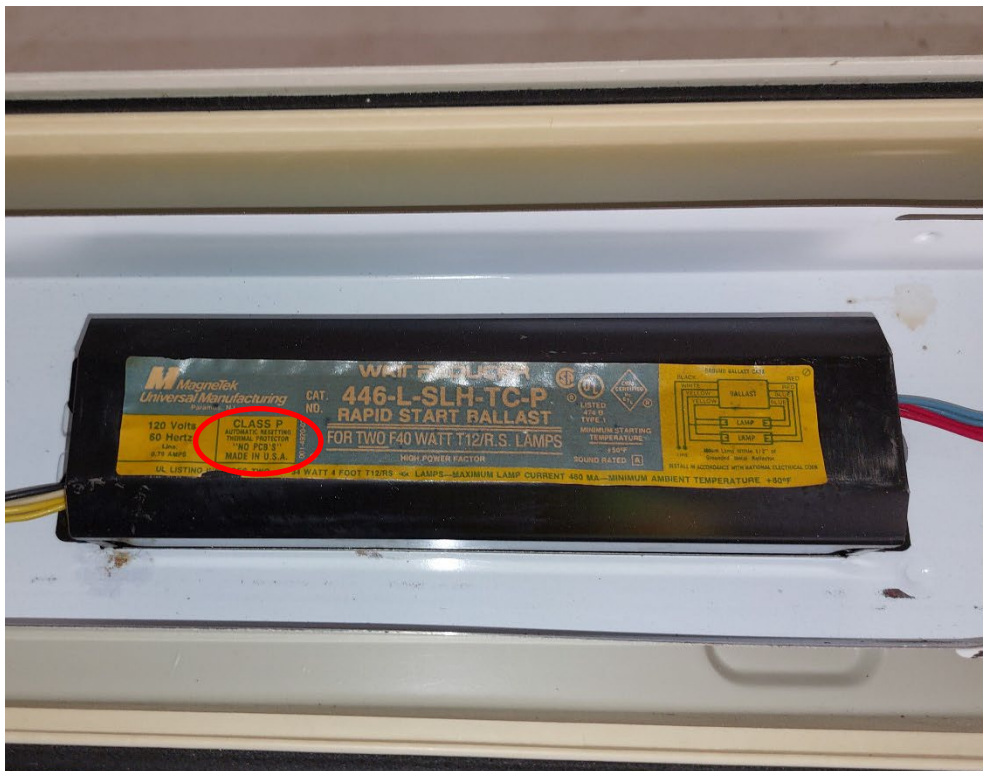
Note: all lighting ballasts observed with “No PCB” labeling ([Photo 20](#))

Photo 20 – “No PCB” labeling on all lighting ballasts observed
