ADDENDUM 4

Contract: 24-C-00032; TPD Howard Avenue Annex Building

## STRUCTURAL ASSESMENT INSPECTION & EVALUATION REPORT

RE: COT Evidence Storage & Impound Lot  
5005 N Howard Ave. Tampa, FL 33601  
Structural Assessment of Existing Facility Building

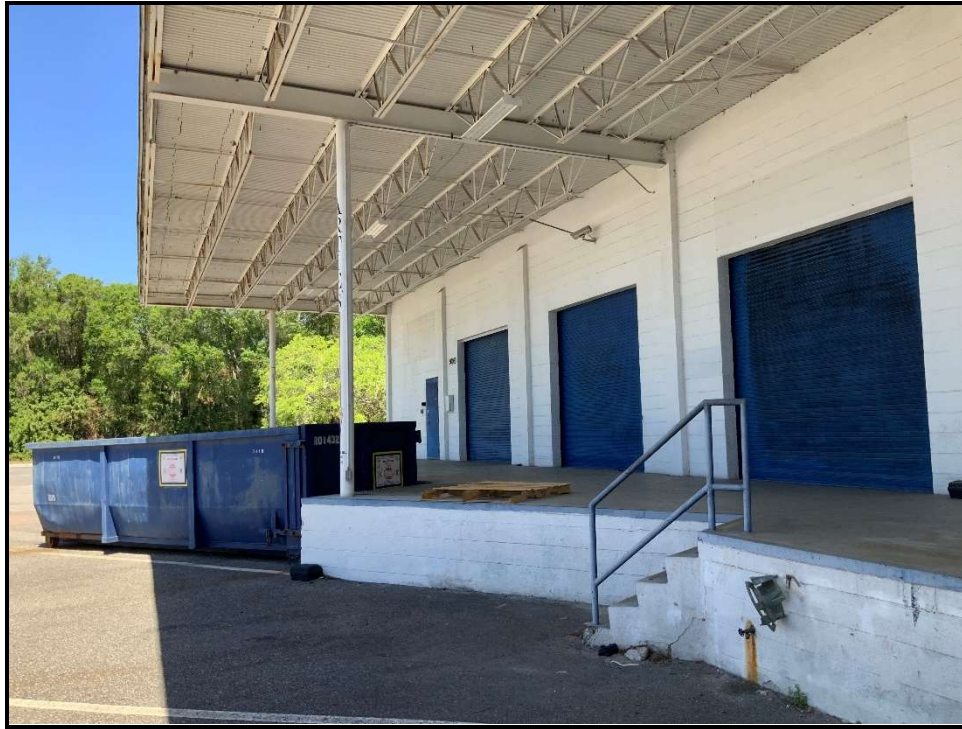
**Photo 1:** Loading dock platform areas

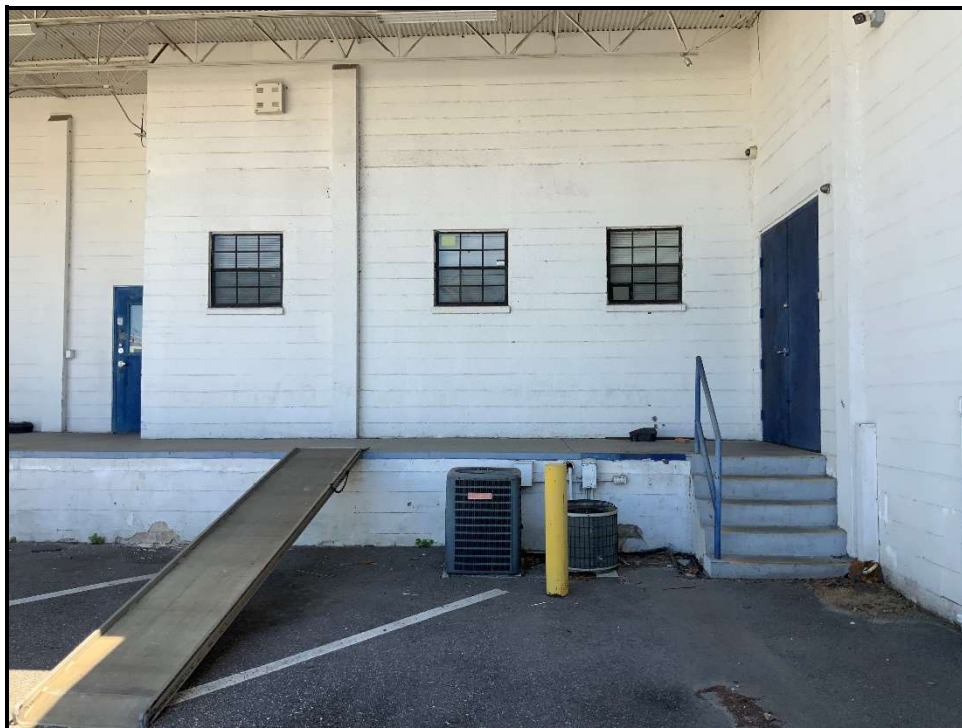
**Photo 2:** Loading dock platform and building access

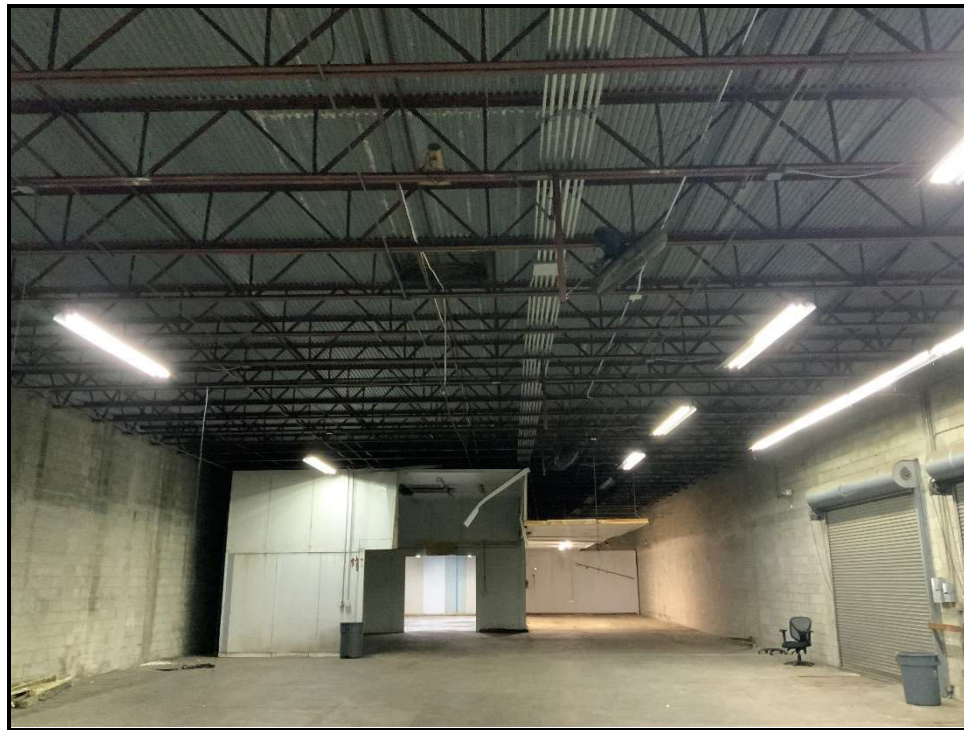
**Photo 3:** South west wing

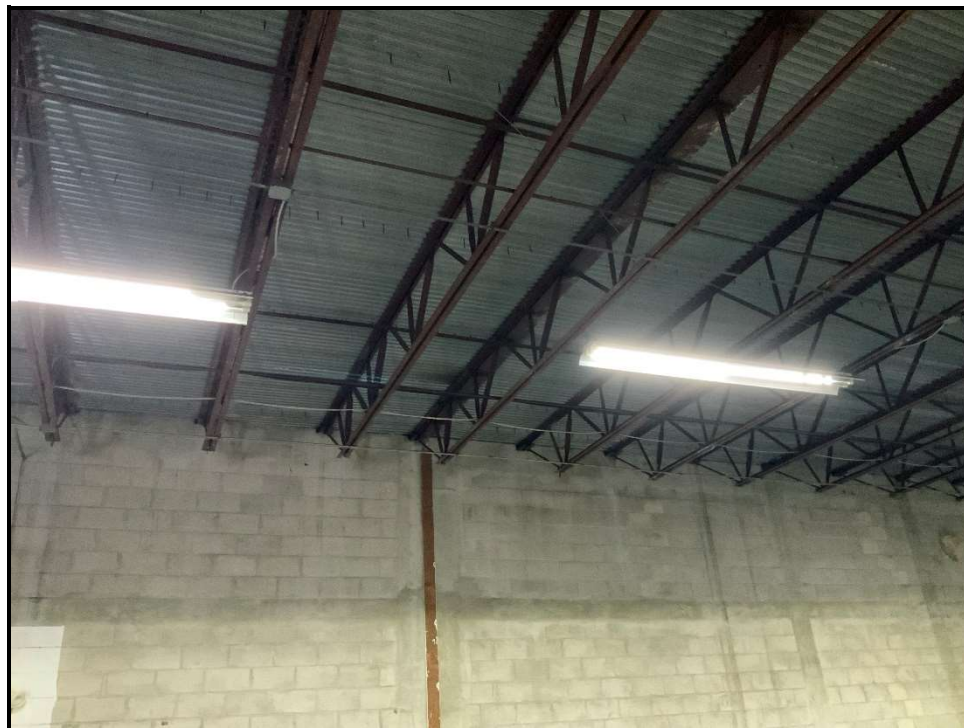
**Photo 4:** South west wing typical roof framing and construction/expansion joint

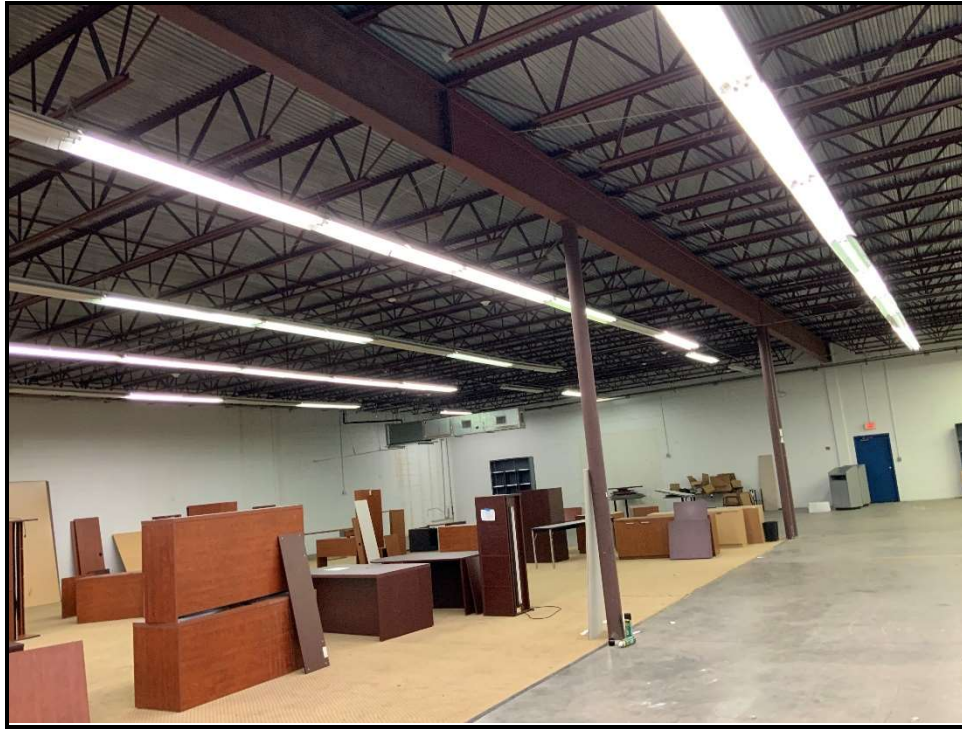
Steel beams and columns were found adequate to comply with current codes.

**Photo 5:** Steel frames placement. 6"Ø steel tube columns and W24 roof beams

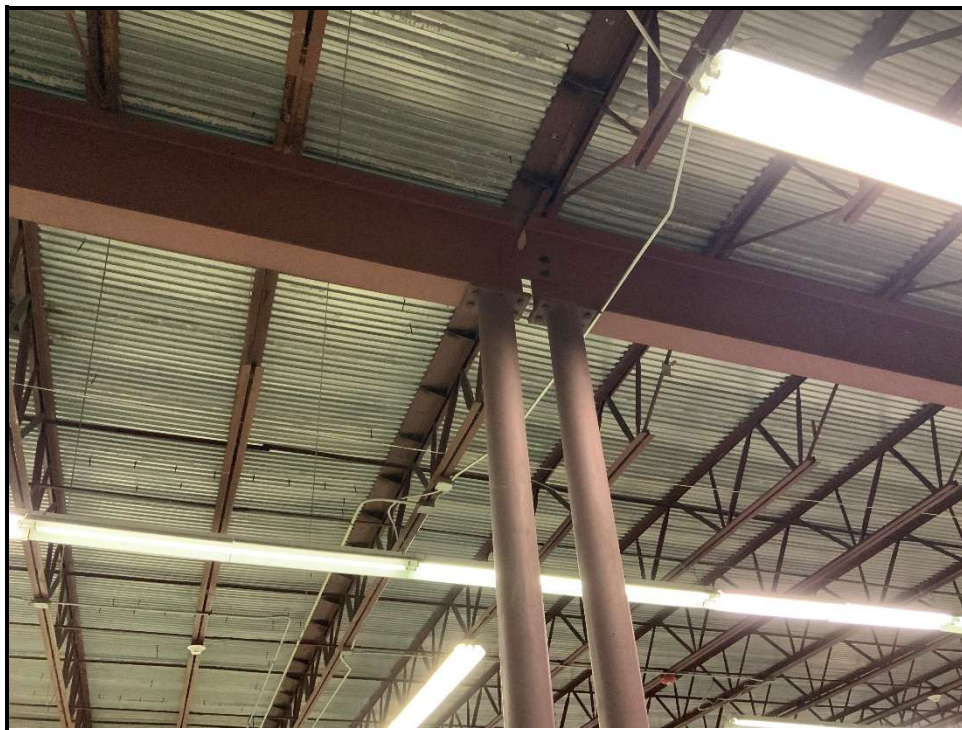
**Photo 6:** Steel frames at construction/expansion joint

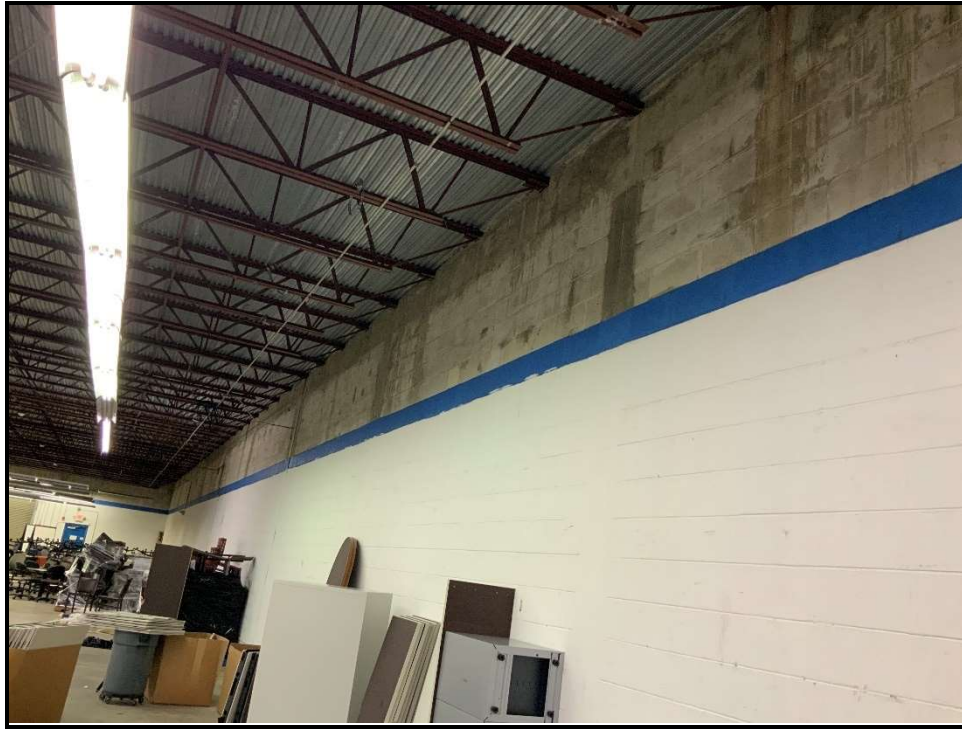
Masonry wall were analyzed as bearing walls, and frame shear walls to resist lateral loads from diaphragm and were found to be sufficient to withstand forces and comply with minimum requirements. However, as a mean to transfer wind out of plane loads, some of the exterior walls were found insufficient to meet and resist wind out of plane loads in combination with sustained dead loads, due to no reinforcement used in block cells. Walls required to be reinforced with vertical #5 rebar at 48" O.C. Refer to appendix "D" for location of walls to be reinforced.

**Photo 7:** Typical interior bearing wall arrangement

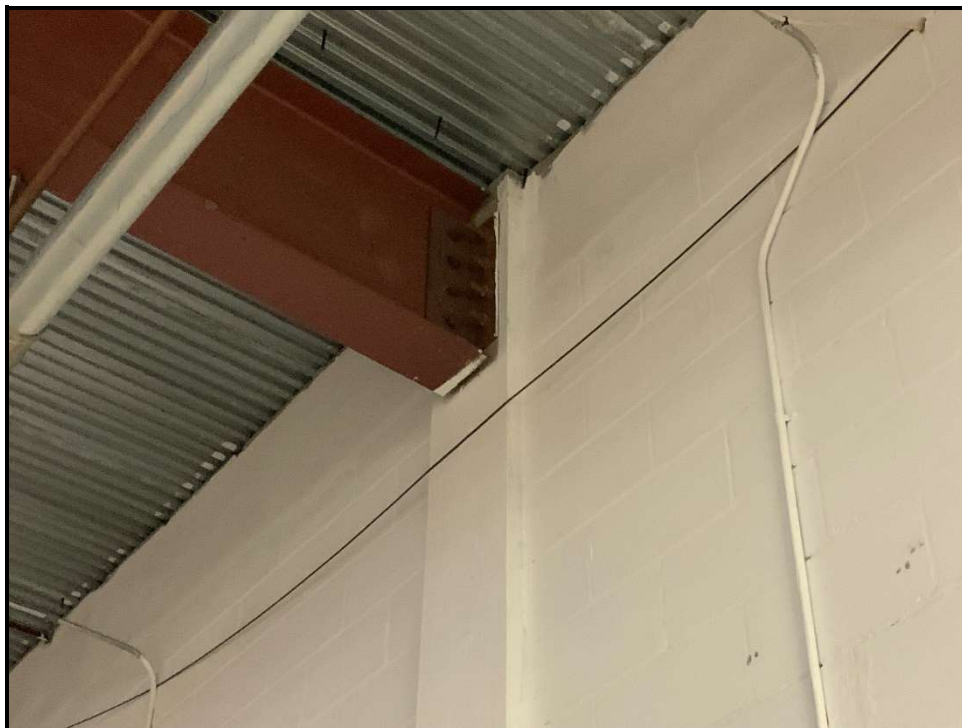
**Photo 8:** W24 Steel beam to concrete column connection

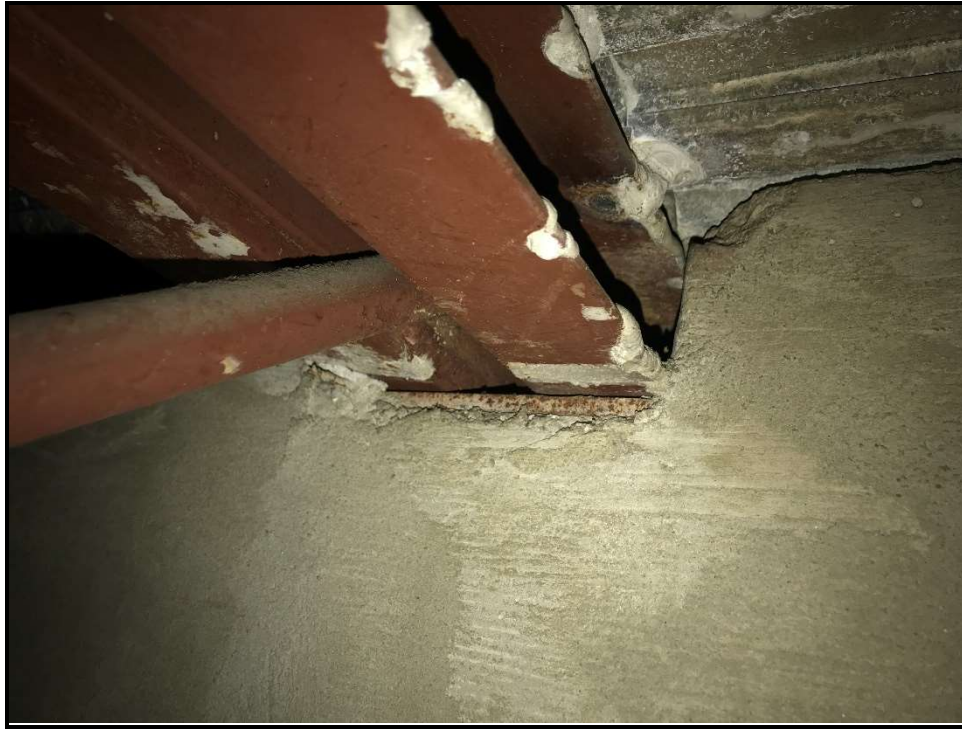
At the roof joist connections to top of concrete tie beams, it was not possible to observe the current condition or connection of the joist seat to embed plate, thus it was assumed that a field welded connection was provided.

Roof joists were found adequate to sustain gravity loads and design and service level. However no horizontal or x bridging was observed at interior and exterior joists at first panel point. It is required to install a continuous bridging at first panel point at both ends. The minimum weld required to the joist seat and embed plate would be 3/16" x 3" at each joist.

**Photo 9:** Typical roof joist seat at concrete tie beam.

- Roof joists require to be provided with horizontal bridging at first panel point bottom chord as specify by the SJI.
- Exterior masonry walls as shown on Appendix "D" required to be reinforced with vertical #5 rebar at 48" O.C. See SSK-001 (Appendix "B")
- Recommend interior slab on grade crack repairs. See SSK-002 (Appendix "B").

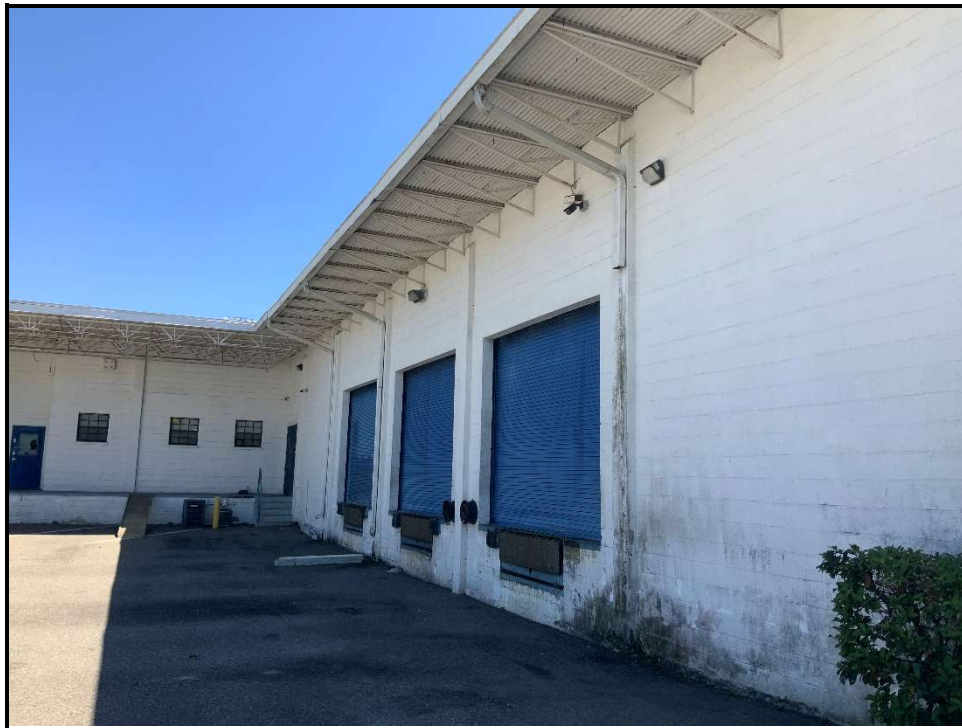
**Photo 10:** West wing north wall partial elevation

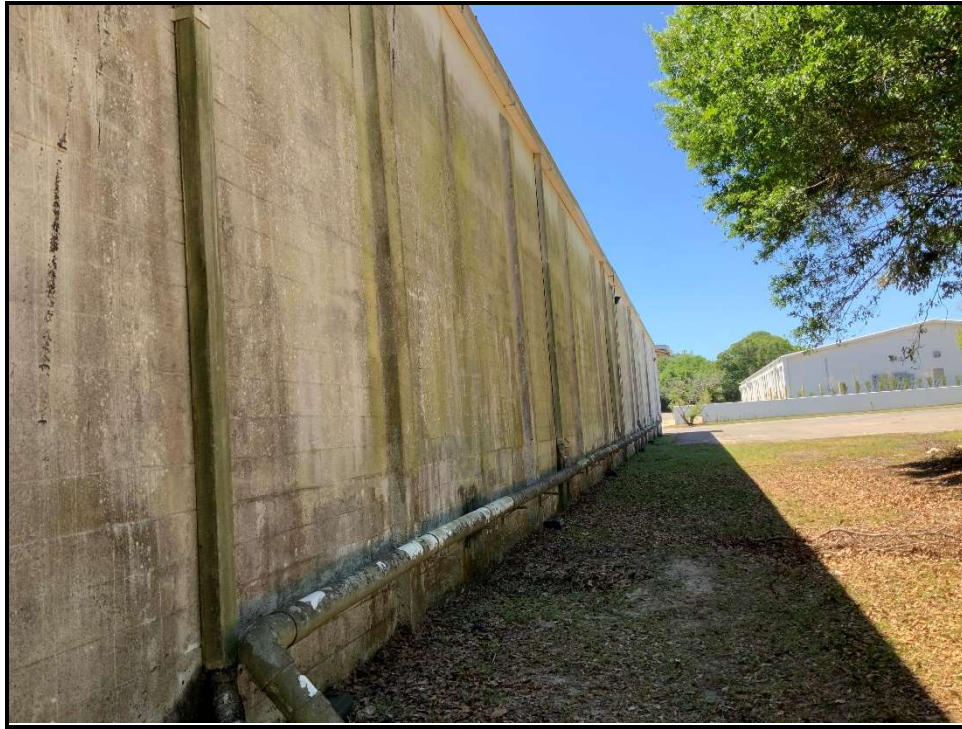
**Photo 11:** West wall elevations.

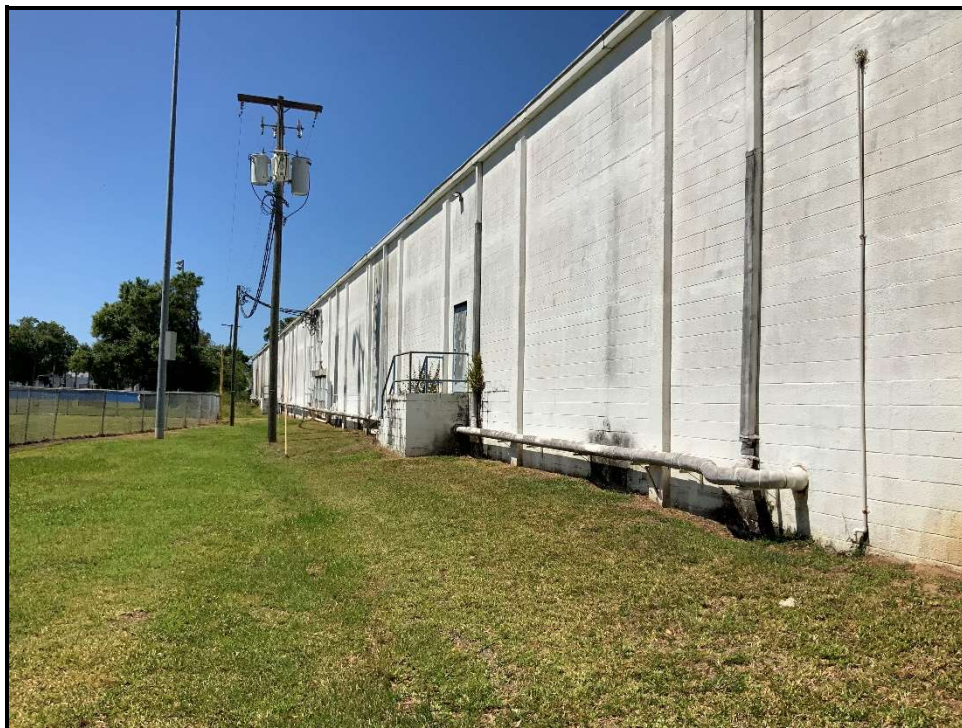
**Photo 12:** South walls elevation

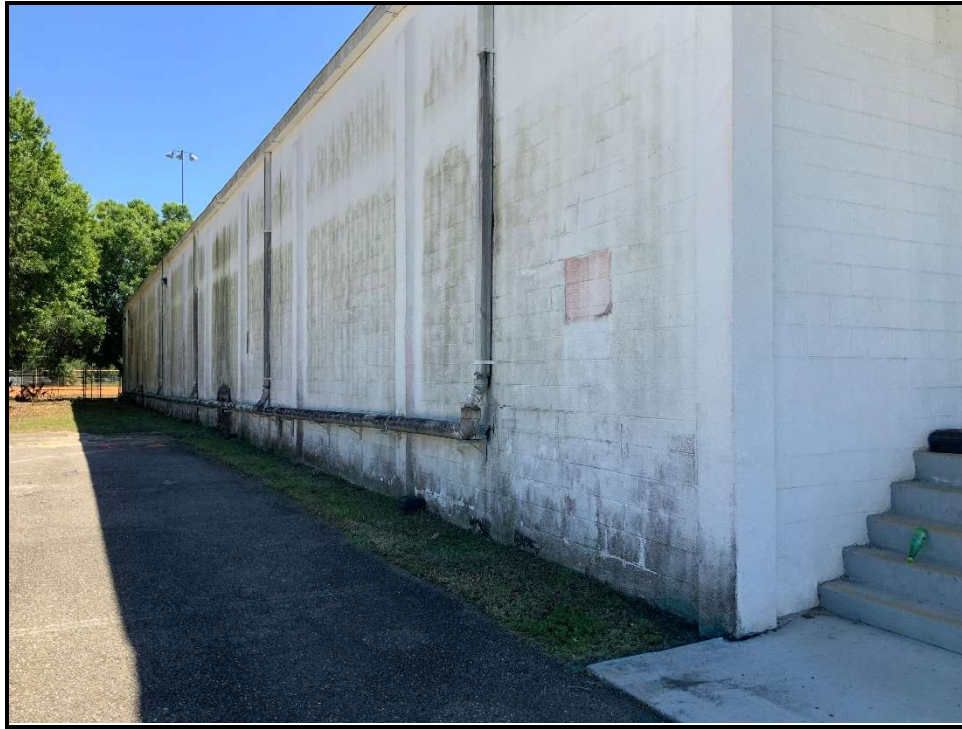
**Photo 13:** East wing north wall elevation

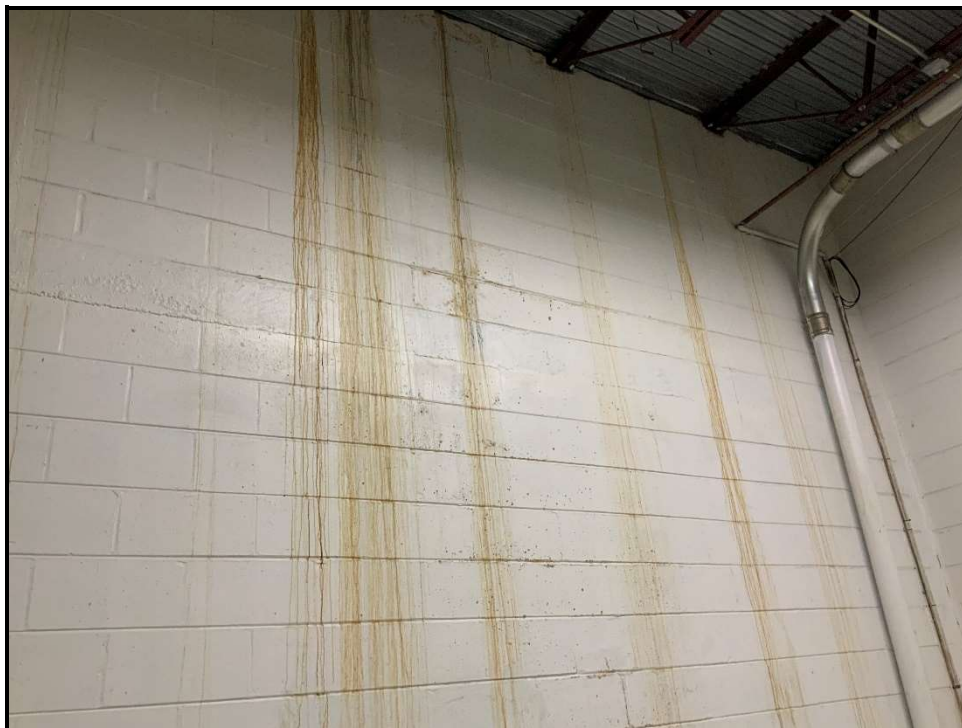
**Photo 14:** Sign of licking and rust

Recommendations: The above observations may not represent a significant risk to the structure, but it is our recommendation provide cleaning and remedial procedures. (See appendix B)

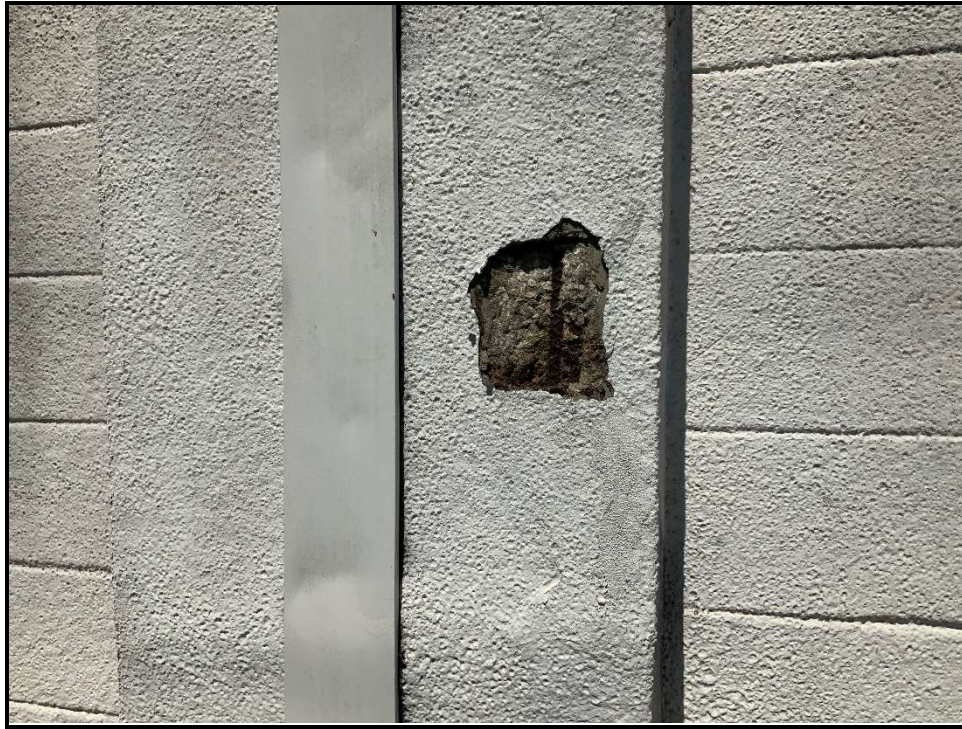
**Photo 13:** Concrete column spalling

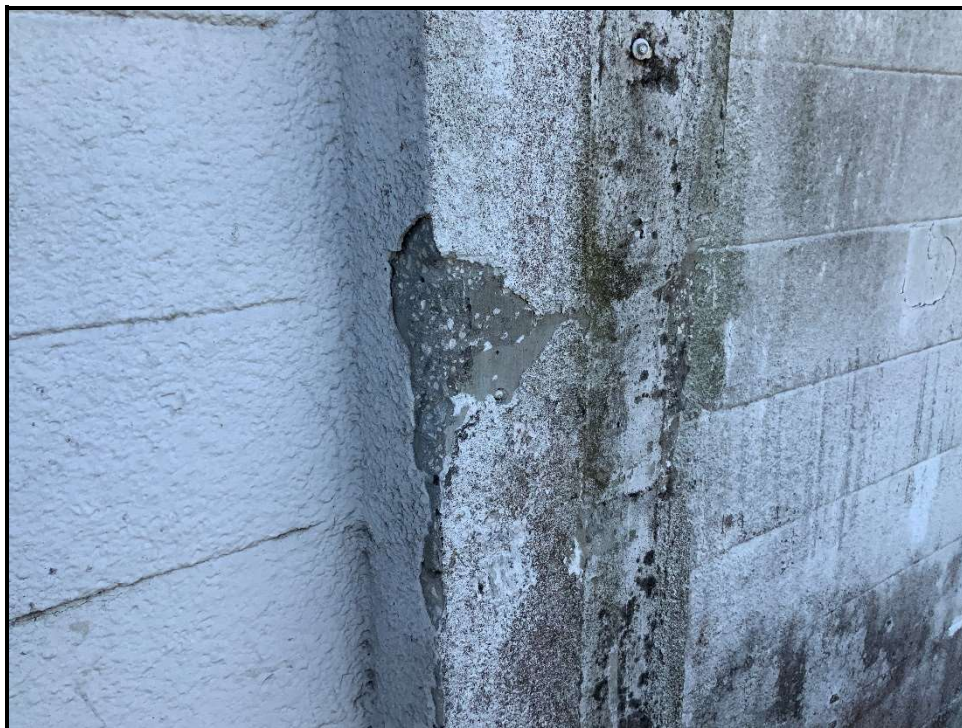
**Photo 14:** Concrete column spalling

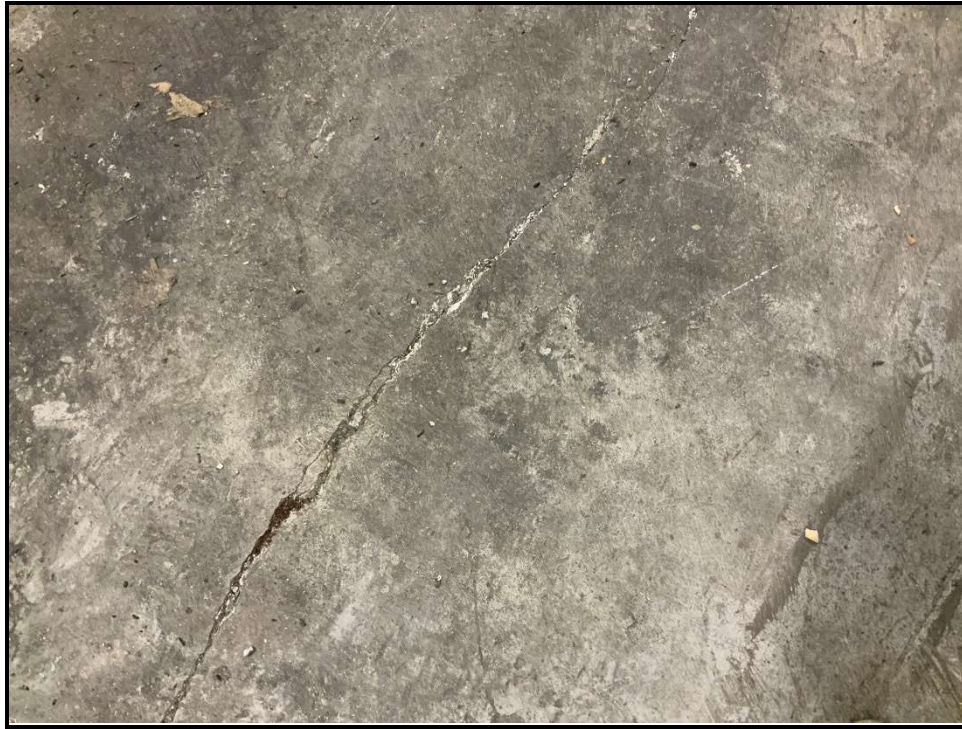
**Photo 13:** Typical slab on grade cracks

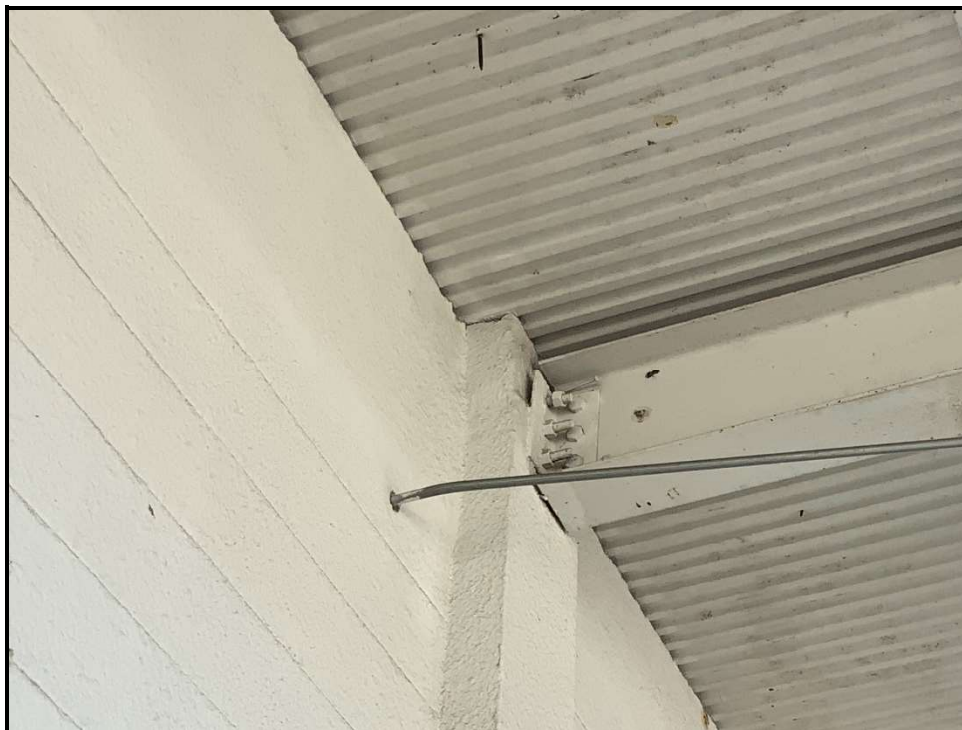
**Photo 14:** Loos bolt at frame connection
