ADDENDUM NO. 1

Contract 14-C-00048; Hillsborough River Dam Walkway Steel Girder and Concrete Repairs

**Subject: Structural Engineering Services
Steel Girder Assessment - Hillsborough River Dam
TWD W.O. 7149
Tampa, Florida**

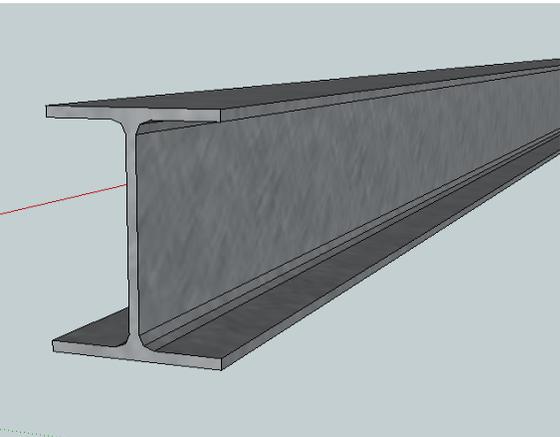
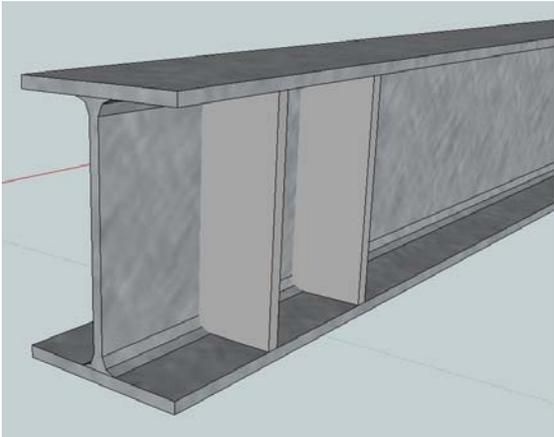
- 3. Slight buckling of the girder web section was observed in Bay #9 adjacent to stringer #5. Refer to *Figure A-27* in Appendix A. The cause of damage is unknown but was assumed to be damaged during either transport or construction processes. The web damage has likely caused the beam to lose a portion of its originally design strength capacity and is recommended to be repaired/strengthened. Web stiffeners can be added to both sides of the girder section. Below is a before and after diagram depicting the desired web stiffener repair (*Figures 7 and 8 below*).

3. **Repair Protocol #3**, depicted in *Figure 7* and *Figure 8* above, includes welding a steel plate section as a web stiffener along the web and flange sections. BillerReinhart estimates a cost of \$150 to \$200 per repair. This cost would include the material (angle section) and the labor (surface prep, cutting/grinding, welding and coating). From the limited survey conducted by BillerReinhart, approximately 2-3 repairs utilizing Repair Protocol #3 are estimated.

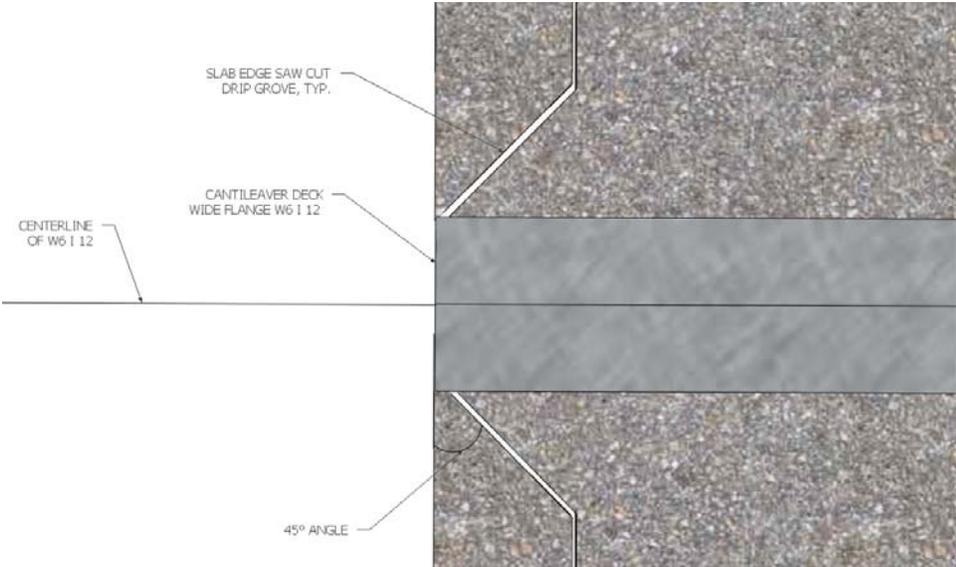
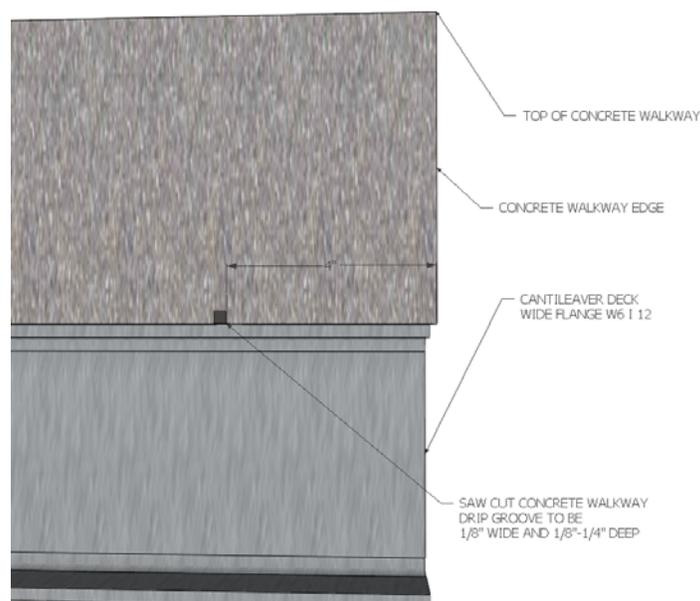
- 4. Protecting the exposed steel from water (and particularly standing water) is considered as a main concern to mitigating any future deterioration issues that exacerbate susceptible conditions. For the current configuration of the platform steel, the stringers extend to the edge of the concrete deck. The platform construction appears to allow water to flow off of the edge of the concrete deck,

migrate along the extended steel stringers to the bearing location. The water appears to be pooling and causing a majority of the deterioration at these bearing locations. To mitigate this condition, a drip cove/groove for the underside of the concrete deck edge is recommended. For example, a groove could be saw-cut (1/8-inch to 1/4-inch deep, hand-held Dremel®-type saw) on the underside of the slab starting at the exterior end of the stringer flange at a 45-degree angle inward to about 4 inches from the deck edge then run parallel to the deck edge. The saw-cut would then angle back out toward the deck exterior edge approaching the next end of the stringer flange (*Figures 9 and 10* below). A drip groove in the underside of the slab edge promotes water to drop off on the outer edge instead of drawing back and running to supporting elements underneath the deck.

- d. Applying a corrosion inhibitor would be approximately \$2/square foot
 - e. Patching deck coating would be approximately \$10/square foot.
 - f. Saw-cut underside of slab (hand-held Dremel®-type saw) for drip groove, depicted in *Figure 9* and *Figure 10* above, would be approximately \$2,000.

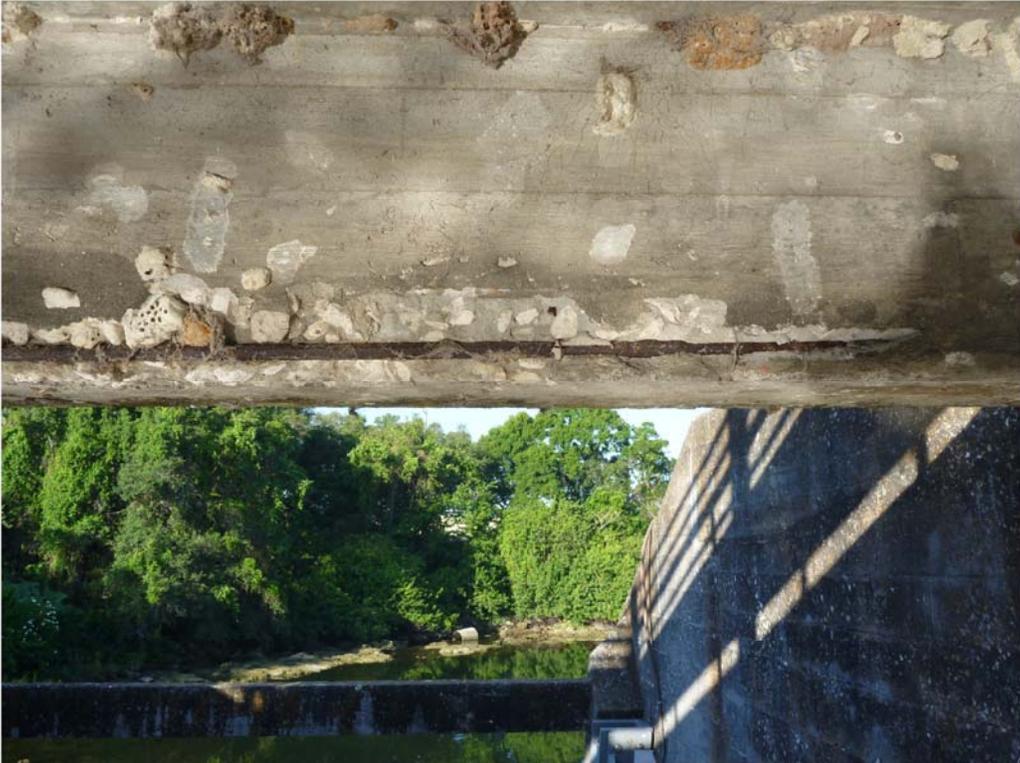
Figure A- 2: South Bay

Table A – Dam/Platform Observations	
Conditions Observed	Reference Photos
Overall	
East elevation looking northward	<i>Figure A-1</i>
South End Bay (Concrete Construction)	
Concrete spalling was observed along the bottom portion of the west concrete support beam. The reinforcing steel was exposed.	<i>Figure A-2</i>
Concrete spalling was observed along the bottom portion of the east concrete support beam.	<i>Figure A-3</i>
Bay #1	
Overall 18WF64 east girder view.	<i>Figure A-4</i>
Flange deterioration was observed along the flange section of stringer #3 of the bay. The deterioration was located near the stringer to girder connection point.	<i>Figure A-5</i>
Flange deterioration was observed along the flange section of stringer #5 of the bay. The deterioration was located near the stringer to girder connection point.	<i>Figure A-6</i>
Bay #2	
Flange deterioration was observed along the flange section of stringer #3 of the bay. The deterioration was located near the stringer to girder connection point.	<i>Figure A-7</i>

Spalling, cracking and other deterioration of the concrete deck and support beams was observed at multiple locations through the structure and is likely due to water intrusion into the elements resulting in corrosion and expansion of reinforcement bars contained in the components (refer to the applicable information and photographs referenced in the text above).

4. **A Concrete Repair Plan*** will need to be developed for the damage to the concrete framing members and concrete deck, such as the damage documented along the north and south walkway bays (*Figures A-2, 3, 39, and 39*). A typical project for concrete restoration would include, but is not limited to, removing unsound concrete, cleaning/grinding corroded/deteriorated reinforcing steel, splicing/supplementing reinforcing steel, installing sacrificial galvanic anodes within repair areas, applying a corrosion inhibitor, and applying/patching top surface coating. The following items would address the standard concrete repair protocol.

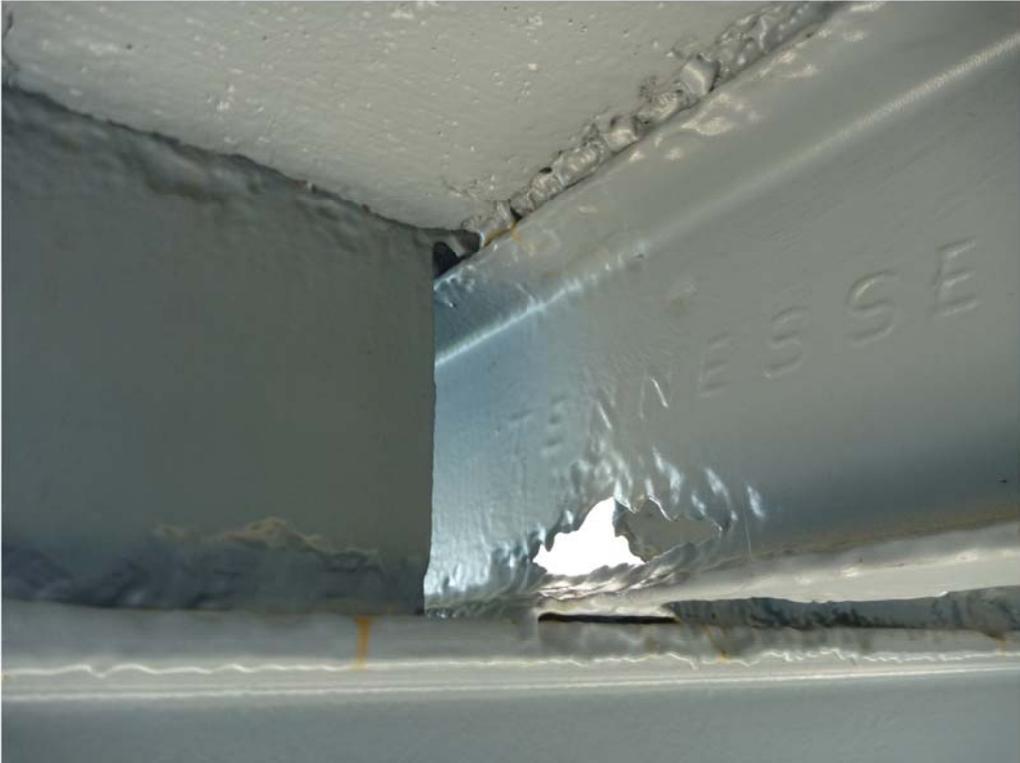
Figure A- 12: Bay #4

Table A – Dam/Platform Observations	
Conditions Observed	Reference Photos
Bay #4	
Web and flange deterioration was observed along the web and flange sections of stringer #4 of the bay. The deterioration was located near the stringer to girder connection point. Full thickness section loss was observed.	<i>Figure A-12</i>
Web deterioration in the east C-channel was observed near stringer #2	<i>Figure A-13</i>
Web and flange deterioration was observed along the web and flange sections of stringer #3 of the bay. The deterioration was located near the stringer to girder connection point. Full thickness section loss was observed.	<i>Figure A-14</i>
Bay #5	
Web and flange deterioration was observed along the web and flange sections of stringer #4 of the bay. The deterioration was located near the stringer to girder connection point. Full thickness section loss was observed.	<i>Figure A-15</i>
Deterioration/Pitting in the girder section was observed along the east girder in between stringer #2 and #3.	<i>Figure A-16</i>

1. For members with section loss (mainly the stringer beams) in the flange and the web: BillerReinhart recommends that the deteriorated flange be cut out and an angle section abutted to and welded to the stringer (back and front) to create a continuous metal section. The angle would need to extend past the area in question to create a solid sustainable repair. The flange cut out would accommodate the radial cove between the vertical web and the horizontal bottom flange. Below is a before and after diagram depicting the described repair (*Figures 3 and 4 below*).

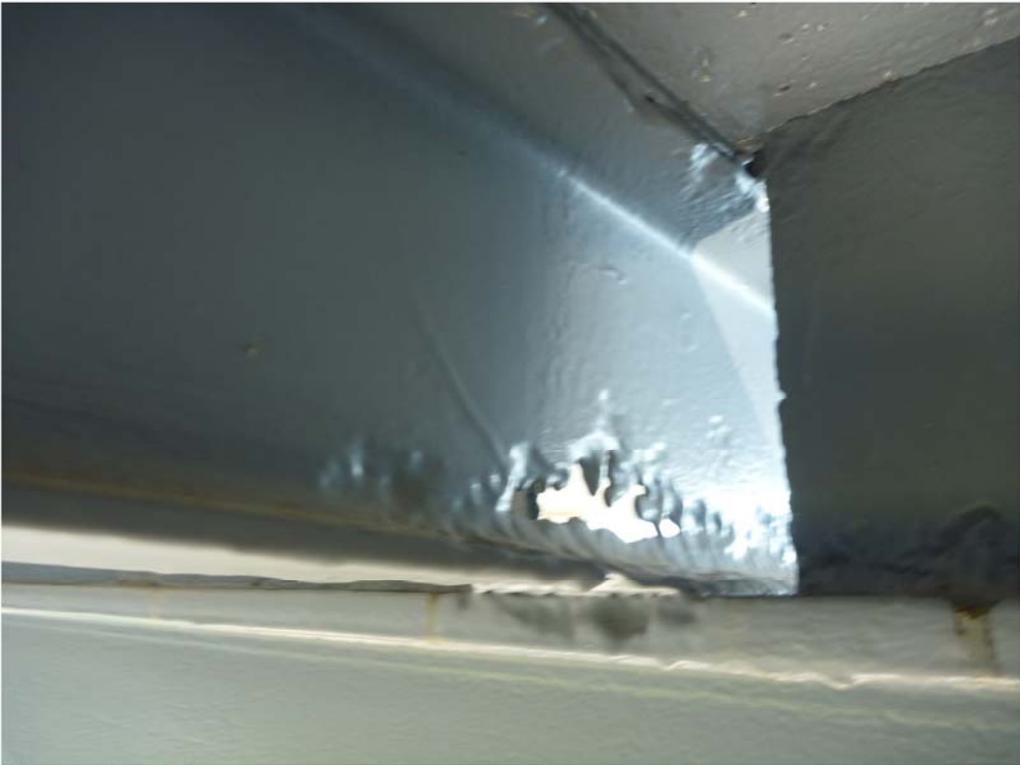
Figure A- 17: Bay #5

Web and flange deterioration was observed along the web and flange sections of stringer #2 of the bay. The deterioration was located near the stringer to girder connection point. Full thickness section loss was observed.	<i>Figure A-17</i>
Bay #6	
Flange deterioration was observed along the flange section of stringer #4 of the bay. The deterioration was located near the stringer to girder connection. Full thickness section loss was observed.	<i>Figure A-18</i>
Deterioration/Pitting was observed along the web section of stringer #3 of the bay.	<i>Figure A-19</i>
Bay #7	
Flange deterioration was observed along the flange section of stringer #4 of the bay. The deterioration was located near the stringer to girder connection. Full thickness section loss was observed.	<i>Figure A-20</i>
Web and flange deterioration was observed along the web and flange sections of stringer #3 of the bay. The deterioration was located near the stringer to girder connection.	<i>Figure A-21</i>

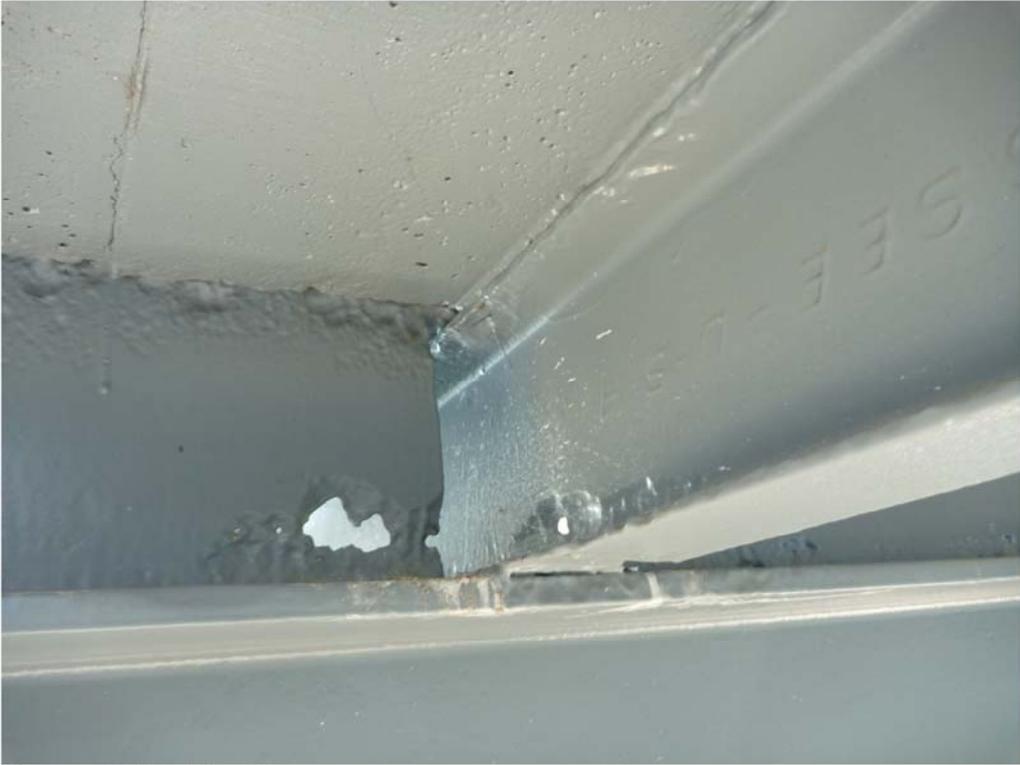
Figure A- 22: Bay #8

Table A – Dam/Platform Observations	
Conditions Observed	Reference Photos
Bay #8	
Web deterioration was observed along the web of stringer #4 and the adjacent C-channel section. Full thickness loss was observed.	<i>Figure A-22</i>
Flange deterioration was observed along the flange of stringer #2 of the bay. The deterioration was located near the stringer to girder connection.	<i>Figure A-23</i>
Bay #9	
Typical girder to concrete pier connection.	<i>Figure A-24</i>
Web and flange deterioration was observed along the web and flange sections of stringer #2 of the bay. Full thickness section loss was observed.	<i>Figure A-25</i>
Flange deterioration was observed along the flange section of stringer #4 of the bay. Full thickness loss was observed.	<i>Figure A-26</i>
Minor web buckling was observed along the bearing end of the girder, adjacent to stringer #5 of the bay.	<i>Figure A-27</i>
Bay #10	
Flange deterioration was observed along the flange section of stringer #4 of the bay. Full thickness loss was observed.	<i>Figure A-28</i>

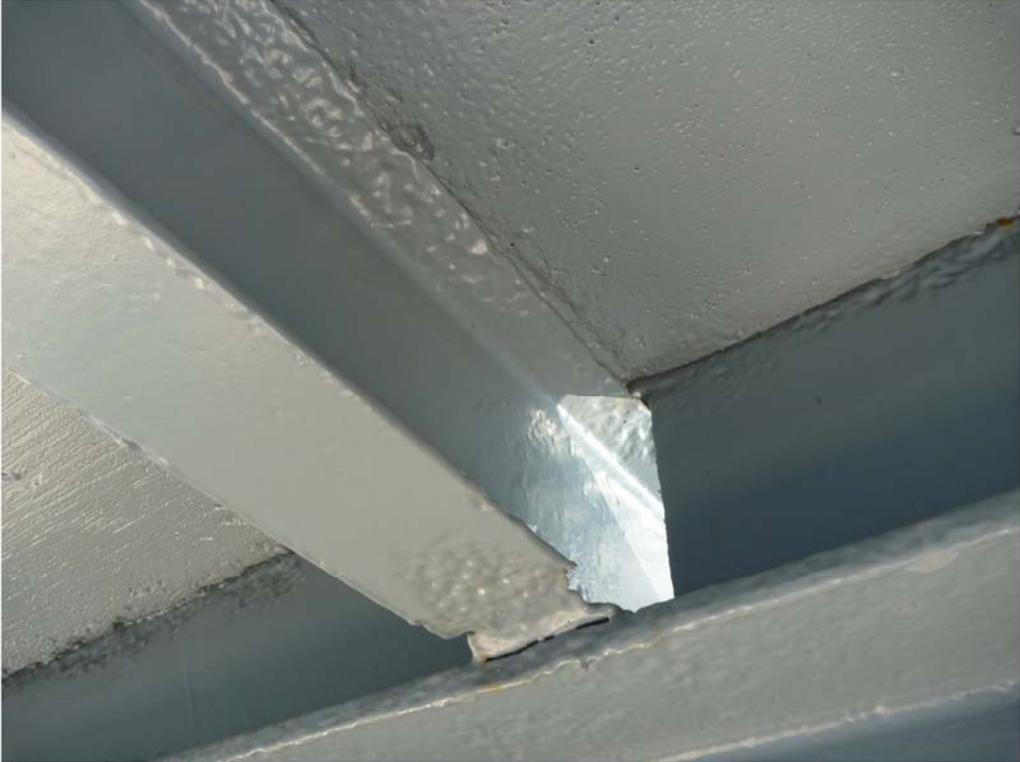
Figure A- 29: Bay #10

Flange deterioration was observed along the flange section of stringer #3 of the bay. Full thickness loss was observed.	<i>Figure A-29</i>
Bay #11	
Flange deterioration was observed along the flange section of stringer #2 of the bay. Full thickness loss was observed.	<i>Figure A-30</i>
Bay #12	
Cracking in the concrete pier was observed below the east base plate. The section was previously repaired.	<i>Figure A-31</i>
Web and flange deterioration was observed along the flange section of stringer #2 and web of the adjacent C-channel.	<i>Figure A-32</i>
Bay #13	
Web and flange deterioration was observed along the flange section of stringer #4 and the web of the adjacent C-channel.	<i>Figure A-33</i>
Flange deterioration was observed along the flange section of stringer #2 of the bay. Full thickness loss was observed.	<i>Figure A-34</i>

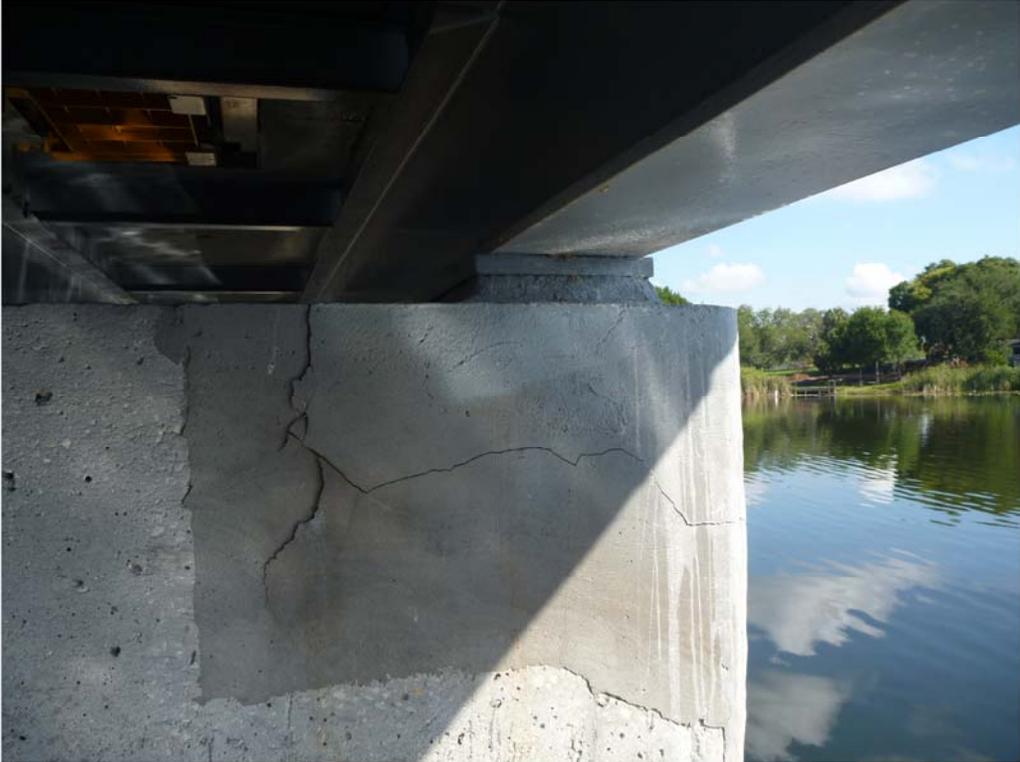
Figure A- 31: Bay #12

1. Cracking and spalling of concrete beams
2. Cracking in the concrete pier was observed below the east base plate, Bay #12
3. Multiple cracks and spalls of the concrete slab (underside surfaces)

7. Although outside this project scope, BillerReinhart recommends that the concrete piers be physically sounded (see explanation above for this process) to evaluate the extent of damage and to develop a repair. Representative damage can be seen in *Figure A-31* of Appendix A.

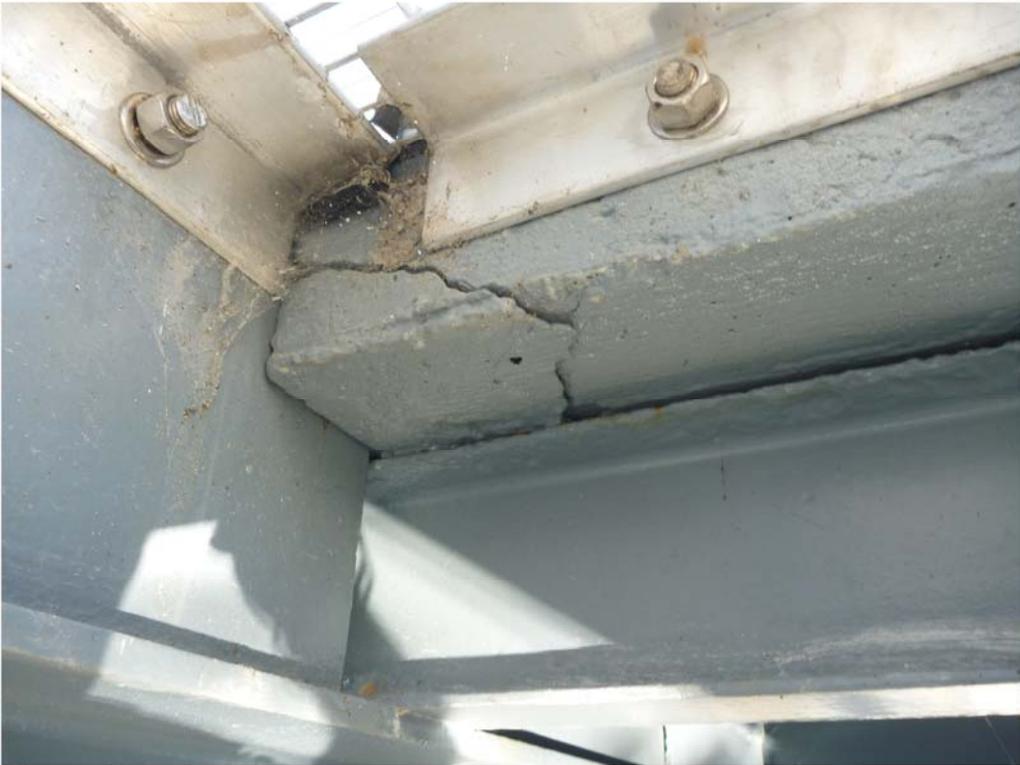
Figure A- 35: Bay #14

Table A – Dam/Platform Observations	
Conditions Observed	Reference Photos
Bay #14	
Concrete deck cracking was observed in the bottom of the concrete deck along the deck edge and edge of the grate hatch angle support.	<i>Figure A-35</i>
Web deterioration was observed along the web section of stringer #2 of the bay. Full thickness loss was observed.	<i>Figure A-36</i>
Bay #15	
Web and flange deterioration was observed along the web and flange sections of stringer #2 of the bay. Full thickness section loss was observed.	<i>Figure A-37</i>
North End Bay (Concrete Construction)	
Concrete spalling was observed along the west deck edge. The spalling was adjacent to a guardrail base connection plate.	<i>Figure A-38</i>
Concrete spalling was observed in the bottom of the concrete deck along the western portion of the bay.	<i>Figure A-39</i>

6. Although outside the scope of this project, BillerReinhart recommends that the concrete components of the north and south walkway bays be physically sounded. *Physical Sounding* is the process of tapping and/or dragging a relatively heavy metal object (such as a hammer or club) on the concrete surface in order to audibly evaluate discernible pitch/tonal differences. A “solid sound” is audibly apparent and is indicative of secured/adequate concrete. A “hollow sound” is also readily audibly apparent and is indicative of damaged/dislodged concrete often caused by the expansion of corroding steel reinforcement. Physical soundings are useful to evaluate the extent of damage and to develop a repair extent. Representative damage can be seen in *Figures A-2* and *A-3* of Appendix A. A similar recommendation applies to the multiple bottom deck cracks and spalls observed throughout the survey. Refer to *Figures A-35*, *A-38* and *A-39* of Appendix A.
