Section C

Stormwater Service Assessment Program Report

Tampa City Council Update No. 15 - August 2020

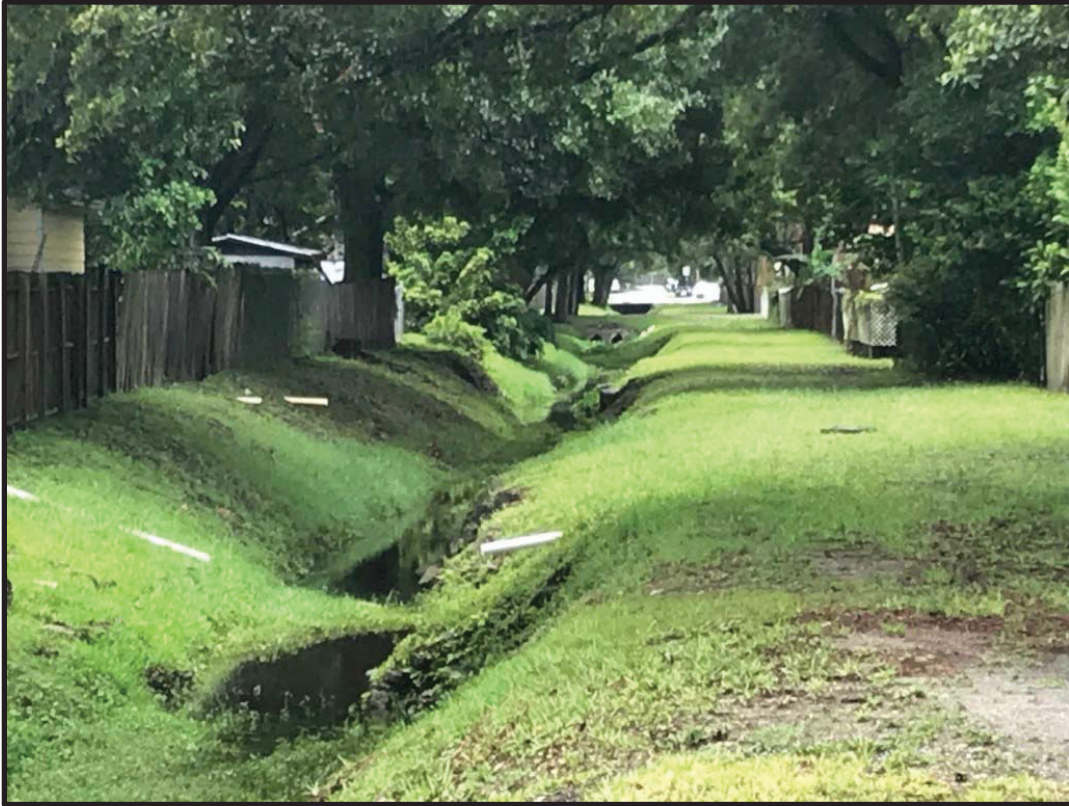
Before

Hamilton ROW Ditch

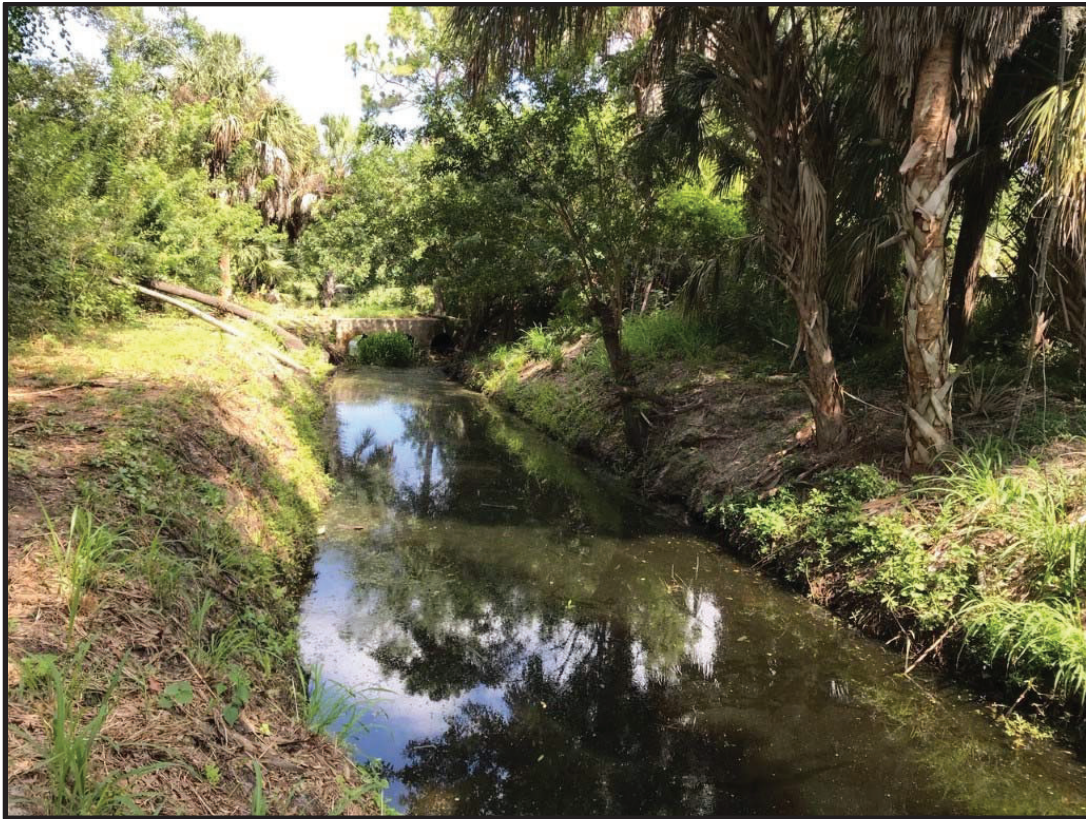
Before

Lois Alley Ditch South of Gandy

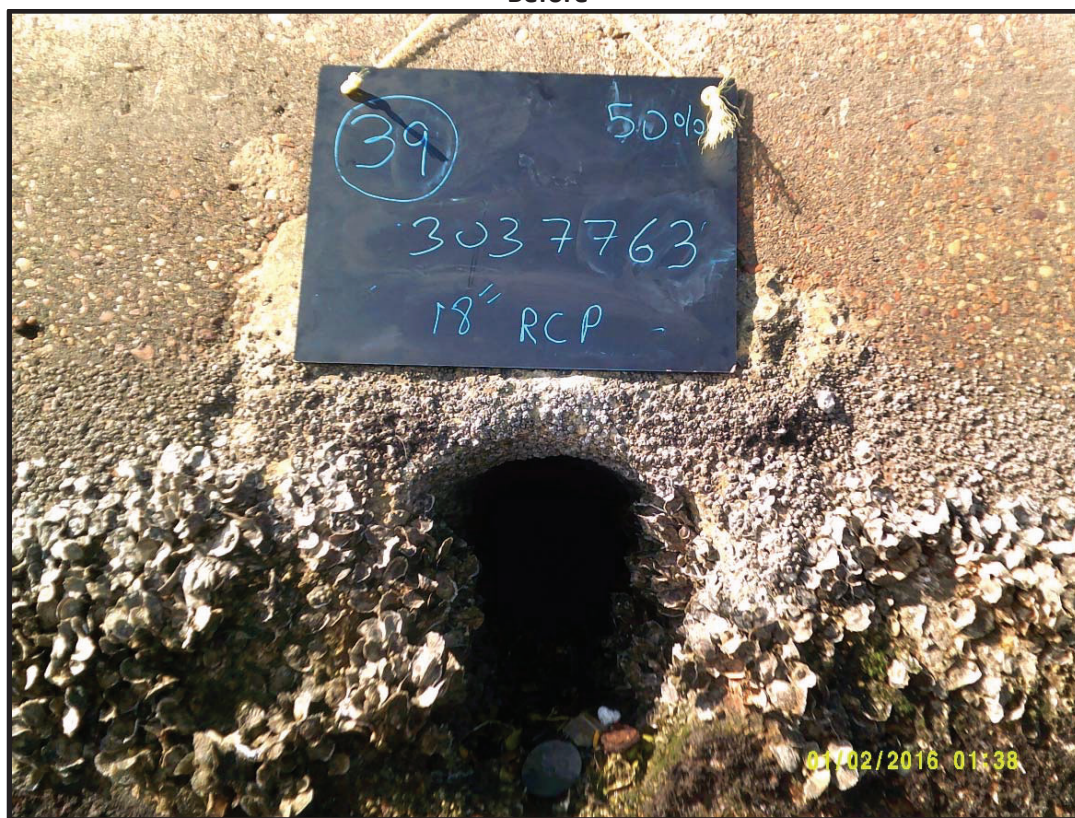
Before

Bayshore Seawall Just South of El Prado

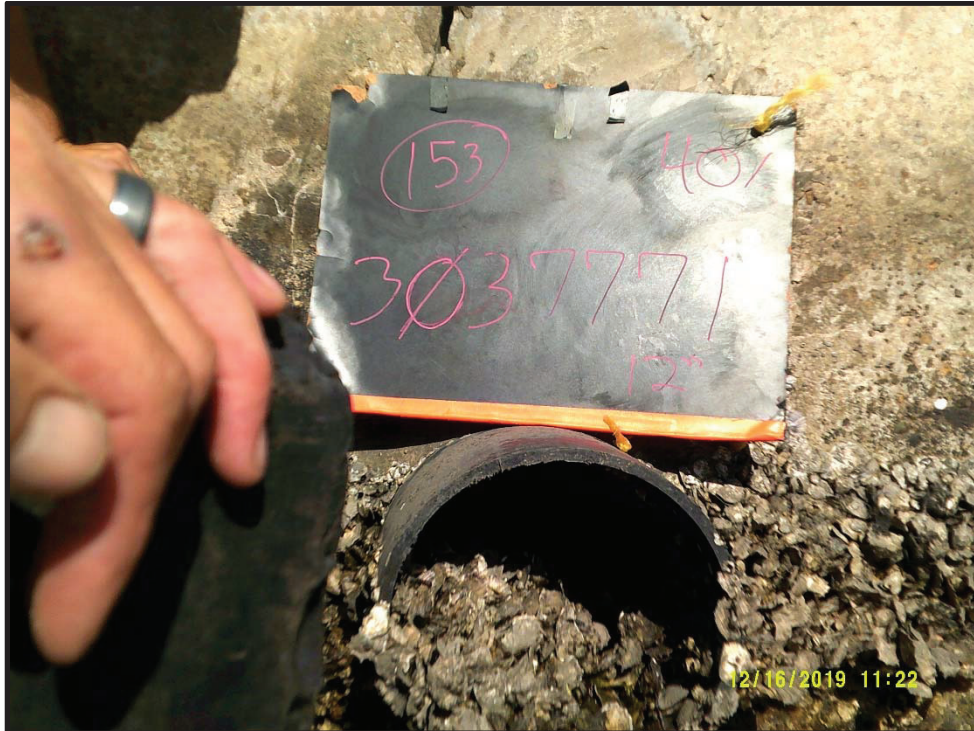
Before

Davis Islands – Erie Ave. at West Davis Blvd.
