ARBORIST REPORT

CITY OF TAMPA – GOLFVIEW FLOODING RELIEF - DESIGN FOR: KISINGER CAMPO & ASSOCIATES

Prepared by:
Richard Peterika, FL-5893B &
Dalton Smith, FL-9314A
02/13/2023

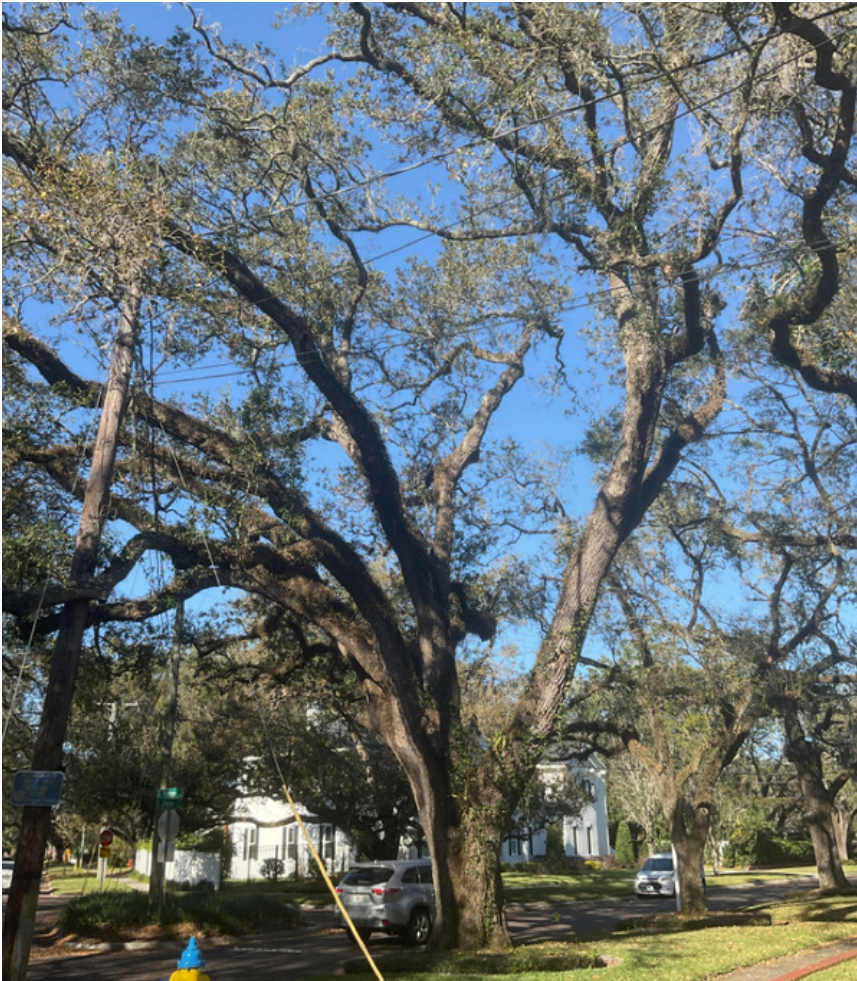
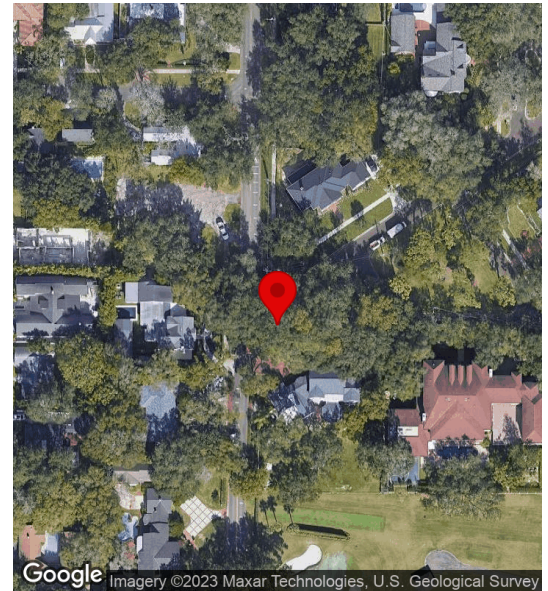
#2 GRAND

A/B Notes: Conflict with curb to north
Defects: Compaction

A/B Notes: Codominant at 8 feet
Defects: Codominant Stems without Inclusion

B/C Notes: South leader becomes tridominant with inclusion present. High aspect ratios. Utility pruned. Lots of sprouting along tertiary branches.
Defects: Codominant Branches (V-Shape) - Deadwood - Adventitious Branches (no decay present)

B/B Notes: Thinning crown
Defects: Dieback (minor) - Defoliation

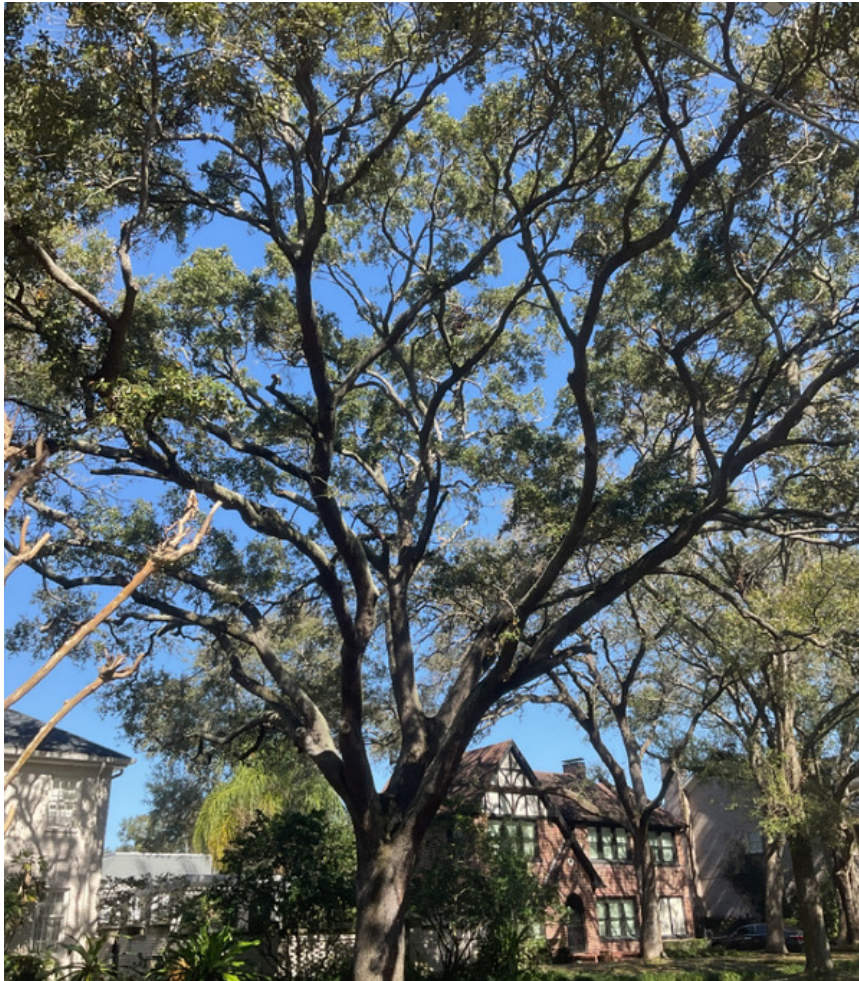
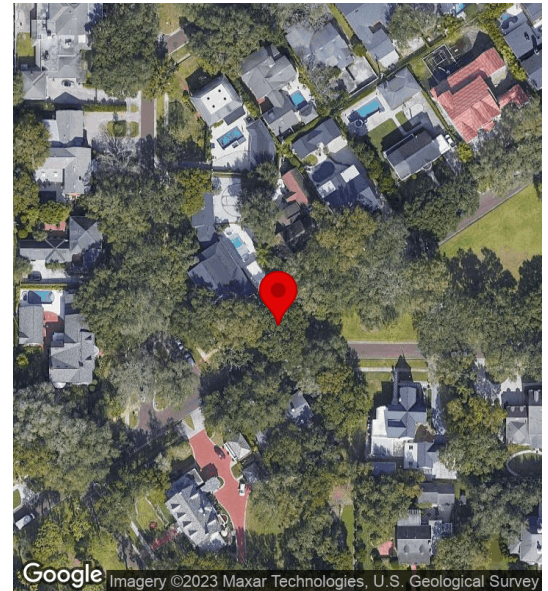
#11 GRAND

A/B Notes: Wide planting strip, good root flare
Defects: Restriction to Growth

A/B Notes: Clear trunk to 14 feet from ground. No inclusion at decurrance
Defects: Tridominant stems

A/B Notes: All pruning cuts made in past have proper wound closure. Restriction in canopy growth to the east from adjacent tree canopy. Minor advantageous sprouting
Defects: Deadwood

B/A Notes: Minor thinning
Defects: Dieback (minor)

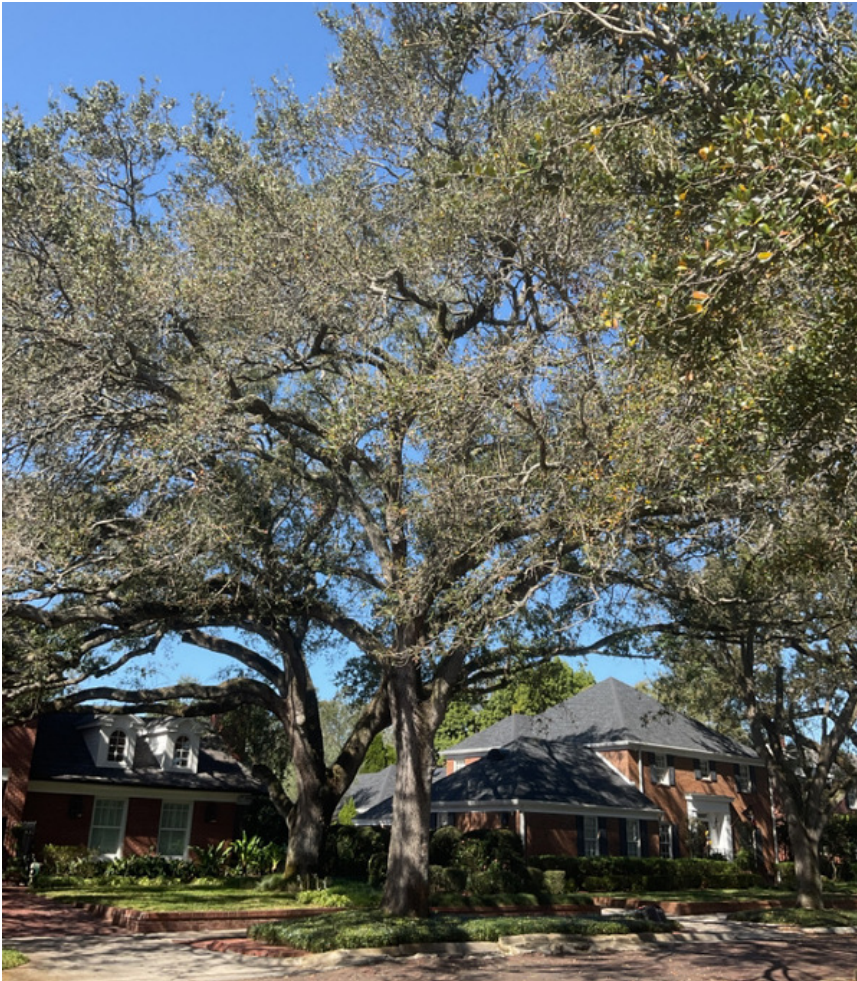
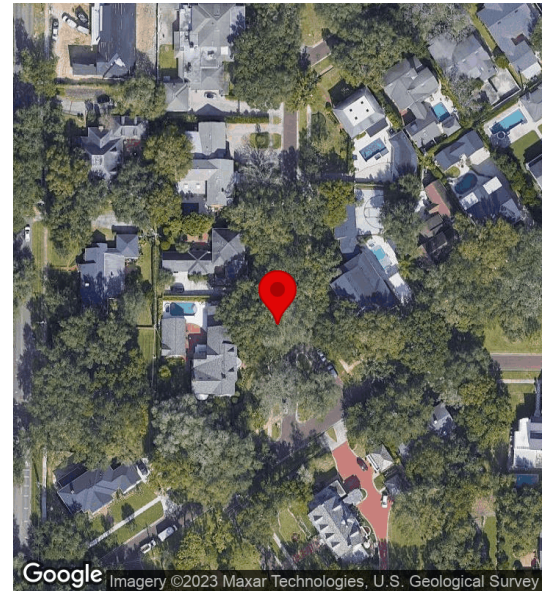
#13 GRAND

Defects: Compaction - Restriction to Growth

Defects: Codominant Stems without Inclusion

Defects: Unbalanced Crown - Deadwood

Defects: Dieback (minor)

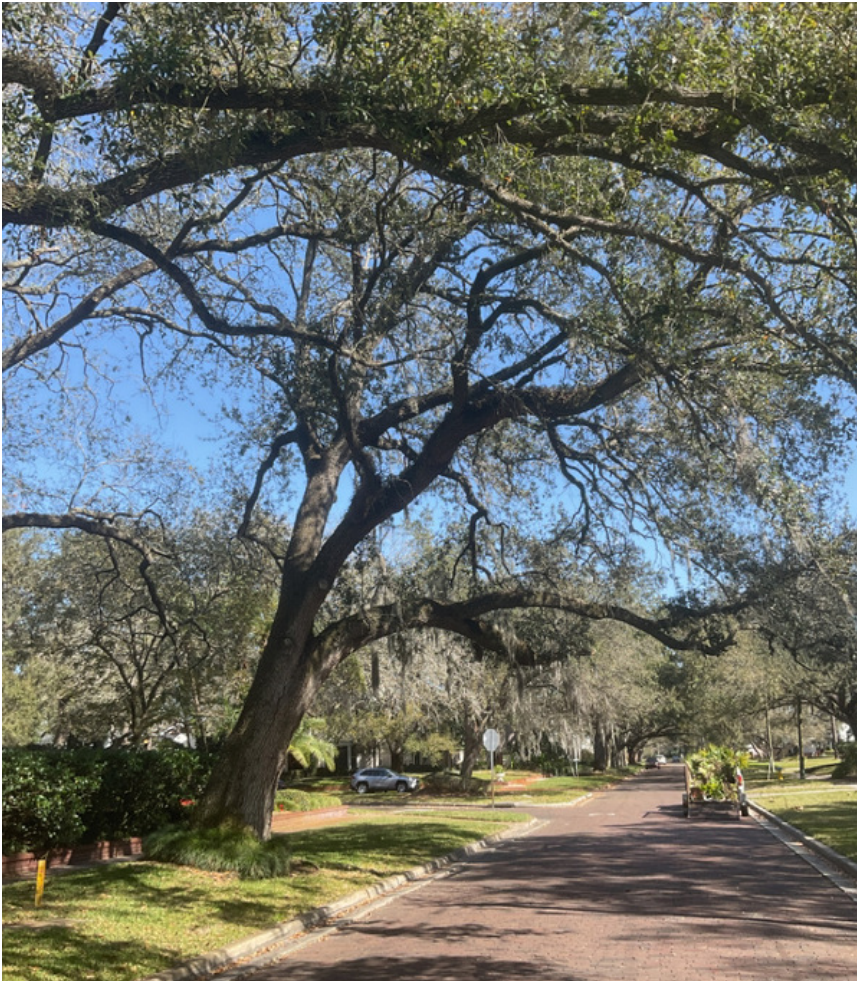
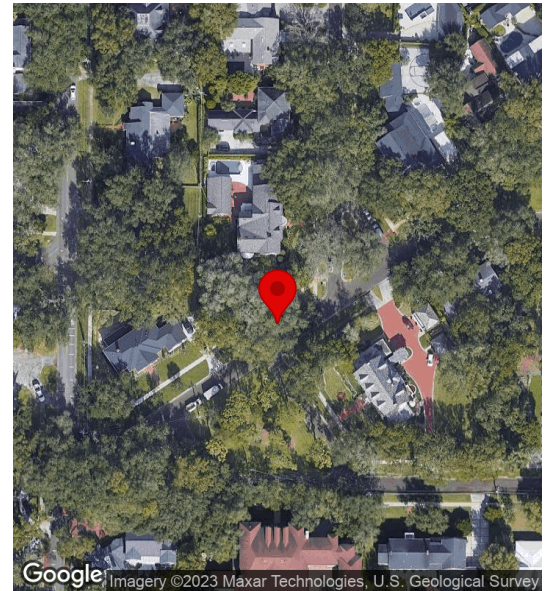
#15 GRAND

The tree with the tag number 407 was included in the inventory and was assessed with the overall condition and hazard rating of a D-8. This Grand tree is classified as a hazardous tree and is located within the City right of way. This tree should be reported to the City's urban forestry department for further assessment.

ROW tree leaning over the road with multiple defects

C/C Notes: 20% of root flare missing from large wound of trunk

Defects: Compaction - Mechanical Injury - Visually obscured

C/D Notes: Large wound on north side of tree, wound closure with extensive rams horning with exposed heartwood. Inclusion bulge splitting with 5 feet long crack on either side of the branch union on trunk. Leaning with all weight on opposite side of missing trunk portion. Minor decay in heartwood at base.

Defects: Codominant Stems with inclusion - Cracking - Cavities - Lean (corrected) - Splitting - Wound (major) - Inclusion Bulge

B/D Notes: 24 inch branch to the south with large crack, being hit by vehicles and is overextended.

Defects: Unbalanced Crown - Broken or Hanging Branches - Cracks

B/A Defects: Dieback (minor)

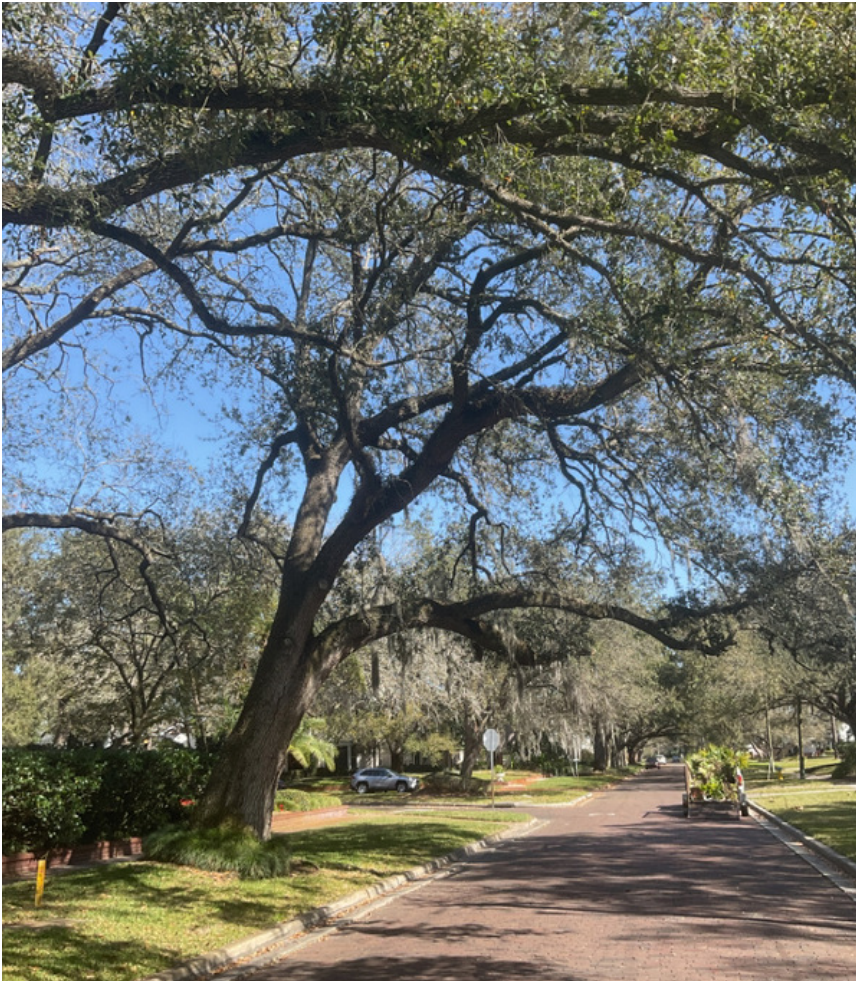
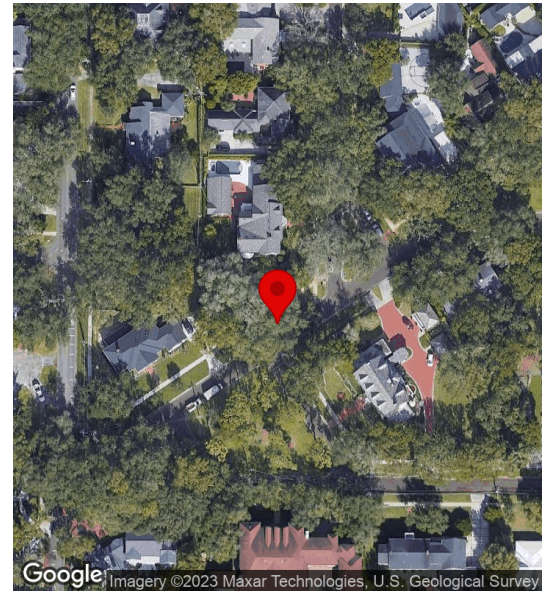
#15 GRAND

ROW tree leaning over the road with multiple defects

C/C Notes: 20% of root flare missing from large wound of trunk

Defects: Compaction - Mechanical Injury - Visually obscured

C/D Notes: Large wound on north side of tree, wound closure with extensive rams horning with exposed heartwood. Inclusion bulge splitting with 5 feet long crack on either side of the branch union on trunk. Leaning with all weight on opposite side of missing trunk portion. Minor decay in heartwood at base.

Defects: Codominant Stems with inclusion - Cracking - Cavities - Lean (corrected) - Splitting - Wound (major) - Inclusion Bulge

B/D Notes: 24 inch branch to the south with large crack, being hit by vehicles and is overextended.

Defects: Unbalanced Crown - Broken or Hanging Branches - Cracks

B/A Defects: Dieback (minor)

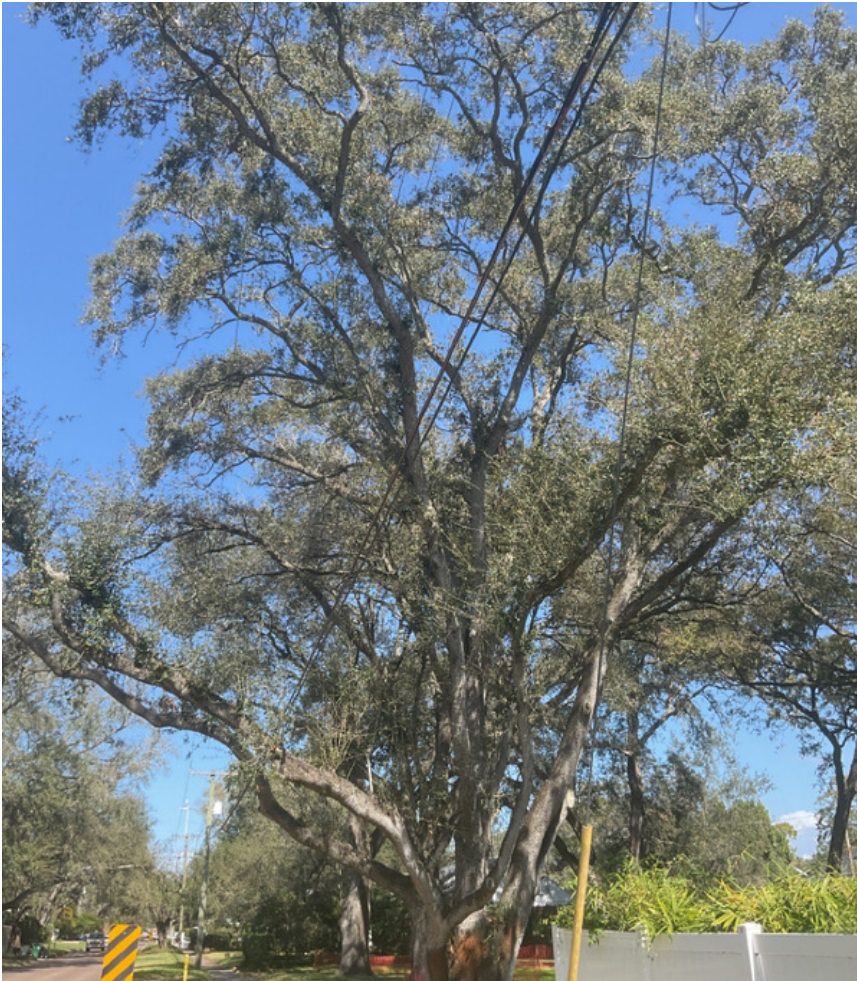
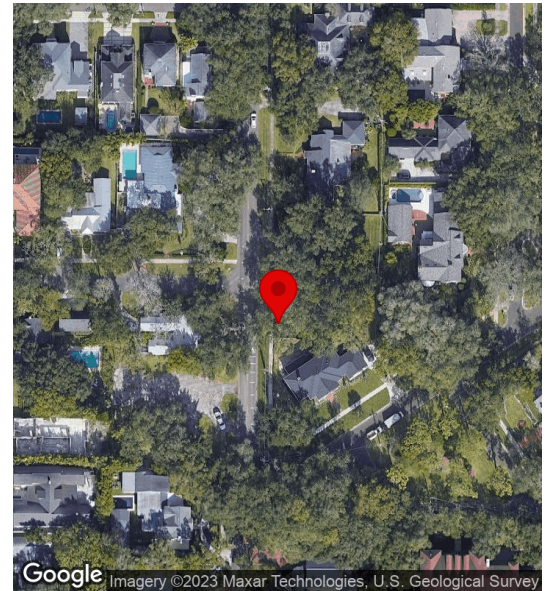
#20 GRAND

Defects: Compaction

Defects: Codominant Stems with inclusion

Defects: Adventitious Branches (no decay present)
- Pruning Issues

Defects: Dieback (minor)

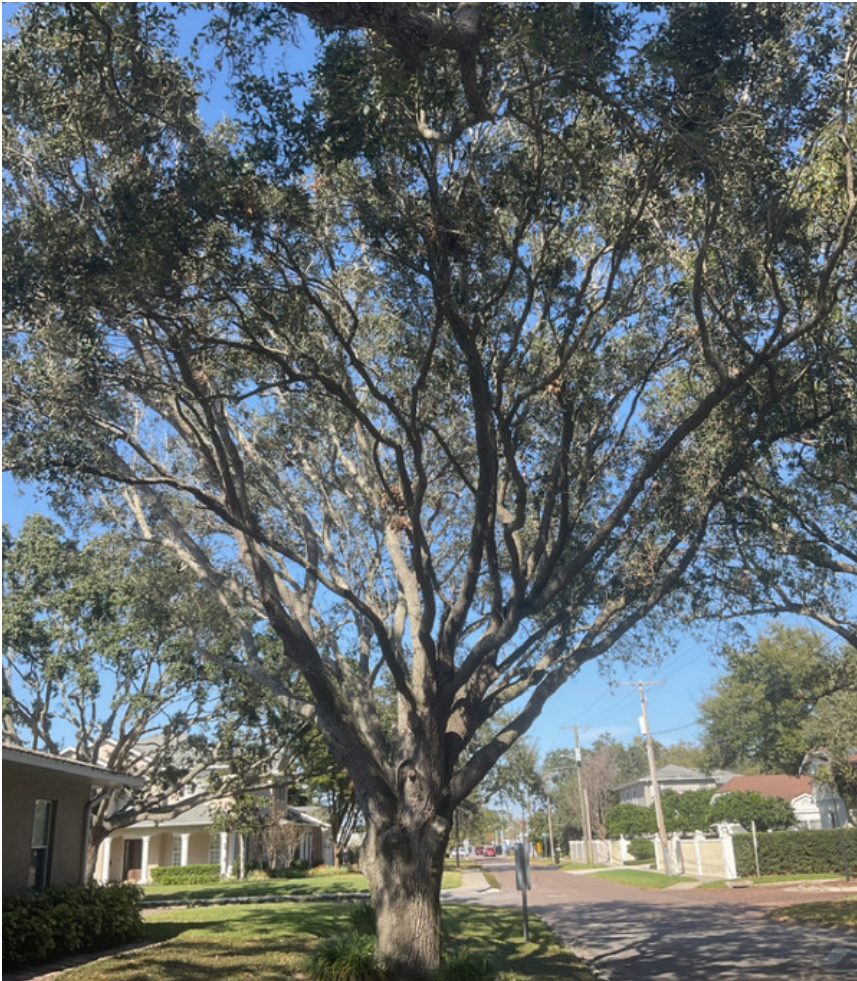
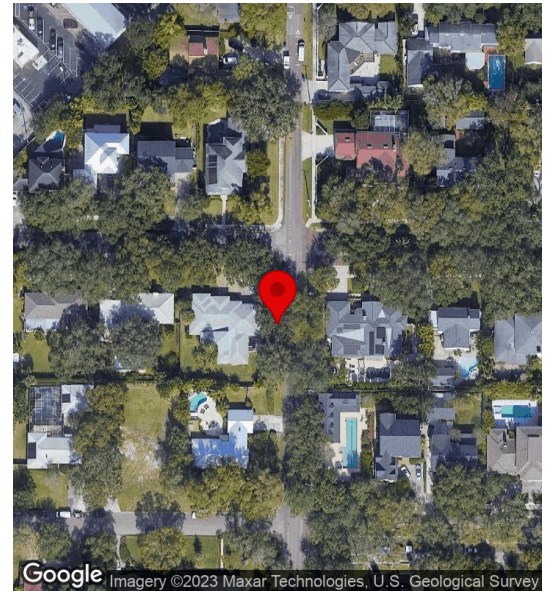
#46 GRAND

A/B Notes: Road to the east, large room in yard
Defects: Compaction

B/C Notes: Multi dominant from 6 feet from ground. Inclusion present between all stems. Half of stems pruned out with bulge around past cuts from wound closure.
Defects: Codominant Stems with inclusion

B/C Notes: Many vertical branches
Defects: Codominant Branches (V-Shape) - Pruning Issues - Adventitious Branches (no decay present)

B/B Notes: Minor thinning
Defects: Dieback (minor) - Defoliation

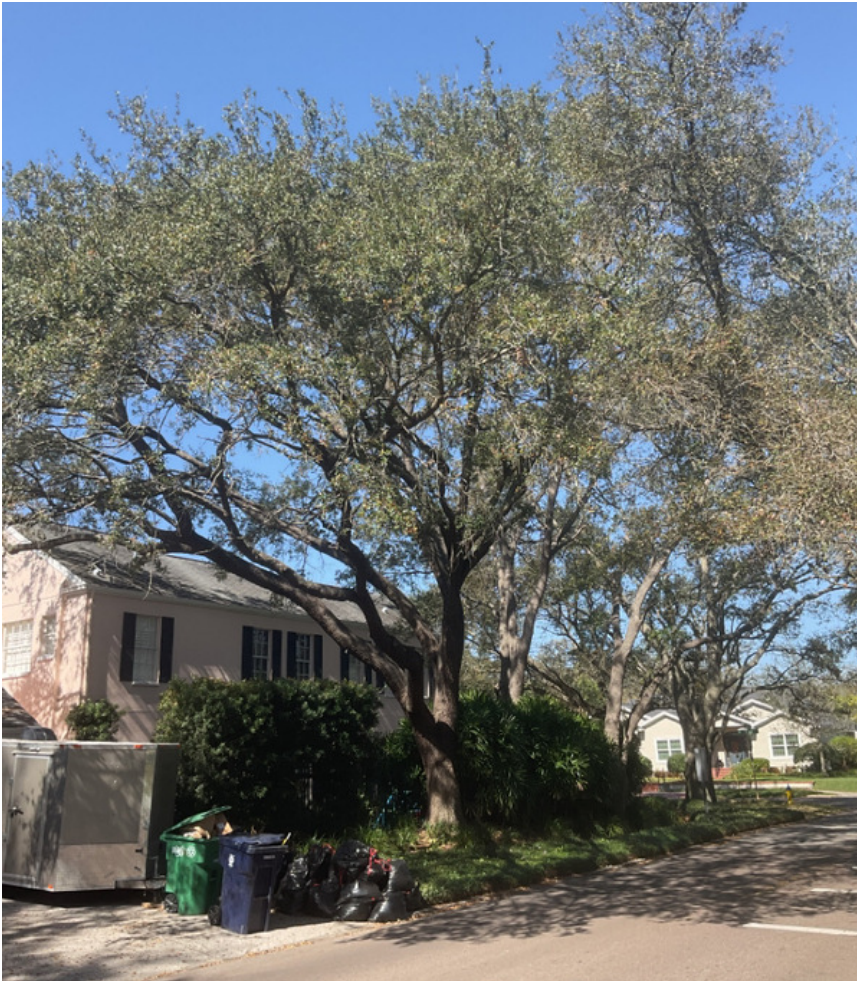
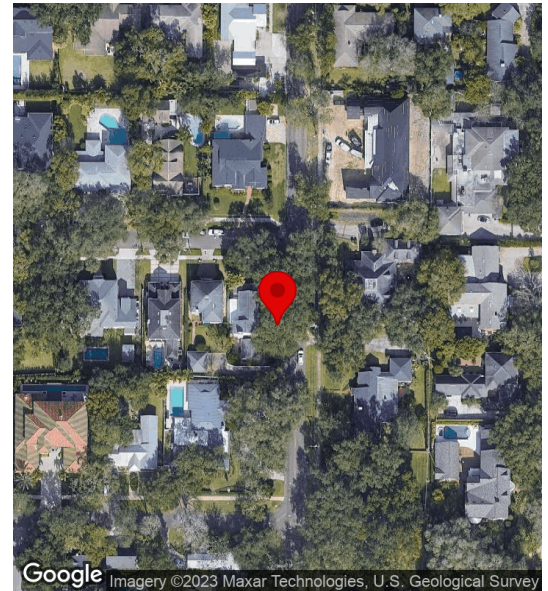
#68 GRAND

Defects: Compaction

Defects: Codominant Stems with inclusion

Defects: Deadwood - Poor Aspect Ratio - Unbalanced Crown

Defects: Dieback (minor)

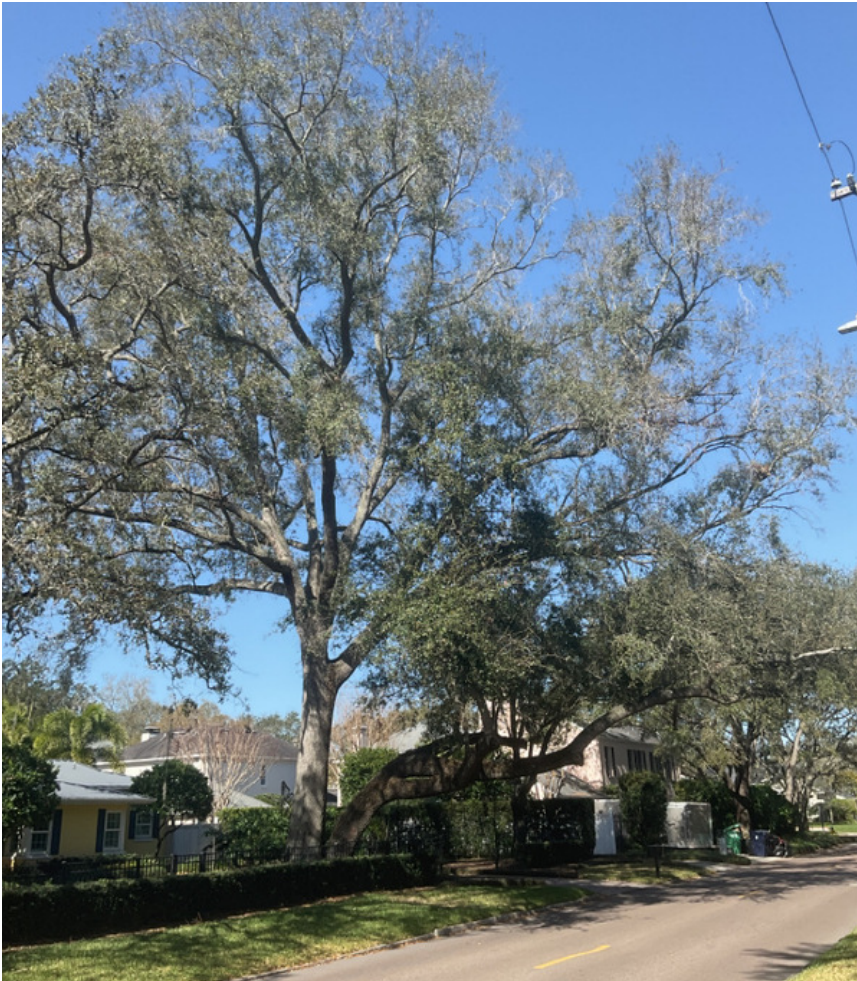
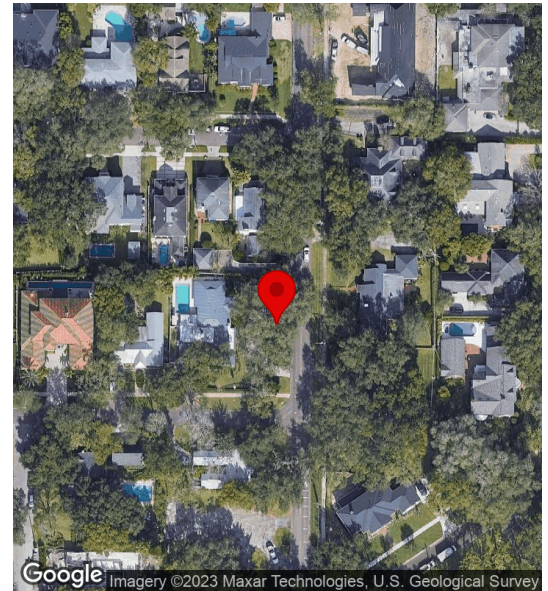
#69 GRAND

Private property, limited assessment. Comprised of two stems from ground. Main central tree could be grand tree by itself with excellent form and structure. Inclusion visible at union. Suppressed stem growing with bowed form over the road. Further assessment needed to know likelihood of full failure of smaller stem. Would increase hazard rating. Preventative mitigation possible.

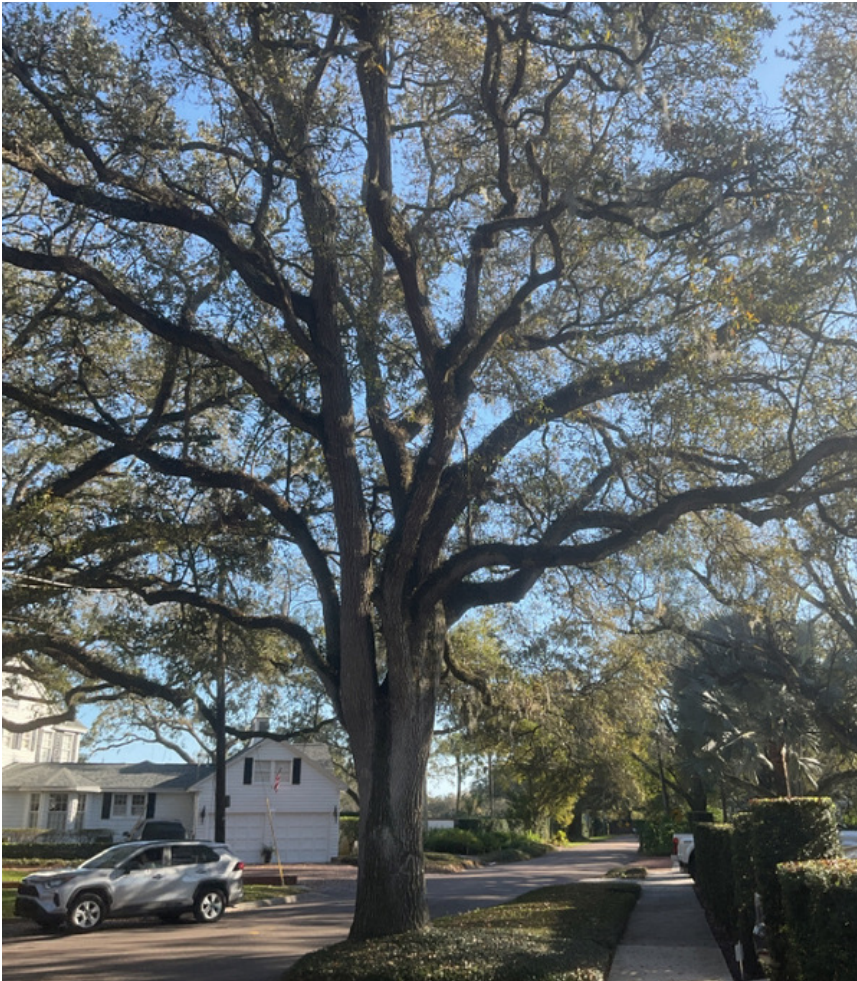
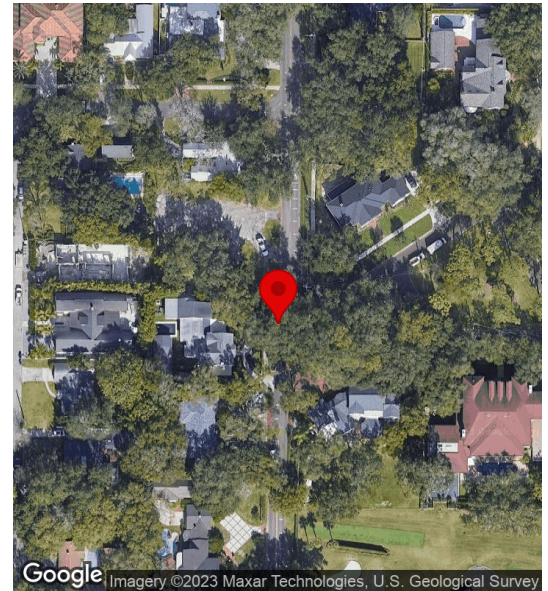
#116 GRAND

Defects: Compaction - Restriction to Growth

Defects: Codominant Stems with inclusion

Defects: Codominant Branches (V-Shape) - Deadwood - Adventitious Branches (no decay present)

B/A Defects: Dieback (minor)

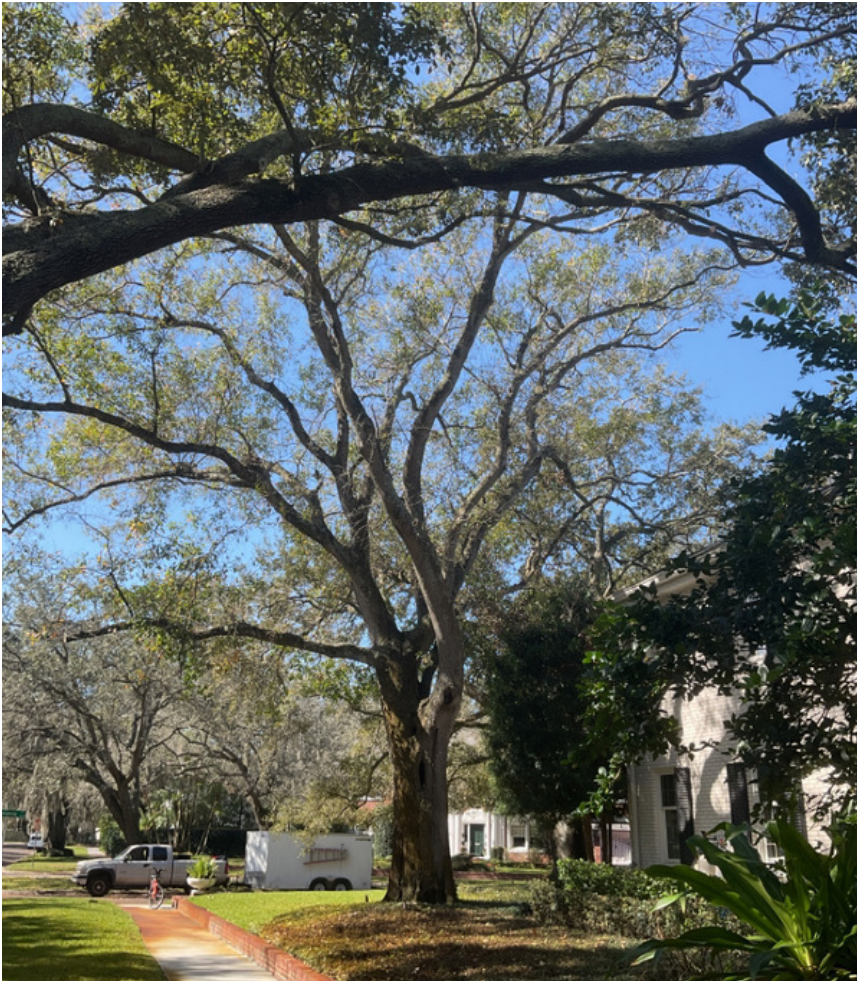
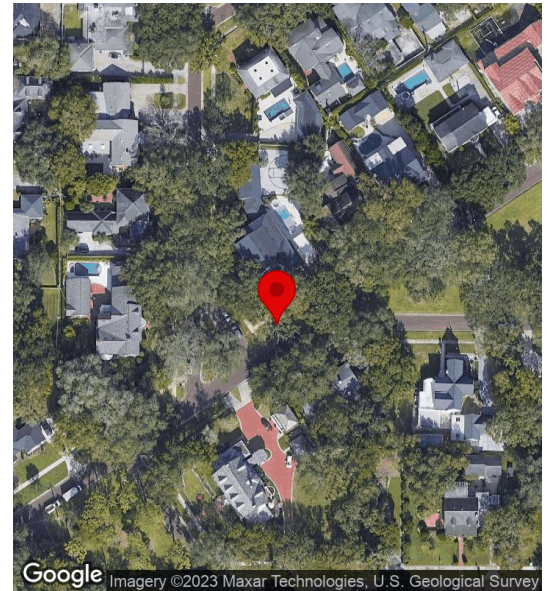
#147 GRAND

Private property tree, limited assessment. Mature laurel oak defects present.

B/B Notes: House within dripline
Defects: Compaction

C/C Notes: Limited, cavity and hollow wood present, unknown extent
Defects: Hollow Wood - Cavities

C/C Notes: Multiple heading cuts and excessive sprouting
Defects: Adventitious Branches (no decay present)
- Pruning Issues - Poor wound closure

C/C Notes: Declining, thinning canopy and dieback
Defects: Dieback - Defoliation

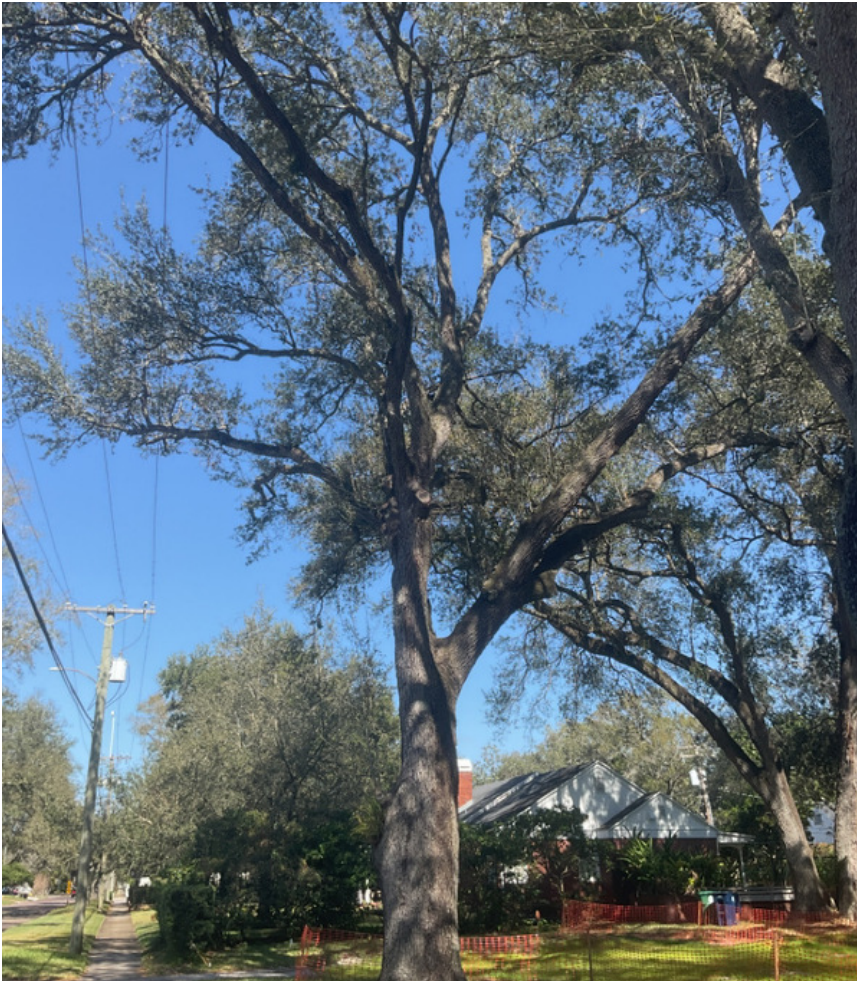
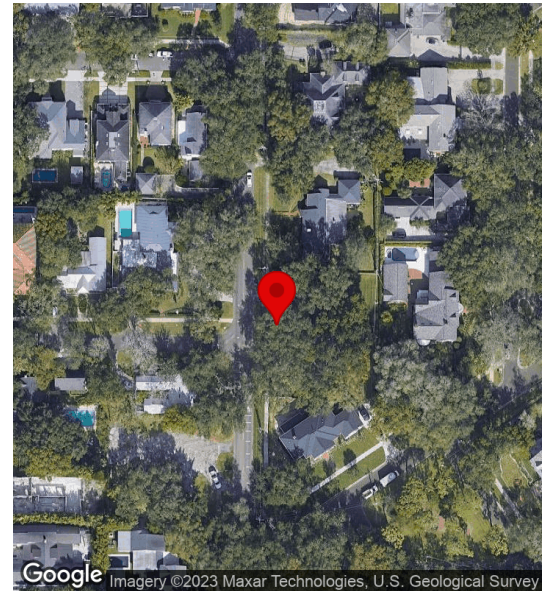
#155 GRAND

Private property, pruned for utility. Major past removal cut of lower branch of 30 inches to prevent further cracking.

A/C Notes: Sidewalk and old driveway within dripline, now clear trunk to halfway up tree. Old crack from past pruned leader, minor

Defects: Inclusion Bulge - Cavities - Codominant Stems without Inclusion - Cracking

Defects: Pruning Issues - Adventitious Branches (no decay present)

C/A Defects: Dieback (minor)

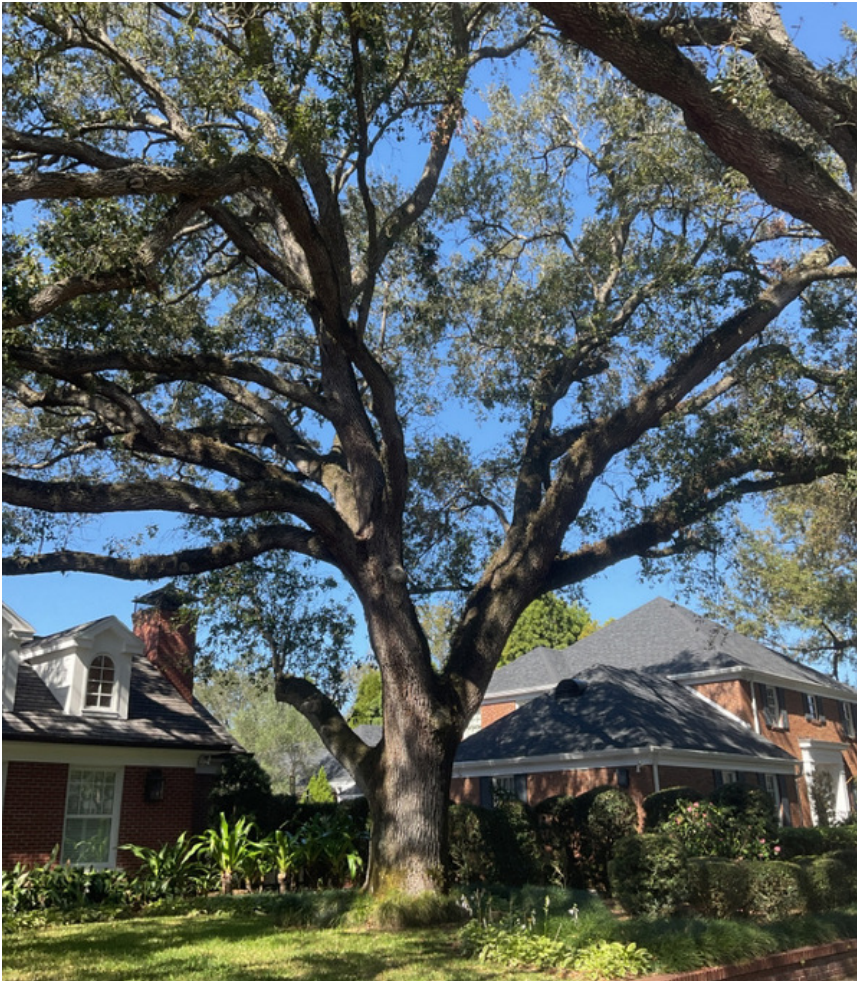
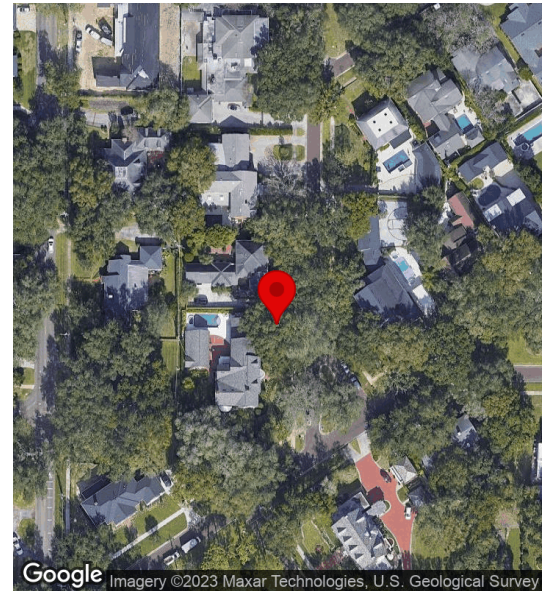
#161 GRAND

B/B Notes: No inclusion, fruiting bodies on bark, not sign of internal decay

Defects: Tridominant stems - Decay Conks or Fungi

Defects: Up-sweeping Branches - Clustered Low Branches - Adventitious Branches (no decay present) - Pruning Issues
