El Prado Blvd.

MOBILITY OPPORTUNITIES AND
DEFICIENCIES AUDIT
2020

City of
Tampa
Florida

DECEMBER 2020

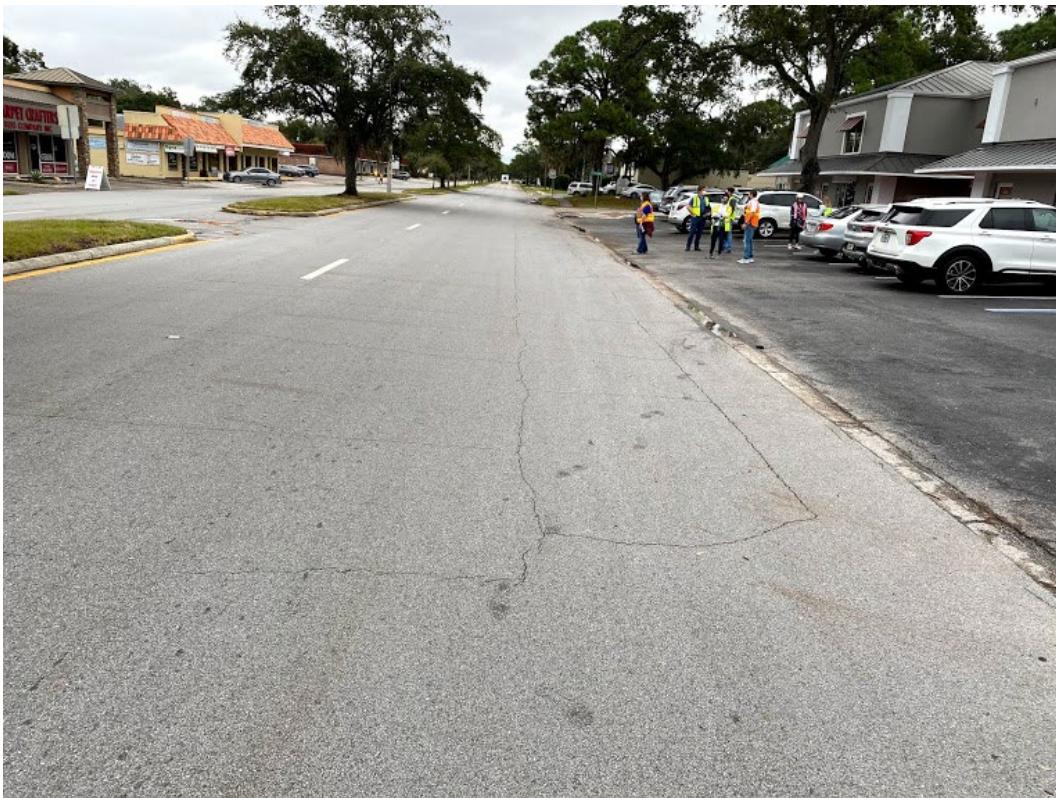
There is a small business district between Hesperides St. and Lois Ave. near the Manhattan Ave. intersection. The pavement widths widen considerably in this section. Several of the businesses have wide curb cuts and parking encroachments within the right-of-way. Considering the wider pavement widths present in this area, on-street parking and/or curbside pick-up/drop-off spaces may be options.

Figure 5: Business District near Manhattan Ave. with wide pavement widths that may accommodate parking and long curb cuts that may be consolidated.

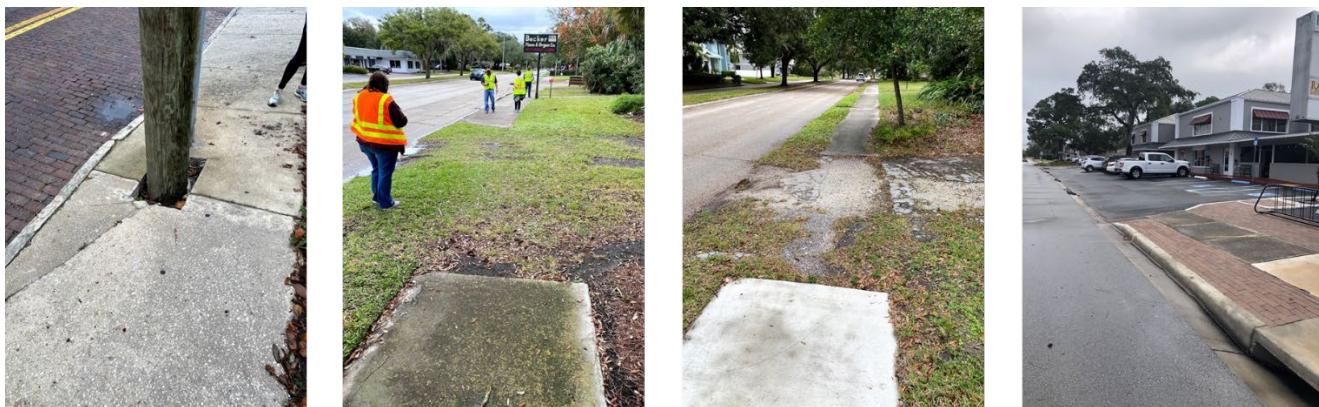
This project will include construction of a 5' minimum concrete sidewalk on the north side of the corridor as part of the federally funded Transportation Alternatives Project. The approximate right-of-way width is 100' for the majority of the corridor, narrowing down to approximately 40' from MacDill Ave. to Bayshore Blvd. The north side sidewalk should be designed to be linear, with variations to avoid existing conflicts. There may be several encroachments encountered including utilities, mailboxes, and parking. These encroachments should be evaluated during design. Several driveways are paver driveways that may remain providing that an ADA accessible route can be accommodated. Where parking encroachments are encountered a consistent, clearly delineated concrete walkway should be provided.

Figure 7: Sidewalk gaps, drop-offs, and lack of delineation through wide driveways are some of the hazards and accessibility obstacles observed.

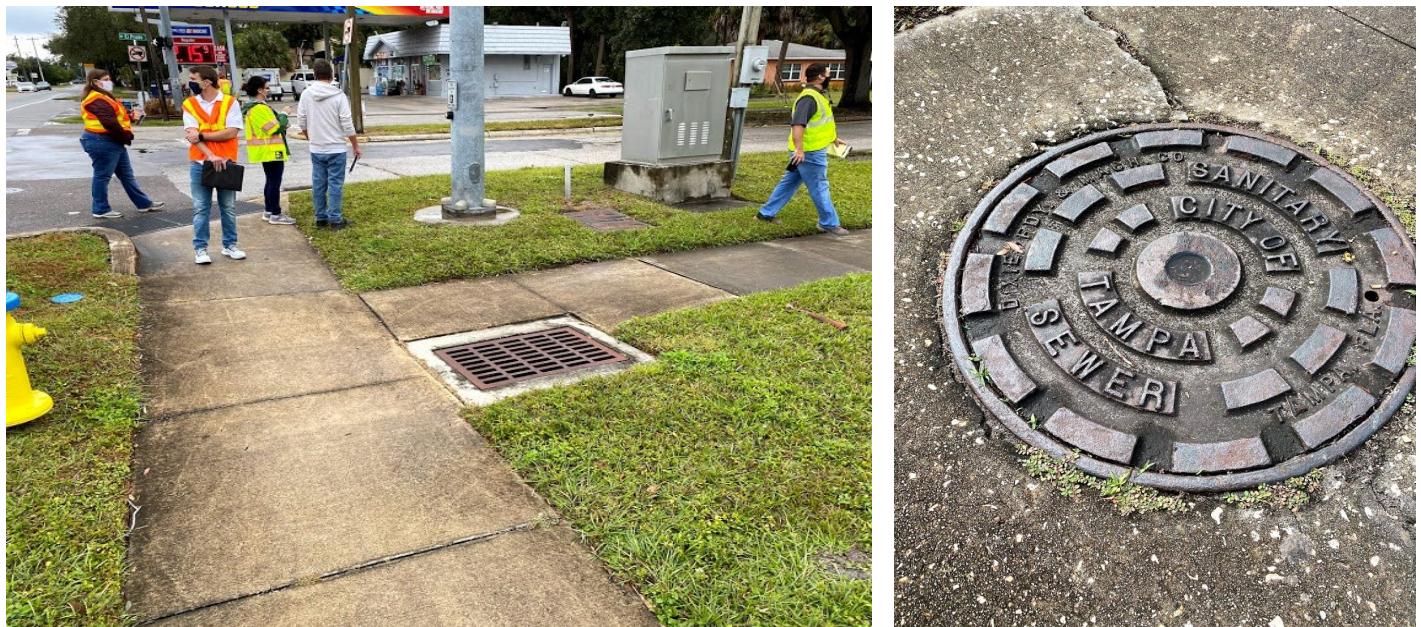
The south side sidewalk should be evaluated for ADA concerns and existing sidewalk condition. All curb ramps shall be upgraded to current ADA standards. There is a portion of the southside sidewalk immediately east of the West Shore Blvd. intersection that acts as a swale to convey stormwater runoff to a grate inlet. Design alternatives and alternate drainage inlet tops should be evaluated during design. Finally, it was noted that there are several sanitary manholes in the south side sidewalk that may not meet ADA standards. Push buttons at the signalized intersections were often inaccessible. These should be considered during design.

Figure 8: Drainage inlet within sidewalk in area of sidewalk swale (left); sanitary sewer manhole cover within southside sidewalks (right)

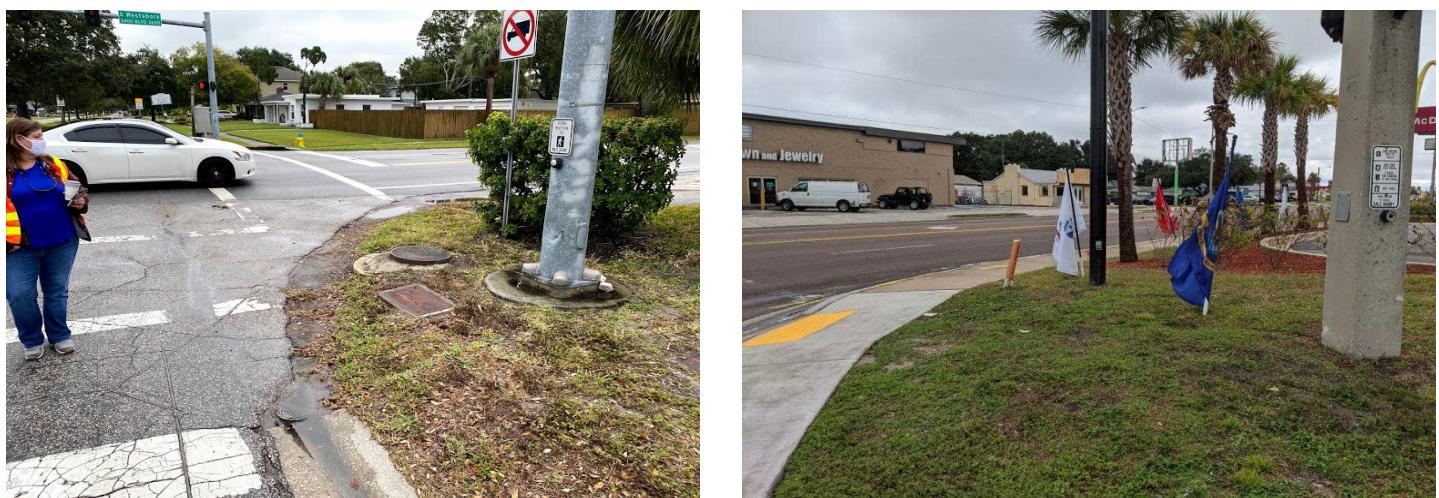
Figure 9: Inaccessible push buttons at West Shore Blvd. and Dale Mabry Hwy, left and right, respectively

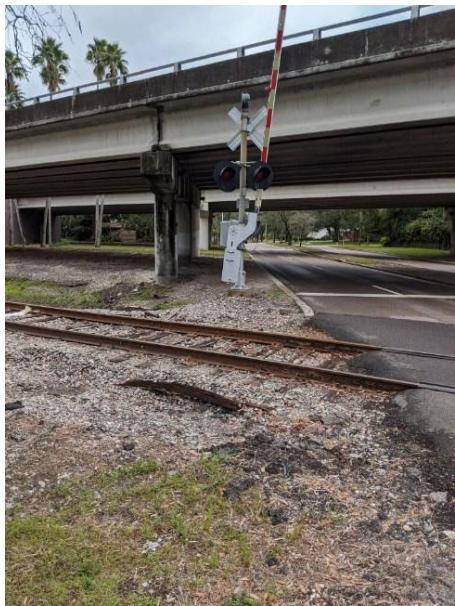
Figure 10: CSX Rail crossing with no sidewalk on north side

Currently, the two largest barriers are Dale Mabry Blvd. and the CSX Railroad crossing. The Dale Mabry Hwy. intersection should be considered for improvements to the pedestrian facilities. Sidewalks and bike facilities across the CSX rail line should be included within the project.

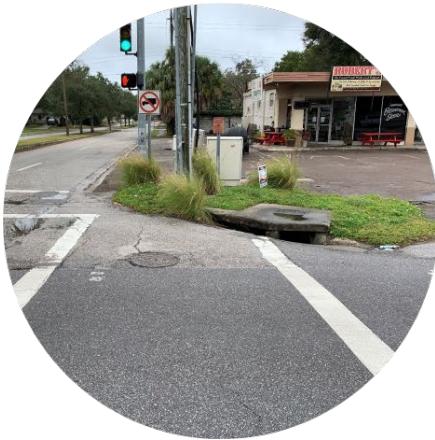
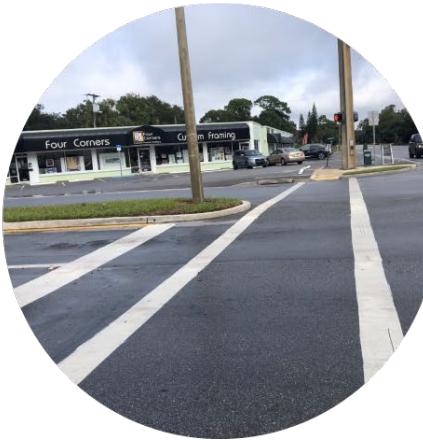
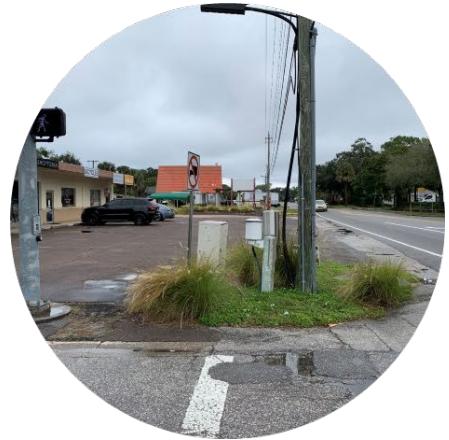
Figure 12: Long crossing distances for pedestrians and lack of ramps and landings make intersections dangerous and inaccessible.

All signalized intersections should be analyzed to determine needed operational and safety improvements, especially considering the proposed lane diet. Unwarranted space may be used to better serve multimodal users. Crossing distances should be reduced and opportunities for pedestrian refuge islands should be evaluated. Signal timings, bike specific striping (bike boxes), cyclist detection, right turn restrictions, and leading pedestrian intervals (LPI) should be considered.

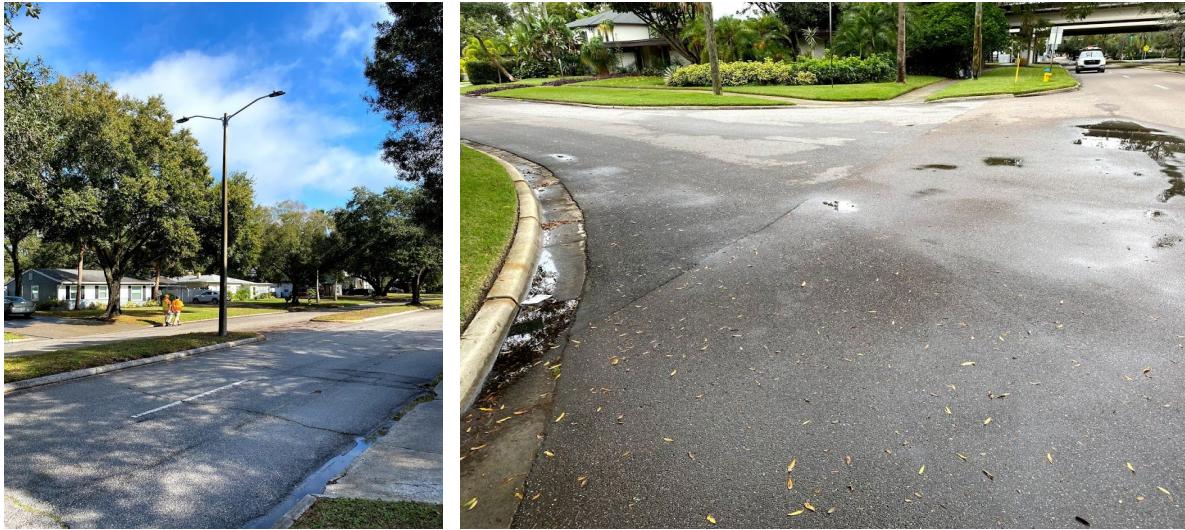
The intersection of Drexel Ave. is skewed with large curb radii, creating long crossing distances. Reconstruction of a portion of the curb returns and the median islands should be evaluated, along with any proposed pedestrian crossings. Along the corridor, there are several midblock median openings that may no longer function after the lane diet. Considerations should be given to either closing or properly signing for restricted movements (no U-turns) all median openings. However, the designer should work to understand how the public may use these openings.

Figure 13: Mid-block median openings may not allow U-turns under proposed conditions (left); Drexel Ave. is a skewed intersection with a wide throat (right)

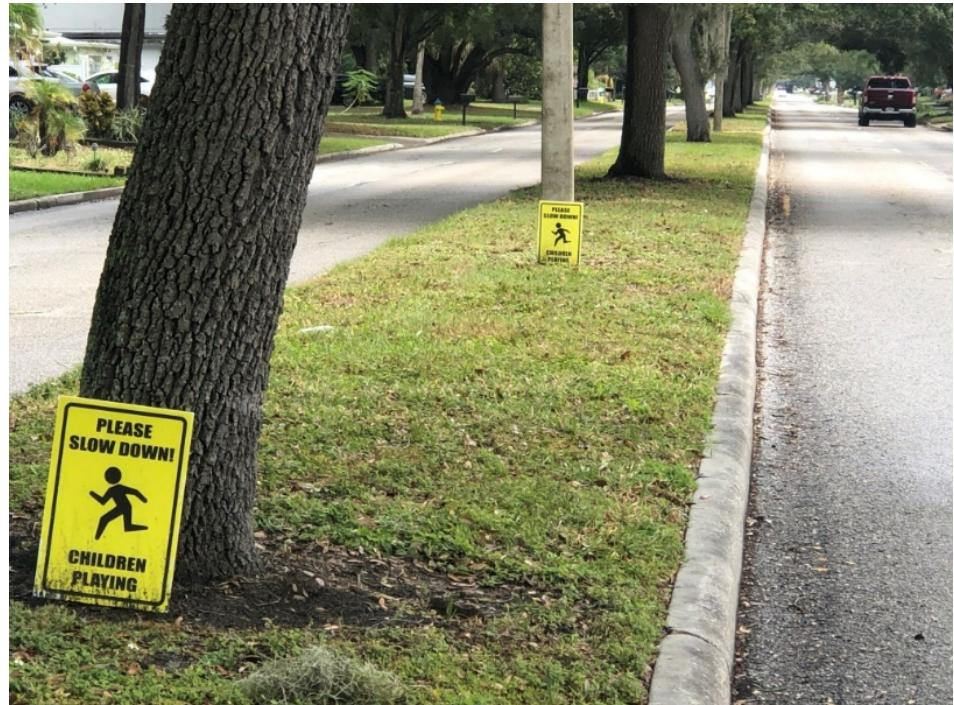
Figure 14: El Prado residents have already attempted to slow traffic on their own by placing these placards in the median

Traffic calming along the corridor should be considered. In addition to narrow lanes and enhanced signage and striping, horizontal and vertical deflection should be evaluated as part of the project. The City has incorporated horizontal and vertical deflection as a means to calm traffic on other recent projects. The Hampton Terrace and Ridgewood Park Neighborhood Traffic Calming Projects employed raised medians,

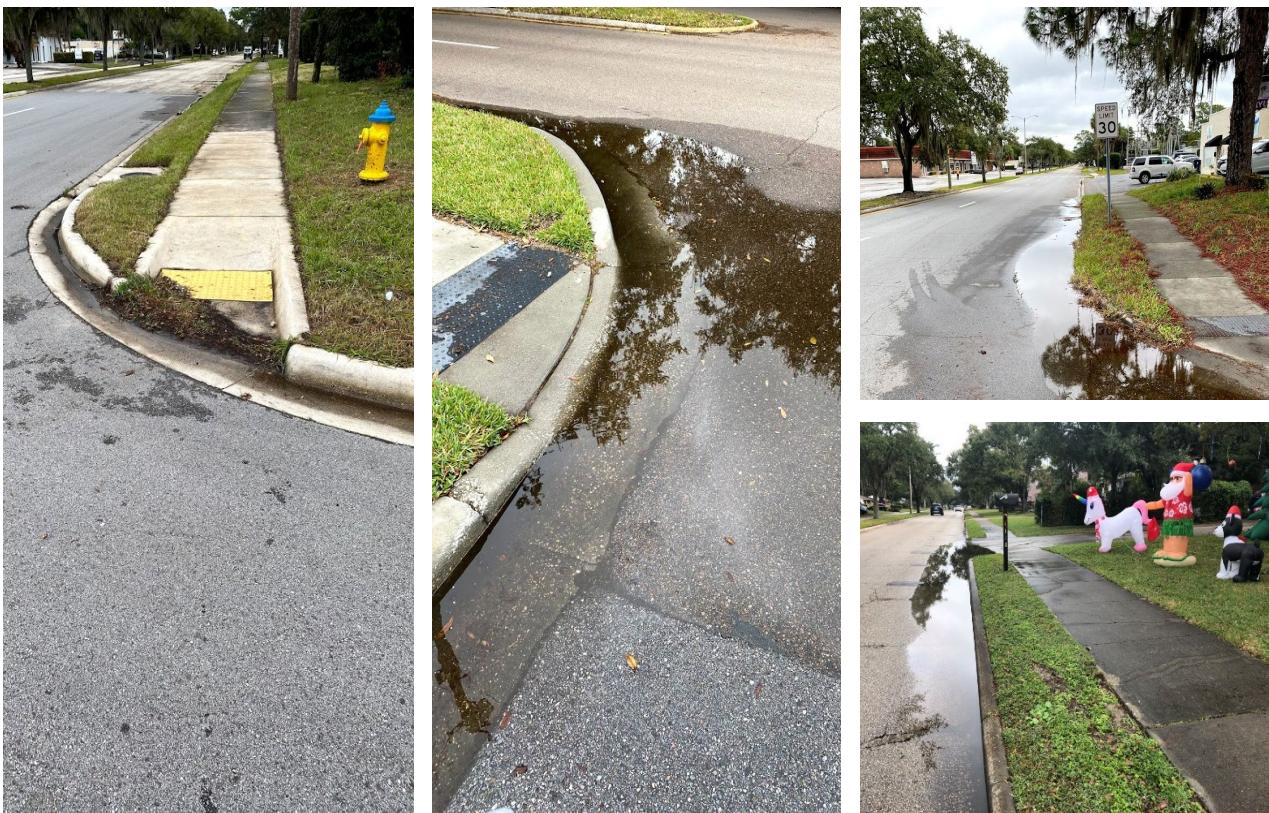
There were several areas of ponding encountered during the on-site audit. Removing ponding through low maintenance methods should be included within the design. Special notice should be placed on ponding within curb ramps and proposed bicycle facilities.

Figure 15: Ponding and sediment in walkways and bikeways create obstacles that reduce the viability of alternate modes

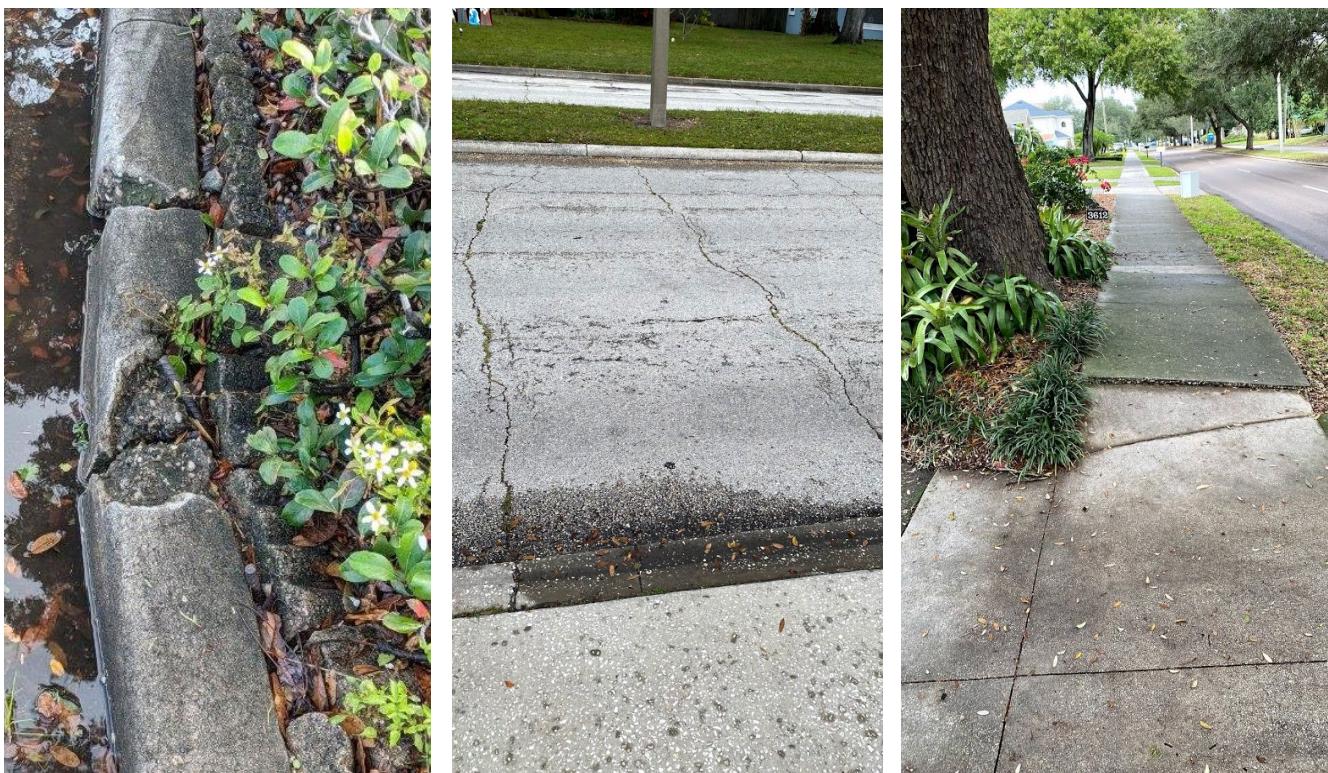
The asphaltic concrete pavement shows signs of several failures. Instances of block cracking were observed during the on-site audit. Recommendations for pavement rehabilitation should be developed during design. Areas of damaged sidewalks were noted on both sides of the road and should be considered for replacement. Several sections of damaged curb were also encountered.

Currently, El Prado Blvd. has a series of relatively young live oak trees that have been planted within a narrow median. Evidence of damage to the existing adjacent pavement was observed. Considering that the roadway is a normal crown section, the damage and uplifting has not caused any drainage issues. However, as the City is proposing a lane diet where vehicular traffic will be forced to utilize the inside lanes, drivability should be considered when evaluating the corridor. Canopy should be evaluated for appropriate clearance. Possible inclusion of a median side shoulder may be considered to reduce future driving surface concerns due to tree roots. Finally, the City's Natural Resources Group should be engaged early in project design development to determine existing tree conditions and evaluate existing trees for pruning or removal.

Figure 16: The City will look to rehabilitate the corridor assets; broken curb, pavement failures, and upheaved sidewalks should be evaluated for correction.
