**RFQ: 15-C-00017**  
**OLD CITY HALL EXTERIOR RENOVATIONS**  
**DESIGN-BUILD SERVICES**

**DESIGN CRITERIA PACKAGE**

CITY OF TAMPA

December 12, 2014

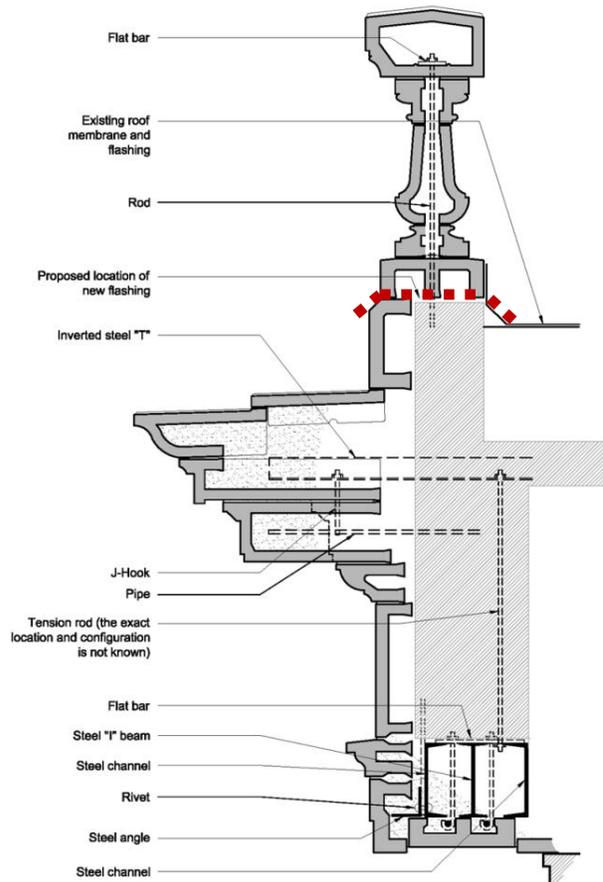
- Cornices: North and East – The 3rd floor terra-cotta cornices are in very poor condition on both elevations, and require remedial work. The cornice is supported by structural steel members and sagging is apparent. Although there are no drawings of the existing structure, based on onsite observations and construction standards of the time, it appears that two steel C-channels and one steel I-beam are bolted together to form the main structural support. The structural beam and channels appear to bear on the large granite columns of the east and north sides. The steel I-beam and C-channels which support the cornice have experienced significant amount of deterioration due to corrosion from exposure to moisture, and will require replacement. The lower terra-cotta pieces that form the bottom of the cornice are hung from rods and pins below the structural beam and channels. The rods and pins have oxidized, and are splitting the terra-cotta.

- **Note:** The following detail represents the existing conditions at the cornice on the 4th floor east and north elevations based on site observations, and historic documentation of typical terra-cotta details of the time period.

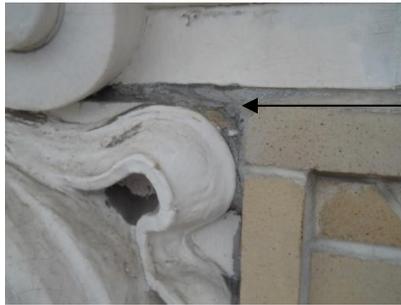
**T9**

Failing sealant repairs

Failing glaze

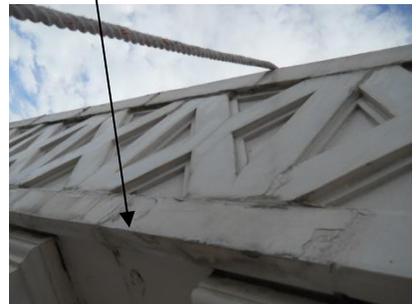
**U7**

Terra-cotta tile protruding from  
face of cornice

Spalling of terra-cotta  
glaze

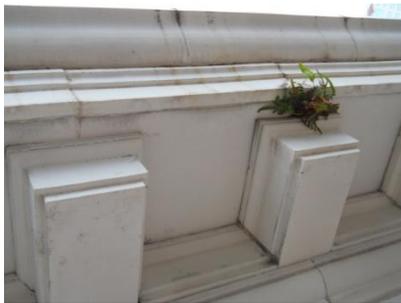
**H4**

Vegetation growth indicating failing joints.

Exposed joint reinforcing.

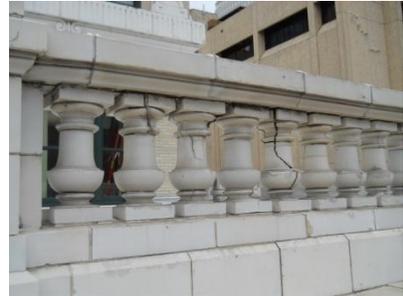
**I8**

Ballusters in varying degrees of deterioration.

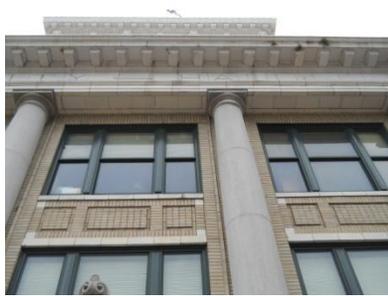
**H16**

Deteriorated steel lintel.

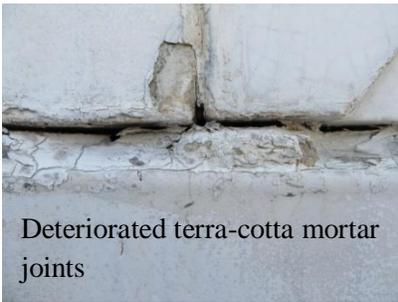
**U8**

Deteriorated terra-cotta mortar joints

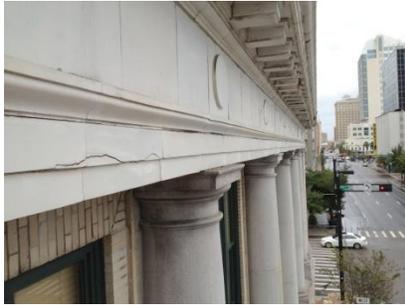
**H16**

Deteriorated terra-cotta finish

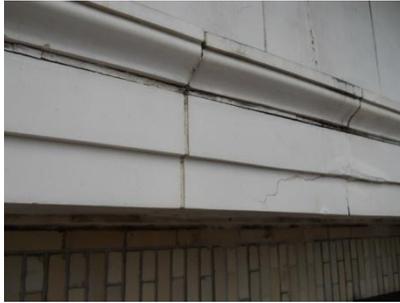
**G10**

Severely cracked soffit panel (this has subsequently been removed)

Failed terra-cotta dentil molding

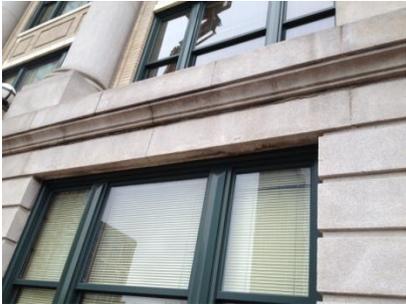
**C7**

Spalled granite

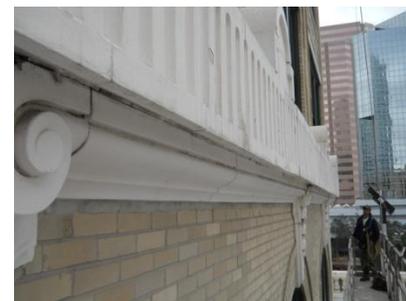
**K14**

Terra-cotta banding replaced with resinous casting

Inappropriate use of a gypsum filler material

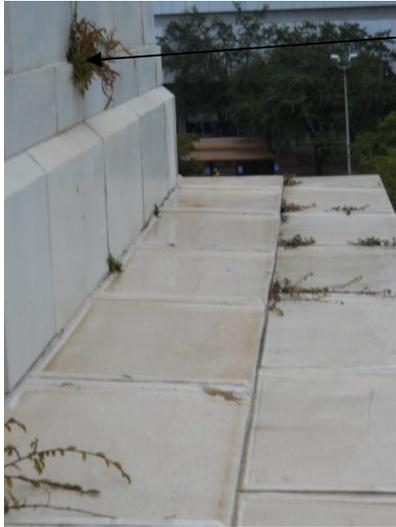
**I2**

Vegetation growth indicating failing joints.

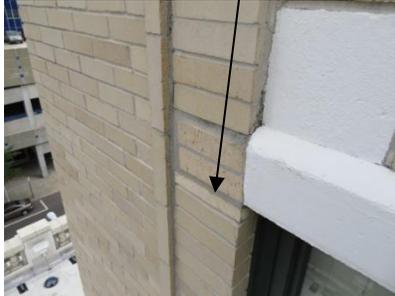
**M14**

Mortar joints failing

Incorrect brick replacement  
color / texture

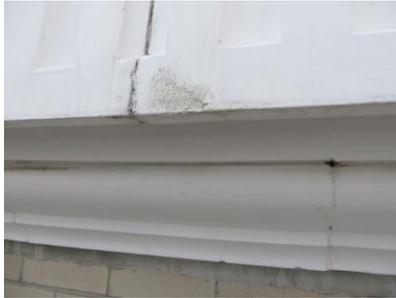
**K9**

Deteriorated terra-cotta mortar joints

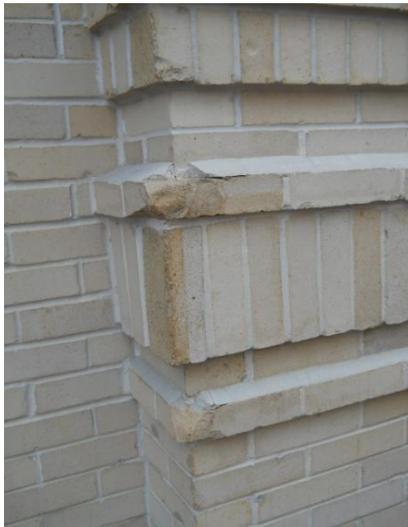
**G14**

Evidence of water intrusion from  
inside of parapet

Cracked concrete banding

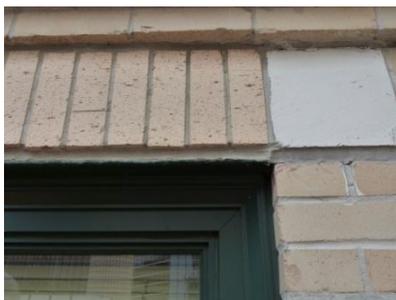
**H12**

Deteriorated steel  
lintel.
