**ADDENDUM 2**  
**Via E-Mail**  
**DATE: May 5, 2025**

Contract: 24-C-00002; E/W Green Spine Cycle Track PH 2A from Howard Ave to Rome Ave

**MC Squared, Inc. (MC²)** has performed the requested geotechnical engineering services, including a pavement condition survey, for the referenced project. This report presents the results of our fieldwork and laboratory testing, evaluation of the data generated, and our input recommendations for the design and construction of the project.

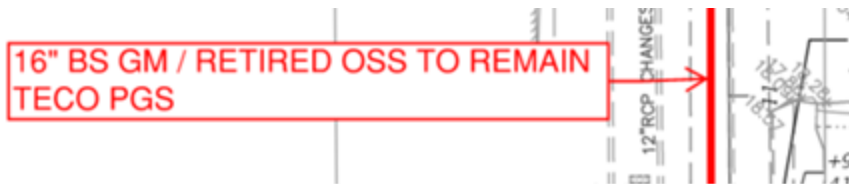
**RFI response:** TECO Peoples Gas provided greenlines during the project design indicating that the line is retired and out of service (see markup below). Per Specification G-1.03: "Contractor to make his own investigations to inform himself fully of the character, condition and extent of all such installations and structures as may be encountered and as may affect the construction operations." Per Specification SP-2.04: "The prime contractor is responsible for organizing the work of and coordination with any and all Utility Agency Owners involved within the project limits. The Utility Relocation Schedules submitted during the design phase have been provided." Utility Owner contact information is shown on General Notes, page 6 of the roadway plans.

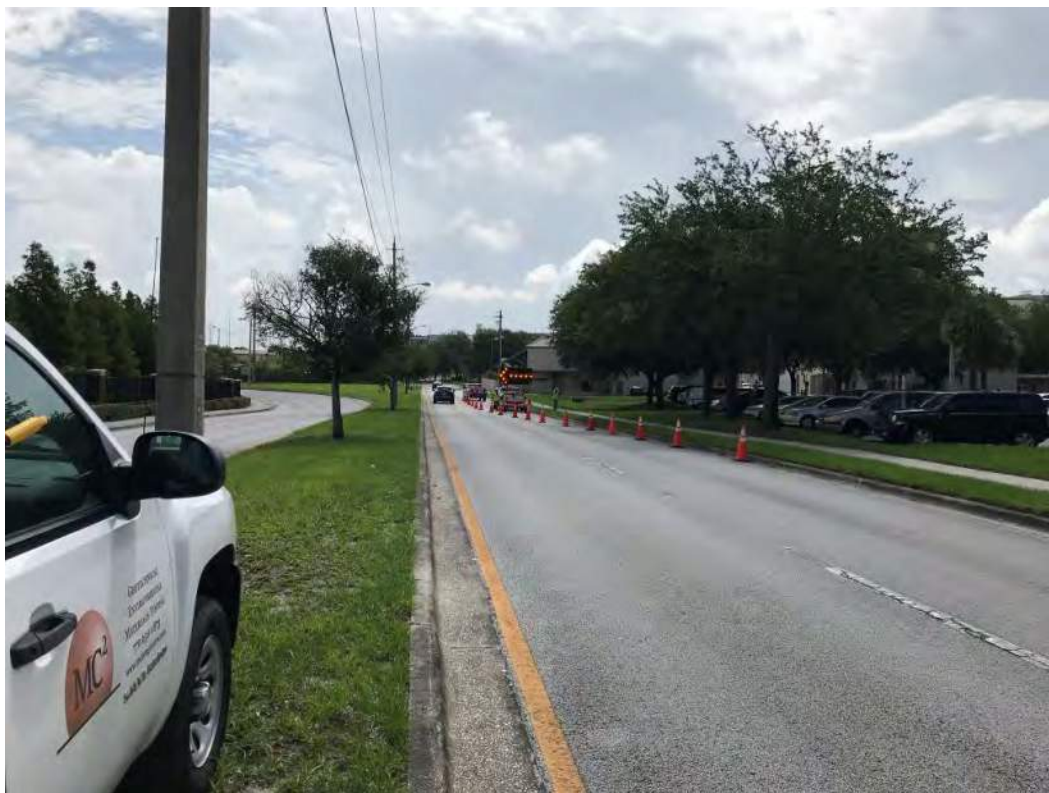
**Figure 2: Nuccio Pkwy facing East (photographed on June 1, 2018)**

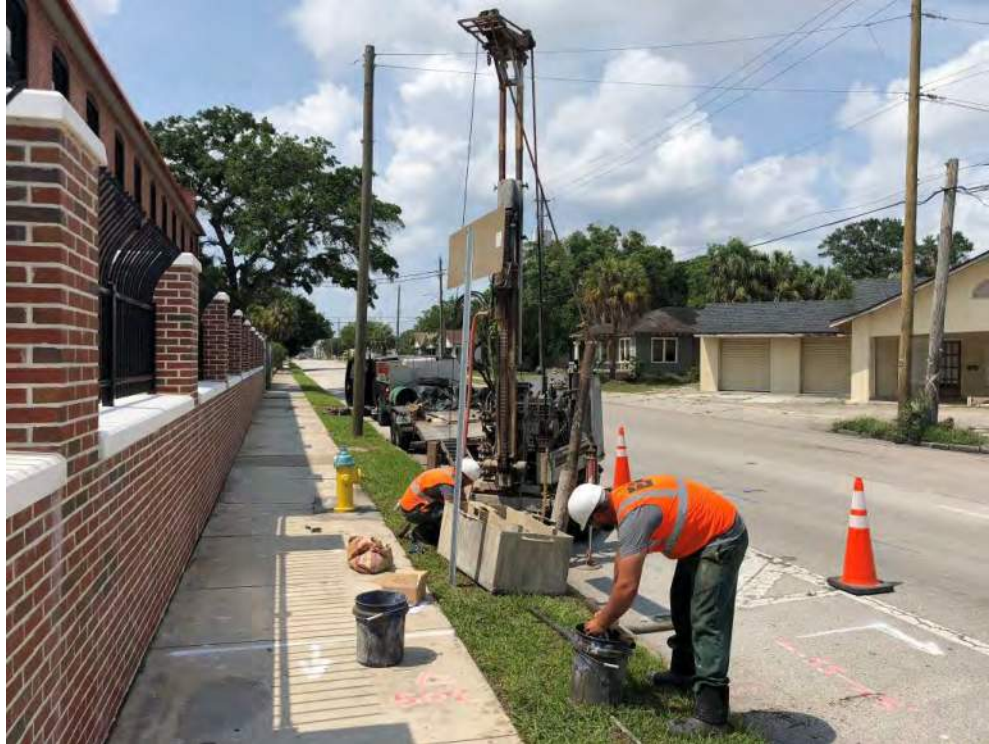
The SPT boring was completed at the site in general accordance with ASTM D1586 (Standard Test Method for Penetration Test and Split Barrel Sampling of Soils) by a truck-mounted drill rig using a wet-rotary procedure and a safety hammer. Representative soil samples were obtained using a 2-in. outer diameter split-barrel sampler driven into the soil by a 140-lb hammer operating freely over a drop of 30-inches. The number of blows required to drive the sampler through a 12-in. interval, after initial penetration of 6-in., is termed the Standard Penetration Resistance, or "N" value, and is indicated for each sample on the boring log. The "N" value may be taken as an indication of the empirical relative density (cohesionless soils) or consistency (cohesive soils) of soils in-situ.

**Figure 3: Performing SPT-01 on N. Howard Ave. (photographed June 6, 2018)**

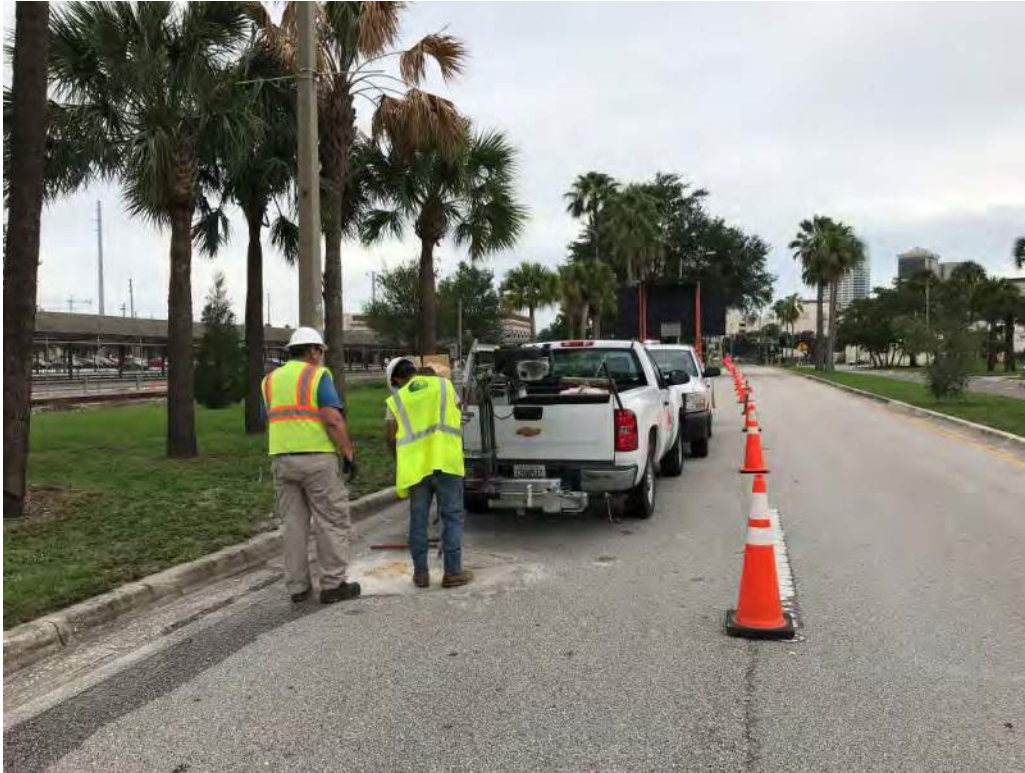
The hand auger borings were completed at the site in general accordance with ASTM D1452 (Standard Practice for Soil Exploration and Sampling by Auger Borings) using a 3 ¼-in. diameter auger bucket. Samples were collected in 4 to 6-in. increments, classified and logged in the field, with confirmatory classifications by **MC<sup>2</sup>** professional geotechnical engineers at our Tampa, Florida laboratory location. Boreholes were backfilled and compacted with soil cuttings.

**Figure 4: Performing C-04 on Nuccio Pkwy., facing southwest (photographed May 29, 2018)**

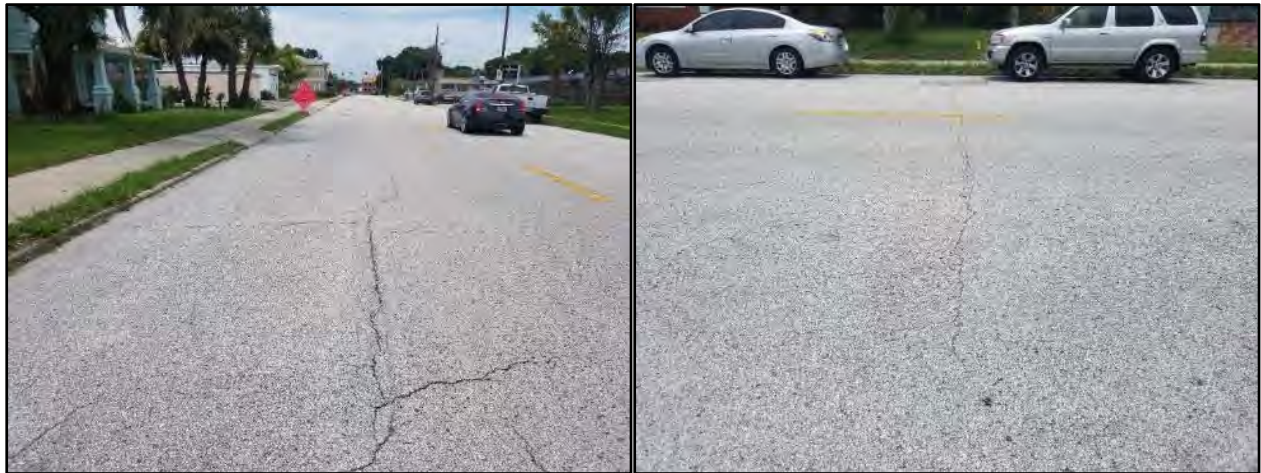
***Figures 3 & 5: Longitudinal Cracking (250-ft. West of N. Fremont Avenue)  
Transverse Cracking (270-ft. west of N. Fremont Avenue)***

Asphalt patches have been used in parking areas and locations where the pavement surface is weathered. Weathered asphalt patches are generally present due to the vehicle traffic load exceeding the design criteria of the roadway.

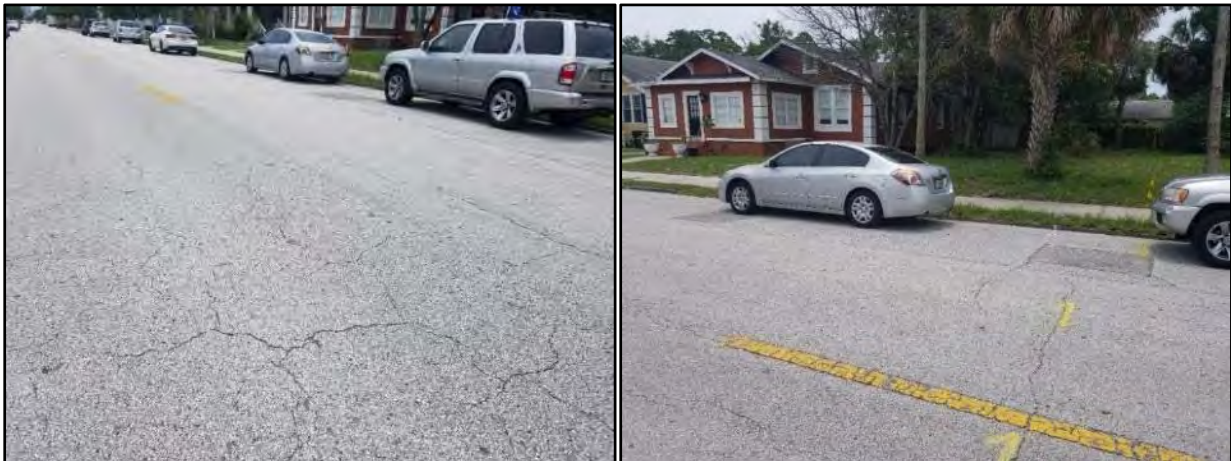
***Figures 6 & 7: Block Cracking (300-ft. west of N. Fremont Avenue)  
Asphalt Patches / Transverse Cracking (270-ft. west of N. Fremont Avenue)***

The pavement condition at this site should be considered **Poor**. This assessment was determined from a crack rating of 3.5 and a rut rating of 8.

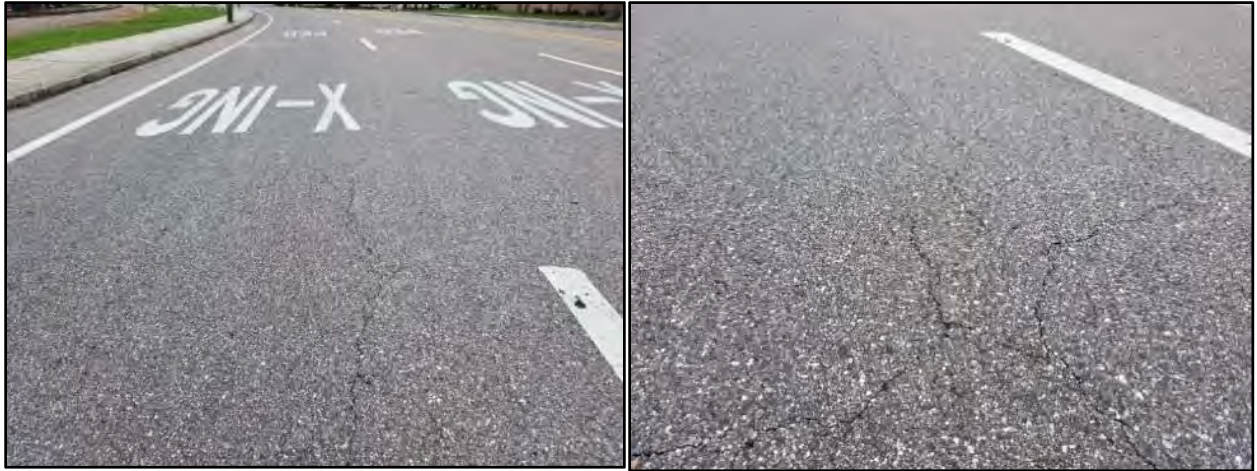
***Figures 8 & 9: Longitudinal Cracking (330-ft. east of North Boulevard)  
Transverse Cracking (280-ft. east of North Boulevard)***

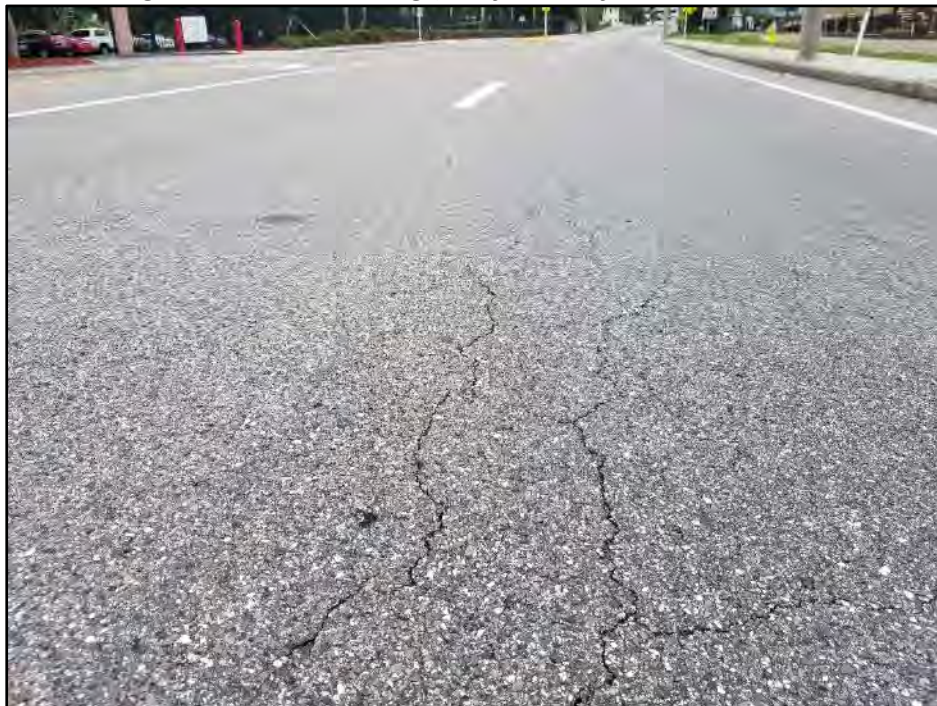
***Figure 10: Block Cracking (335-ft. east of North Boulevard)***

The pavement condition at this site should be considered **Poor**. This assessment was determined from a crack rating of 5.5 and a rut rating of 9.

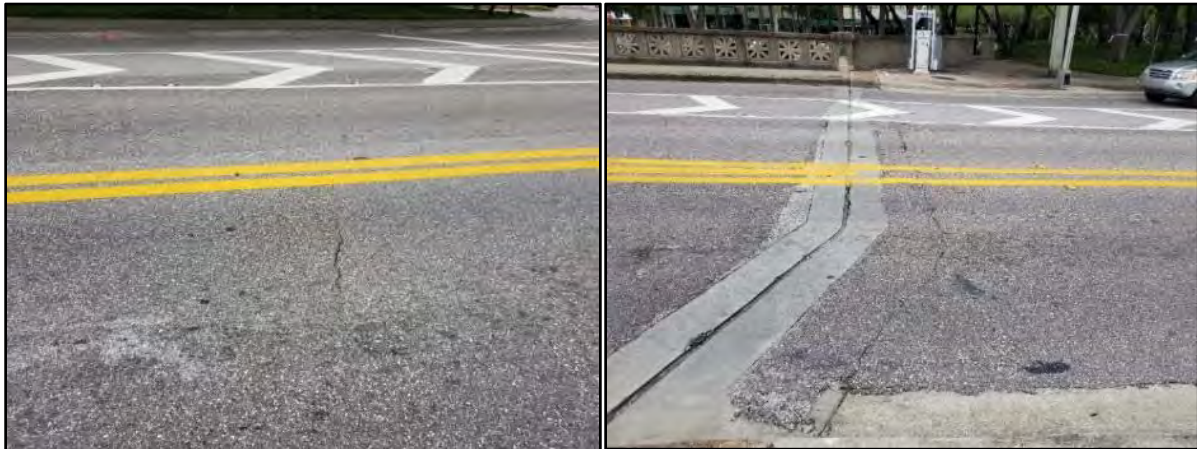
***Figures 11 & 12: Transverse Cracking (200-ft. west of Doyle Carlton Drive)  
Reflection Cracking (240-ft. west of Doyle Carlton Drive)***

The pavement condition at this site should be considered **Fair**. This assessment was determined from a crack rating of 10 and a rut rating of 8.

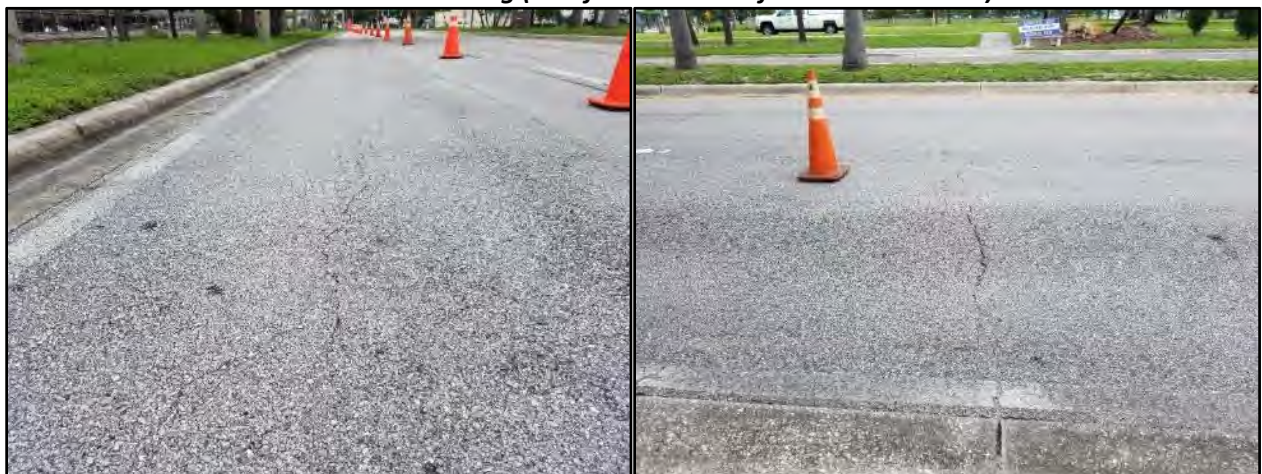
***Figure 13 & 14: Longitudinal Cracking (400-ft. northeast of N. Nebraska Ave.)  
Transverse Cracking (430-ft. northeast of N. Nebraska Ave.)***

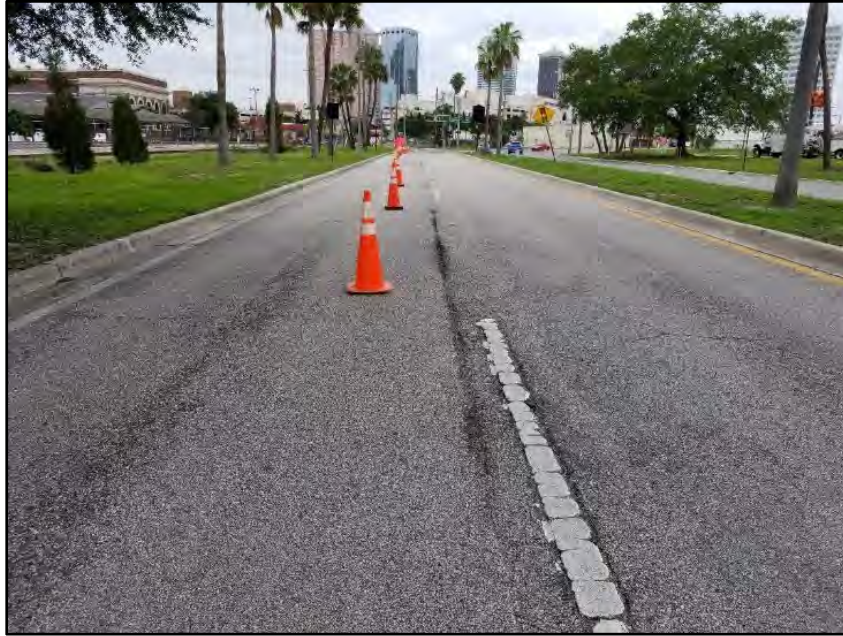
**Figure 15: Transverse Cracking and Raveling (370-ft. northeast of N. Nebraska Ave.)**

The pavement condition at this site should be considered **Fair**. This assessment was determined from a crack rating of 8.5 and a rut rating of 9.

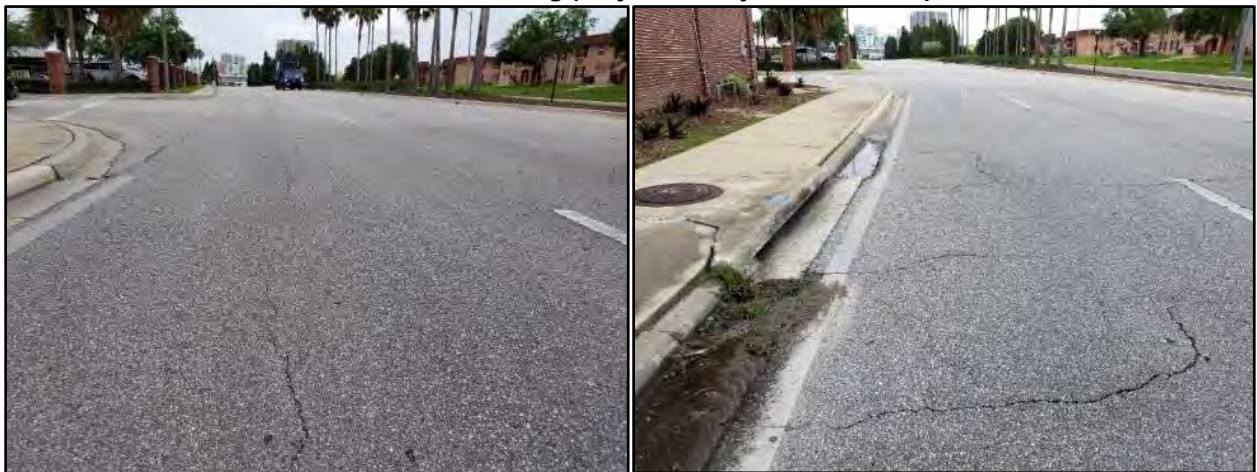
**Figure 16 & 17: Longitudinal Cracking (30-ft. north of E. 6th Avenue)  
Transverse Cracking (80-ft. north of E. 6th Avenue)**

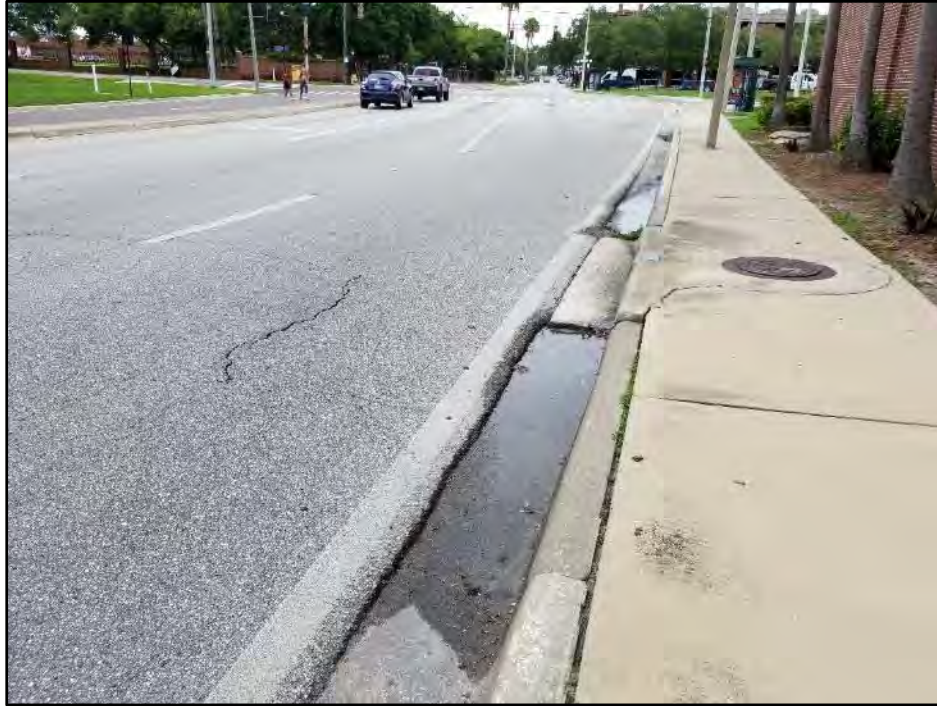
**Figure 18: Poor Drainage (20-ft. north of E. 6th Avenue)**

The pavement condition at this site should be considered **Poor**. This assessment was determined from a crack rating of 6.5 and a rut rating of 9.

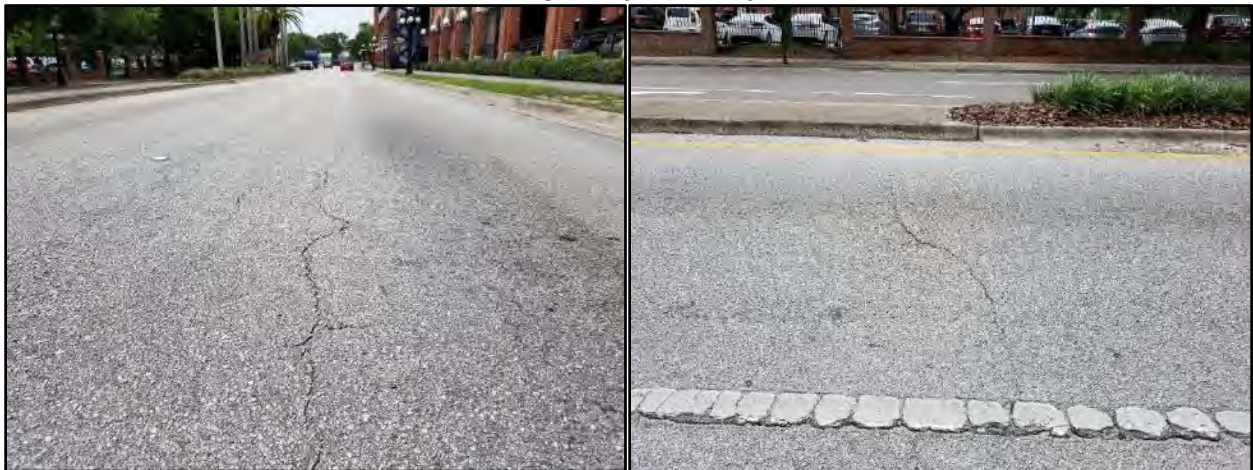
**Figure 19 & 20: Longitudinal Cracking (40-ft. north of E. 8<sup>th</sup> Avenue)  
Transverse Cracking (150-ft. north of E. 8<sup>th</sup> Avenue)**

The pavement condition at this site should be considered **Poor**. This assessment was determined from a crack rating of 7 and a rut rating of 9.

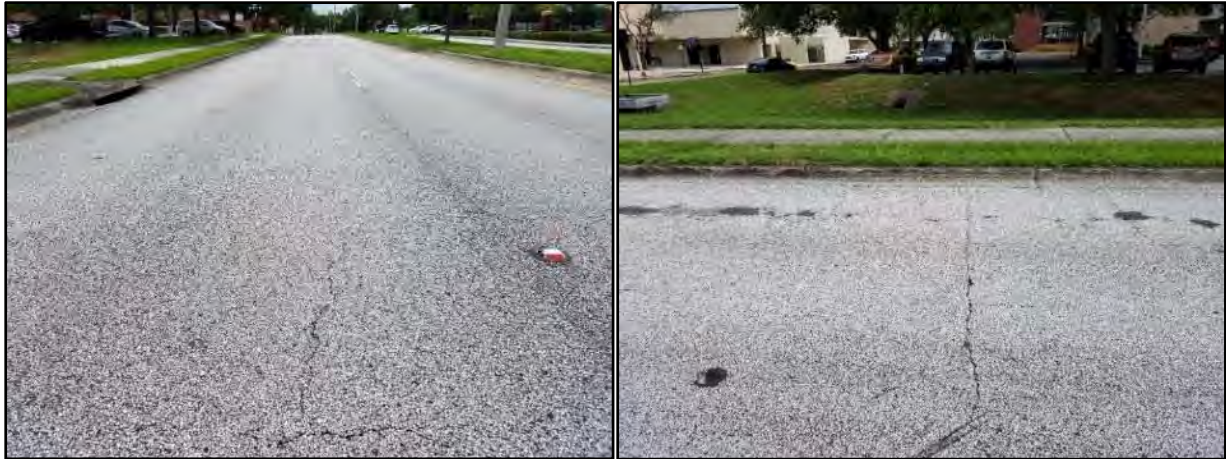
***Figure 21 & 22: Longitudinal Cracking (150-ft. west of N. 14<sup>th</sup> Street)  
Transverse Cracking (80-ft. west of N. 14<sup>th</sup> Street)***

Longitudinal cracks (Class I) and transverse cracks (Class I) are present throughout the roadway. These distresses are generally caused by deficiencies within the pavement and base materials.

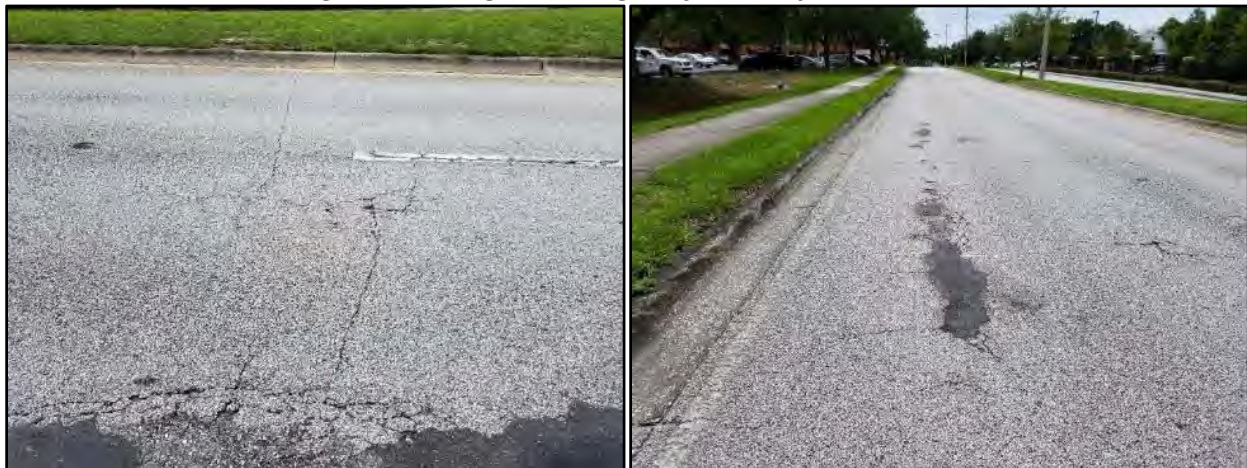
***Figure 23 & 24: Transverse Cracking / Fatigue (Alligator) Cracking (70-ft. west of N. 14<sup>th</sup> Street)  
Alligator Cracking / Patching (70-ft. west of N. 14<sup>th</sup> Street)***

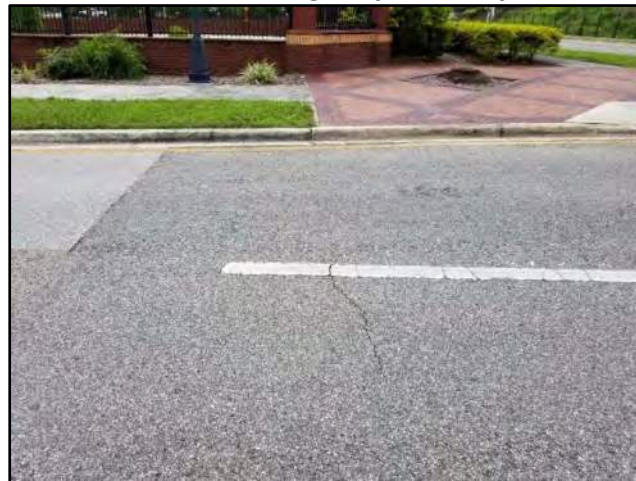
**Figure 26: Transverse Cracking (45-ft. south of E. 13<sup>th</sup> Avenue)**

The pavement condition at this site should be considered **Good**. This assessment was determined from a crack rating of 10 and a rut rating of 10.

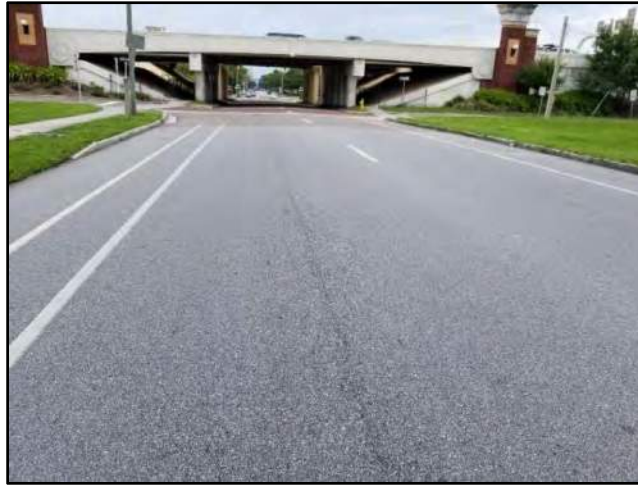
***Figure 27: Transverse Cracking (125-ft. north of E. 14<sup>th</sup> Avenue)***

The pavement condition at this site should be considered **Good**. This assessment was determined from a crack rating of 10 and a rut rating of 10.

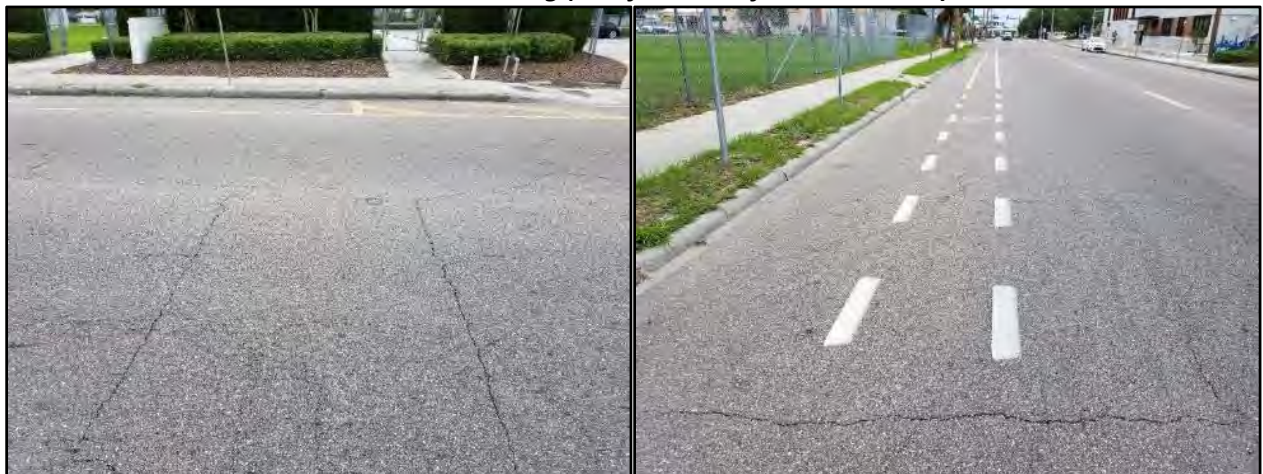
***Figure 28 & 29: Transverse Cracking (160-ft. north of E. 17<sup>th</sup> Avenue)***  
***Transverse Cracking (200-ft. north of E. 17<sup>th</sup> Avenue)***

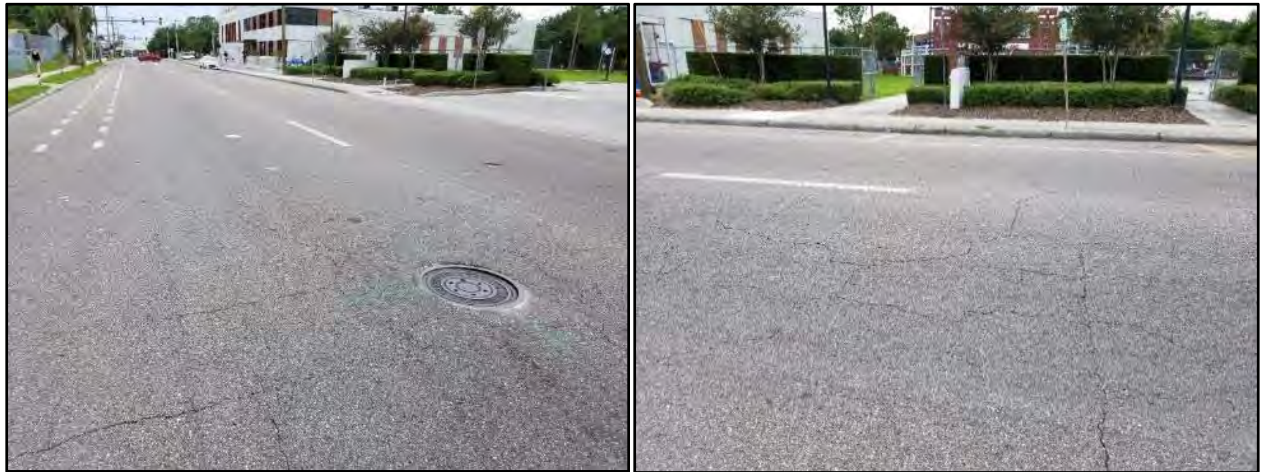
**Figure 30 & 31: Longitudinal Cracking / Transverse Cracking / Block Cracking  
(240-ft. north of E. 17th Avenue) Block Cracking (150-ft. north of E. 17th Avenue)**

Based upon the Pavement Condition Survey performed by **MC<sup>2</sup>**, the pavement condition at this site should be considered **Poor**. This assessment was determined from a crack rating of 3.5 and a rut rating of 9.

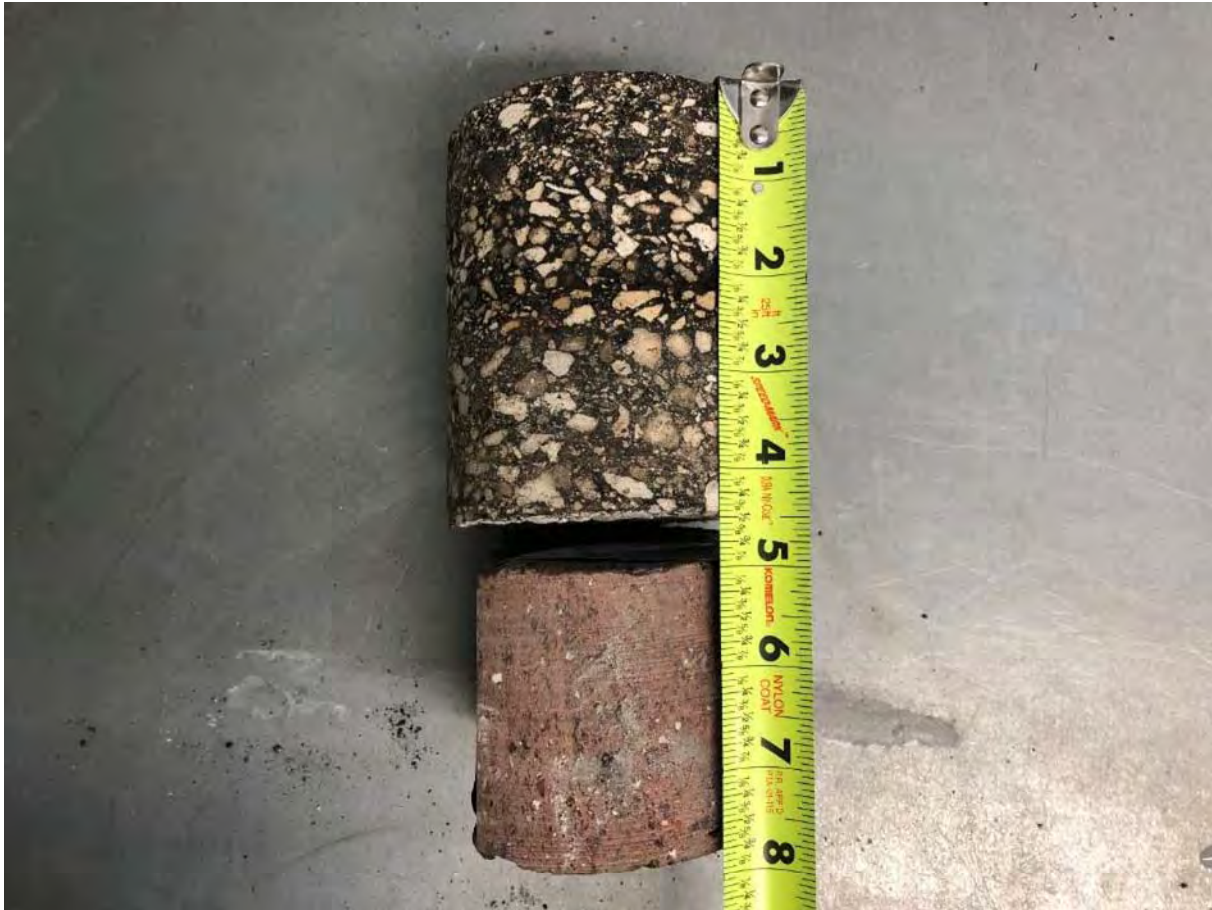
**Core C-01: 4 ½" Asphalt**  
**3" Paver**  
**4 ½" Shell Base**  
**SAND with silt (A-3) Subbase**

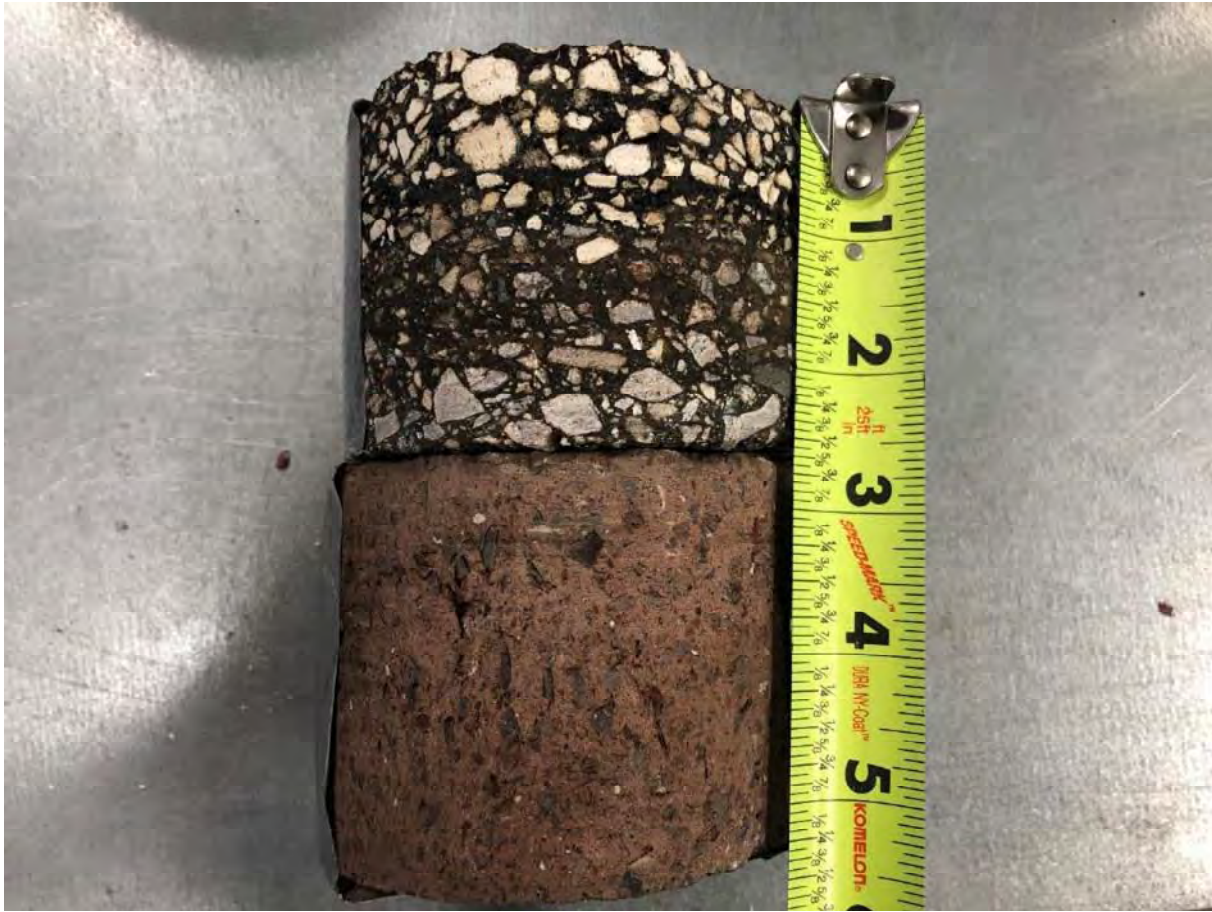
**Core C-02: 2 ½" Asphalt**  
**2 ¾" Paver**  
**No Base Encountered**  
**SAND with silt (A-3) Subbase**

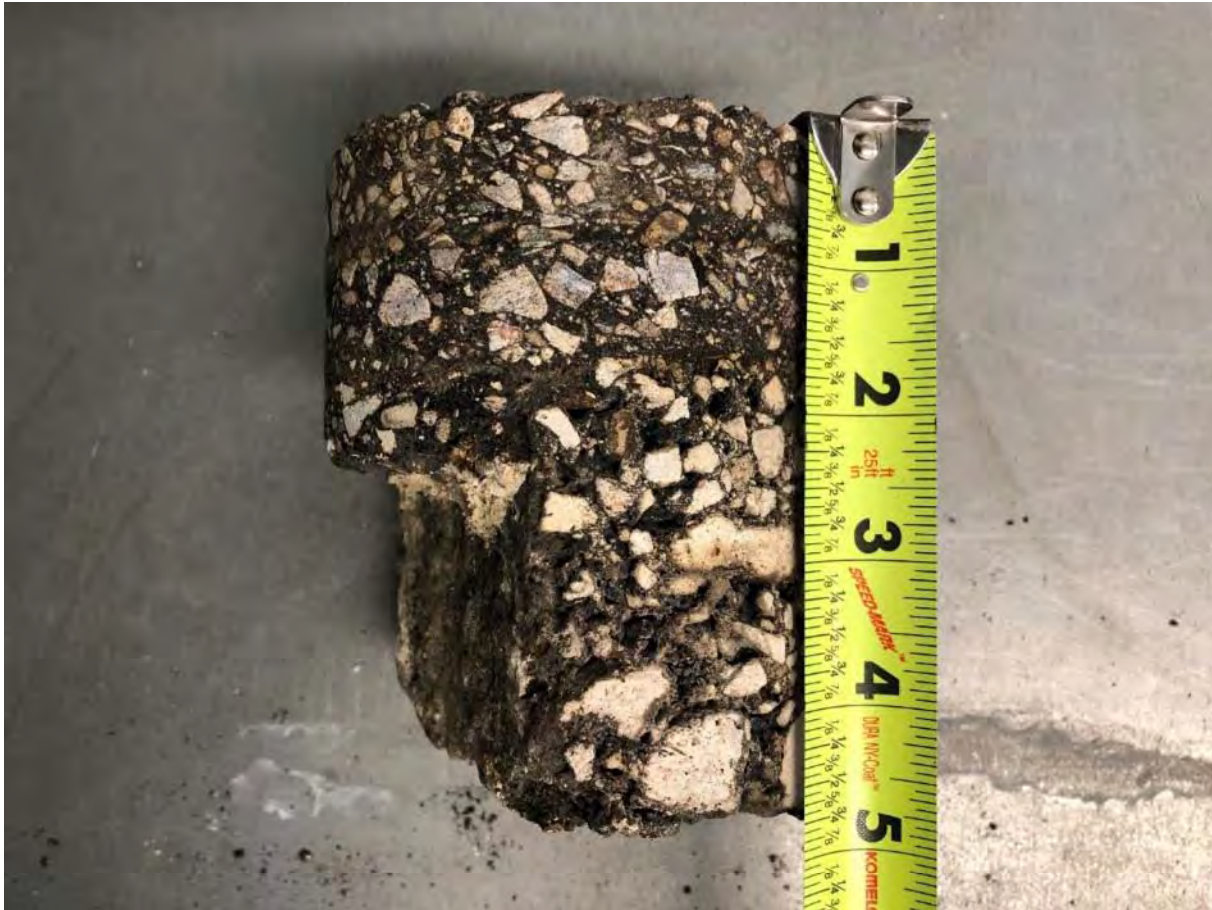
**Core C-03: 4 ¾" Asphalt (cracked underneath as shown)  
 7 ¼" Limerock Base  
 SAND with silt (A-3) Subbase**

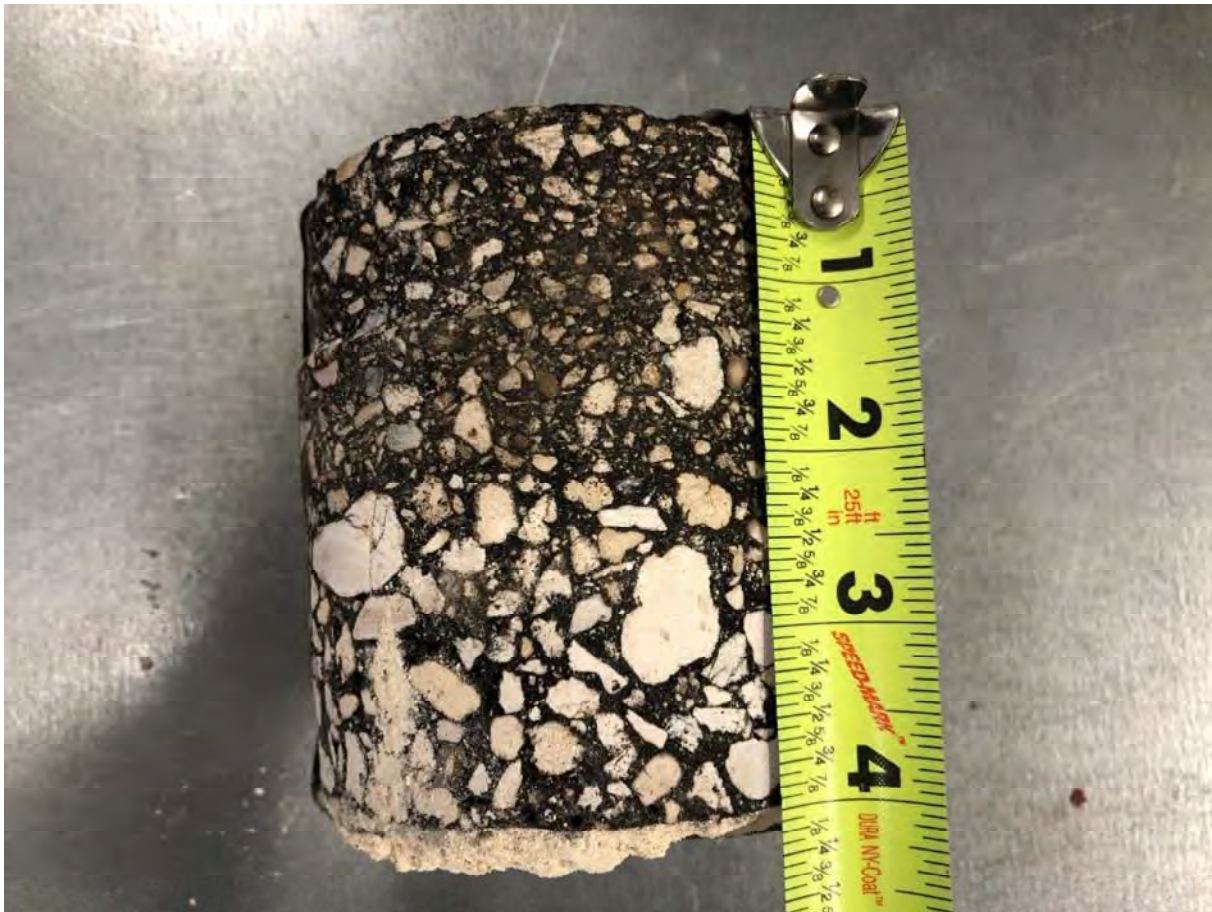
**Core C-04: 4" Asphalt  
10" Limerock Base  
SAND with silt (A-3) Subbase**

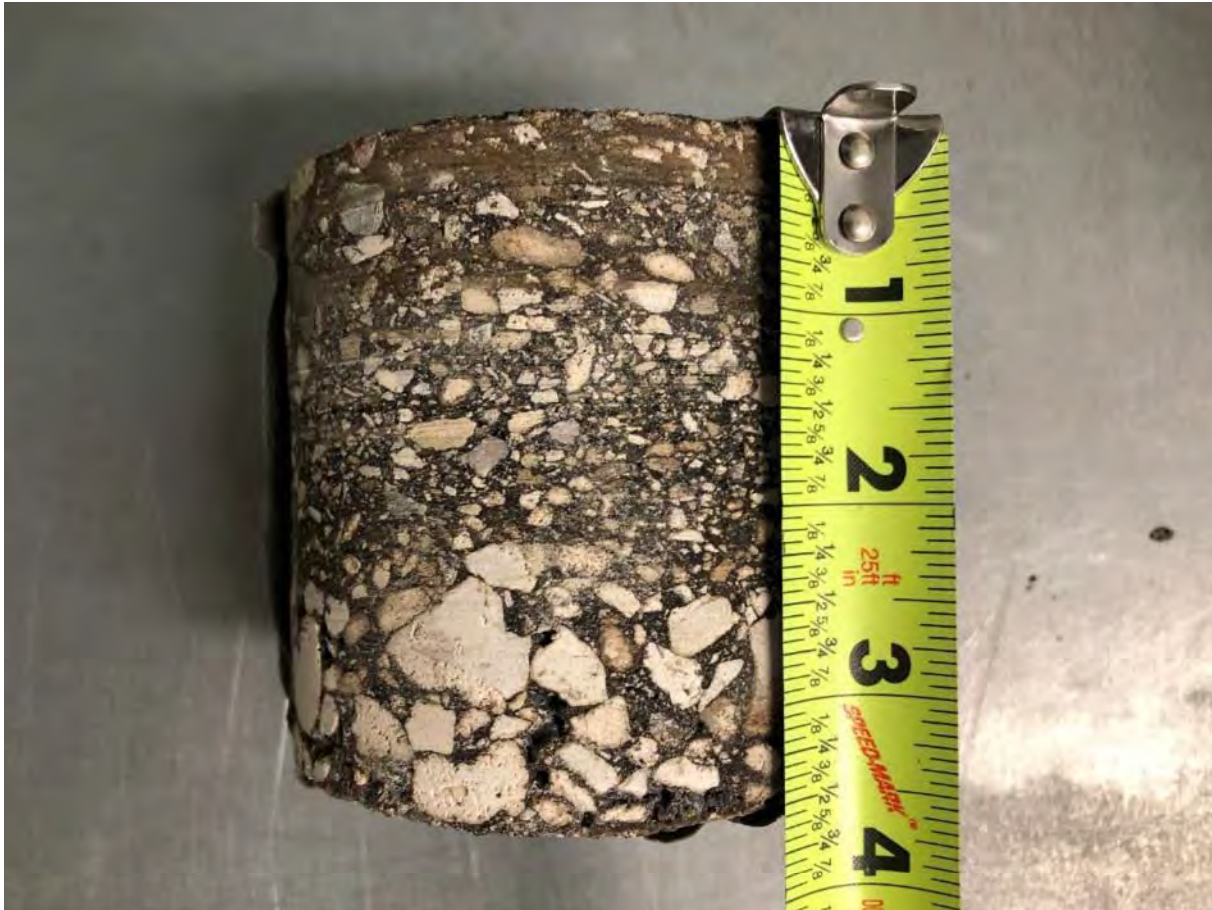
**Core C-05: 3 ½" Asphalt  
8 ½" Limerock Base  
SAND with silt (A-3) Subbase**

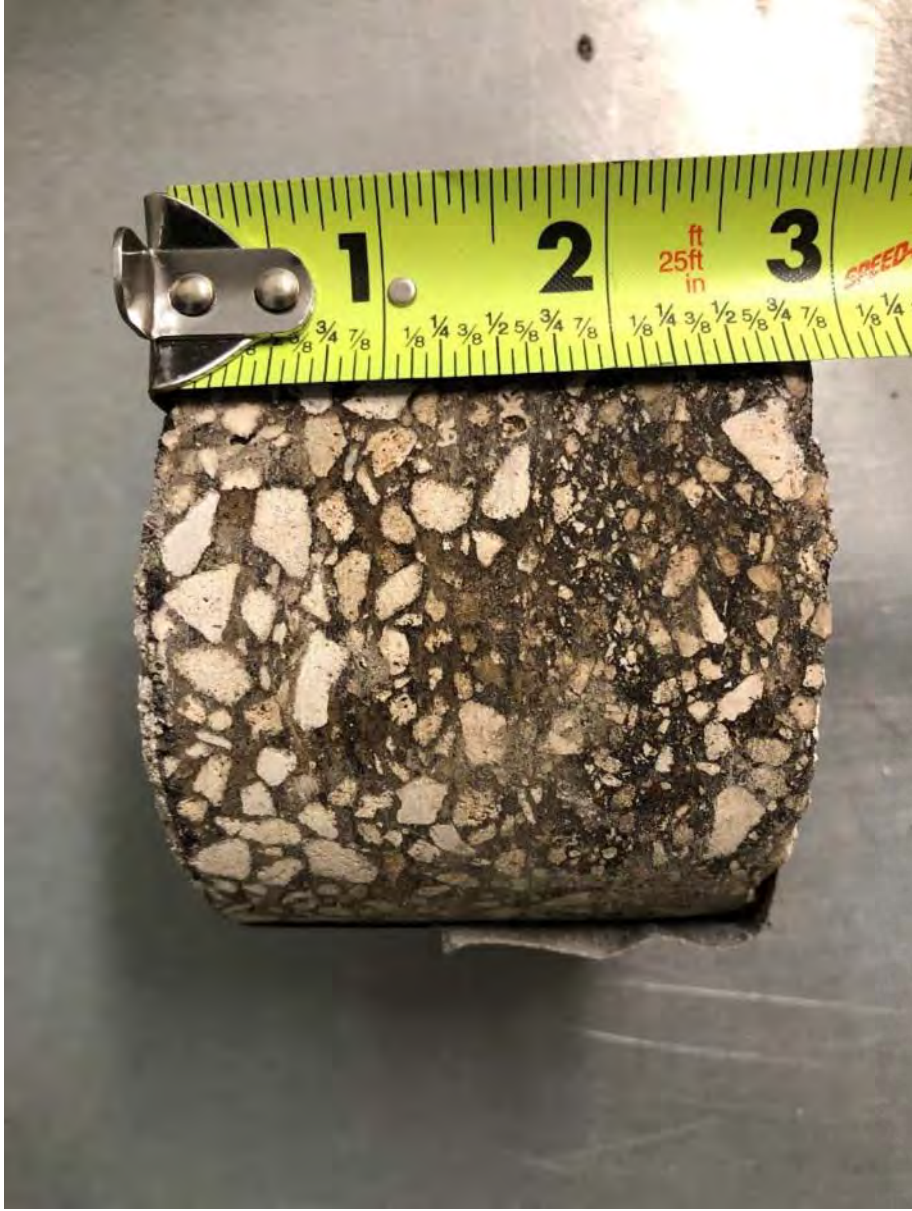
Core C-06: 2 ¾" Asphalt  
9 ¼" Limerock Base  
SAND with silt (A-3) Subbase

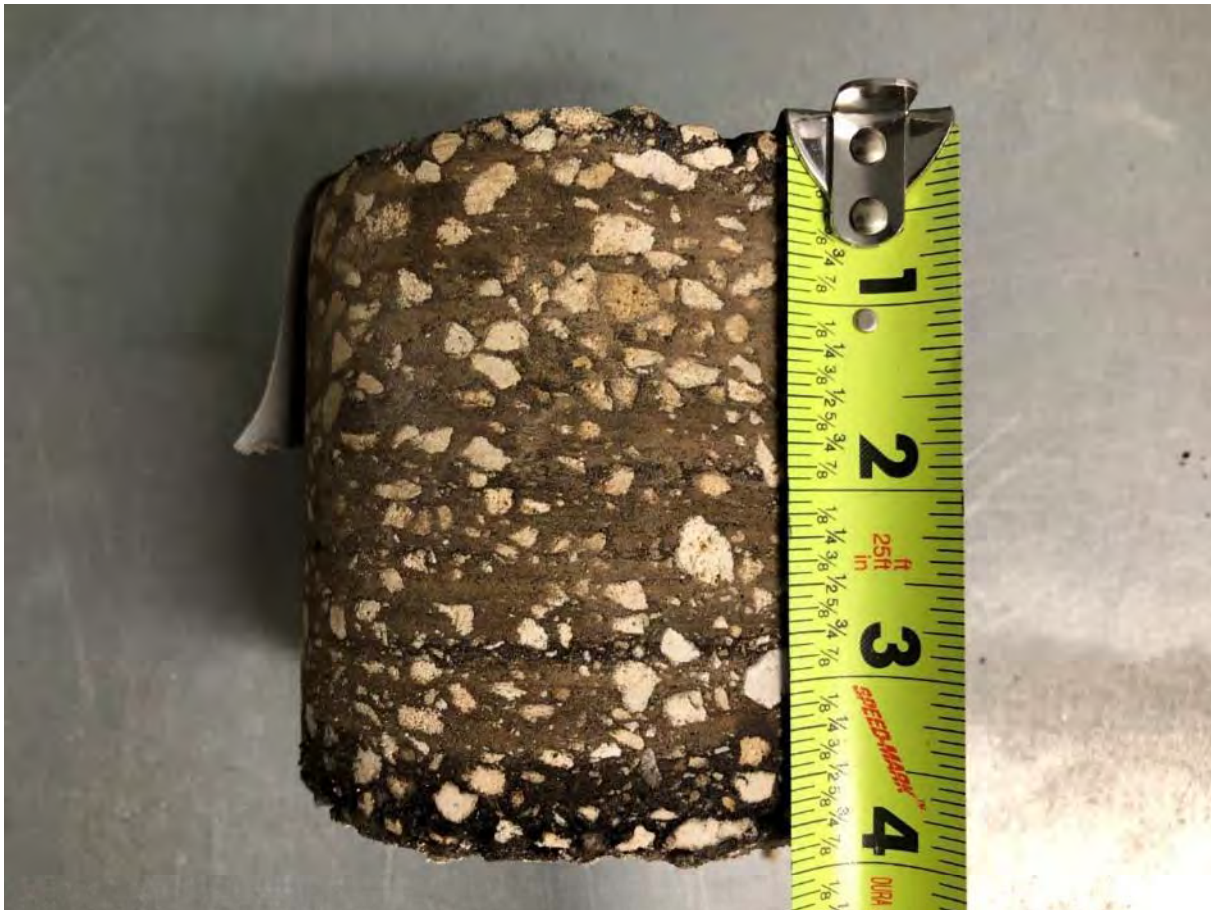
**Core C-07: 3 3/4" Asphalt  
11" Limerock Base  
SAND with silt (A-3) Subbase**

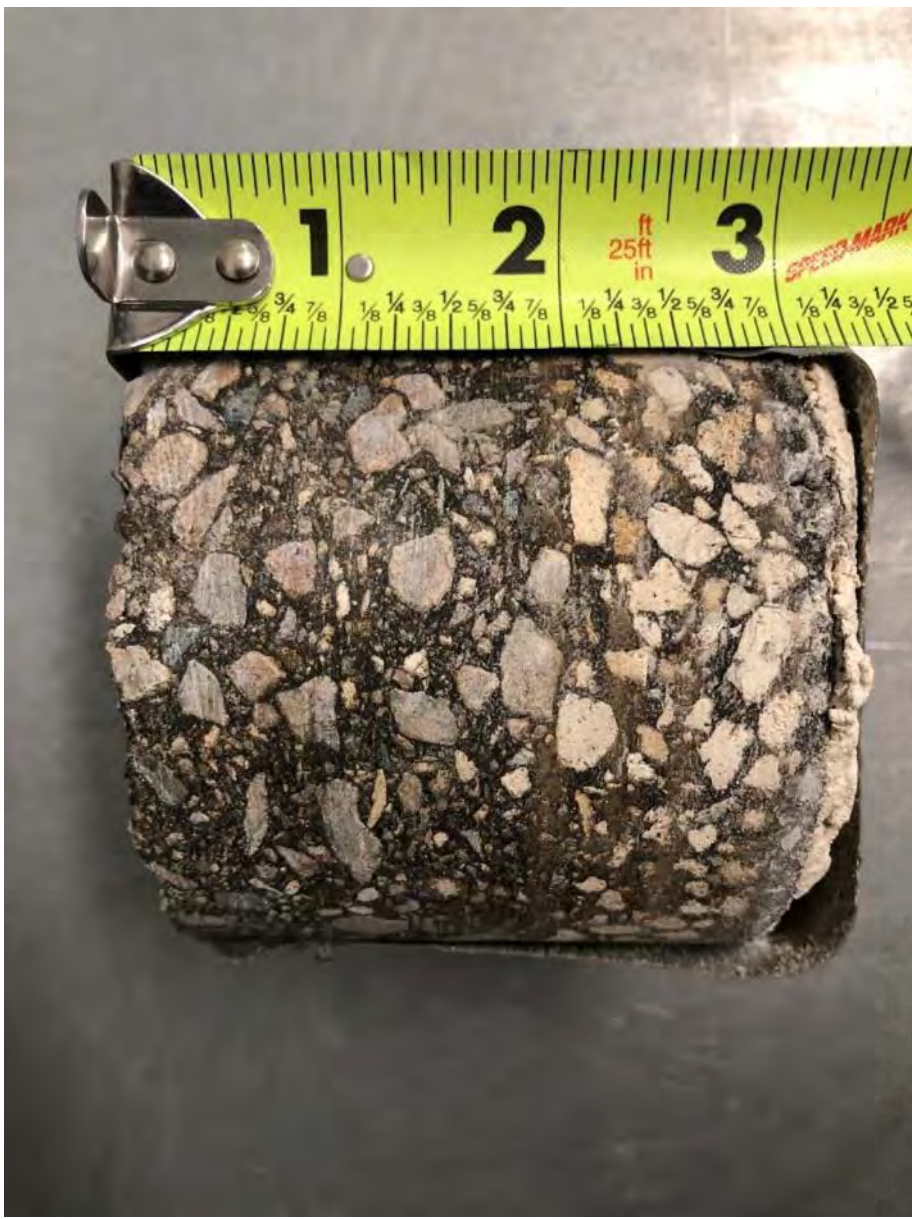
Core C-08: 3" Asphalt  
11" Limerock Base  
SAND with silt (A-3) Subbase
