**ADDENDUM 2**  
**Via E-Mail**  
**DATE: May 5, 2025**

Contract: 24-C-00002; E/W Green Spine Cycle Track PH 2A from Howard Ave to Rome Ave

**MC Squared, Inc. (MC²)** has performed the requested geotechnical engineering services, including a pavement condition survey, for the referenced project. This report presents the results of our fieldwork and laboratory testing, evaluation of the data generated, and our input recommendations for the design and construction of the project.

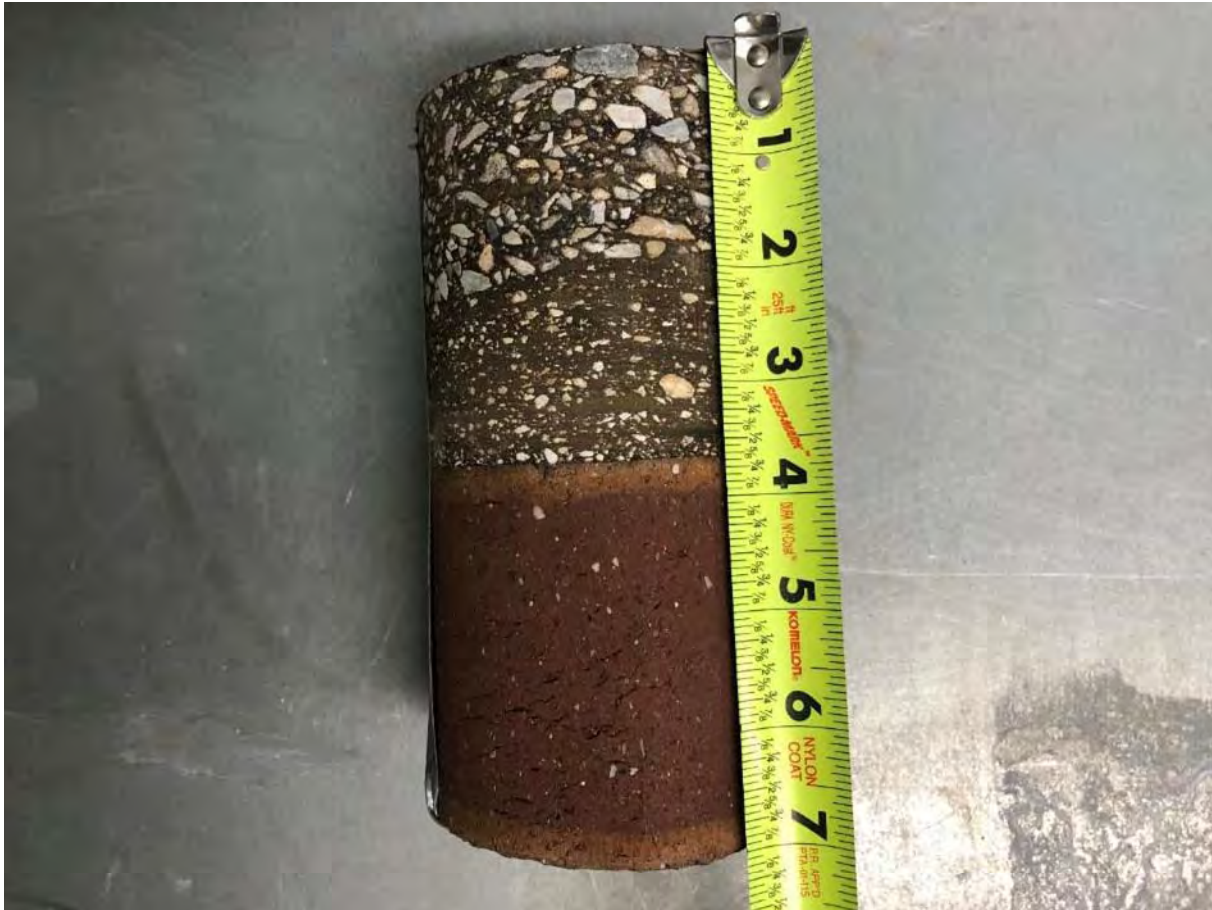
**Core C-09: 3 ½" Asphalt  
3 ½" Paver  
No Base Encountered  
SAND with silt (A-3) Subbase**

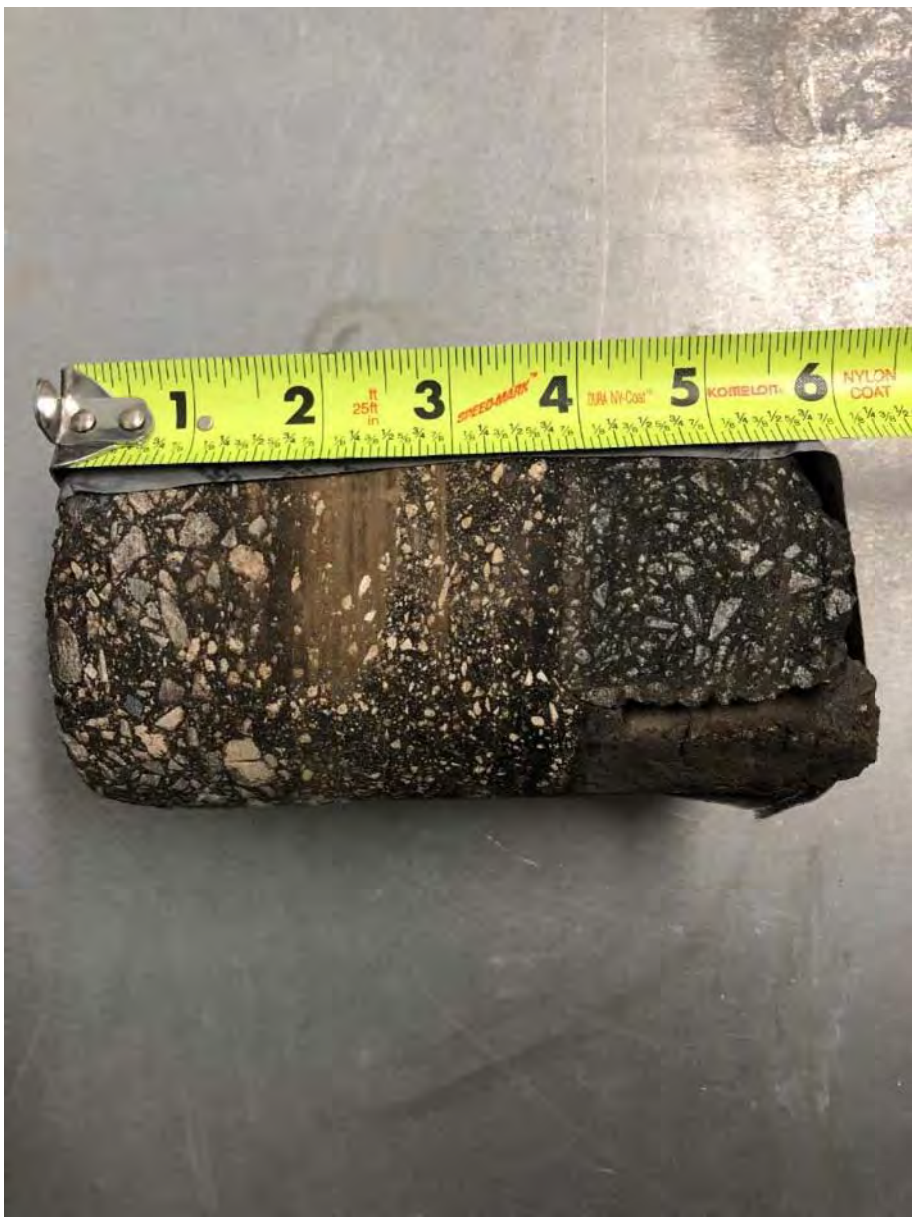
Core C-10: 6" Asphalt (saw cut captured in bottom layer as shown)  
No Base Encountered  
SAND with silt (A-3) Subbase

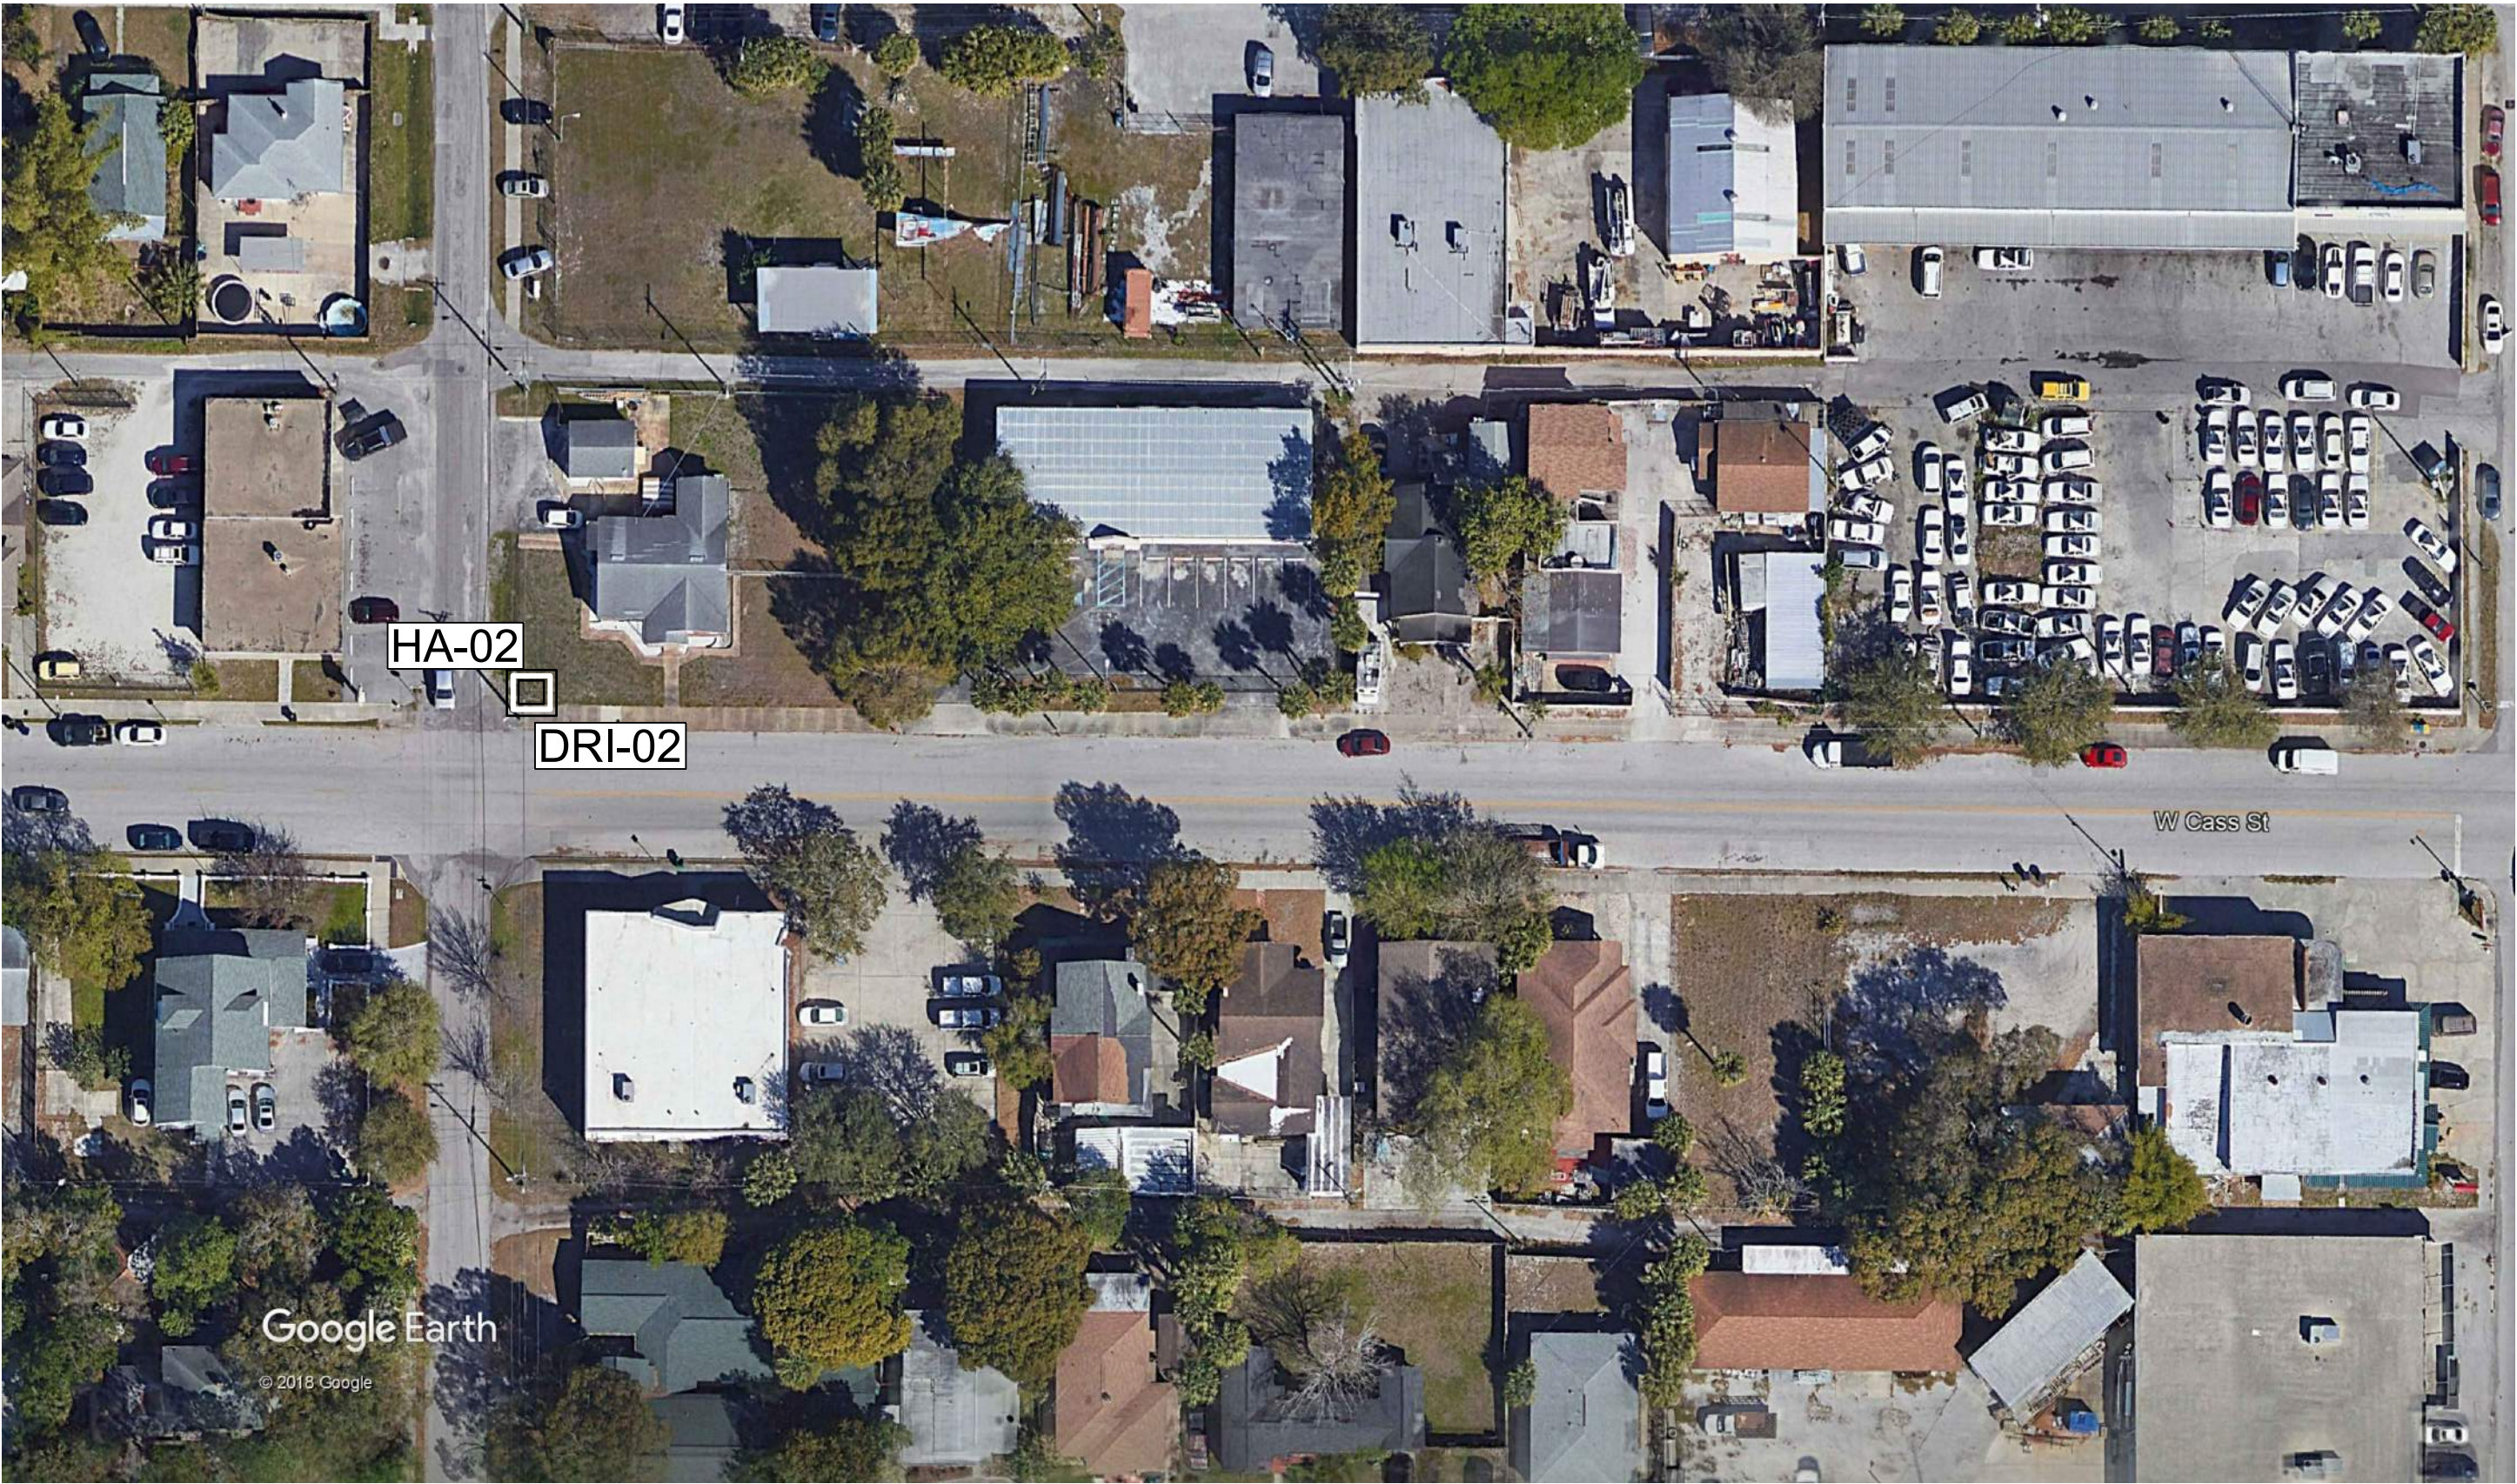
- Approximate Pavement Core Location
- Approximate SPT Location
- Approximate Hand Auger Location
- Approximate DRI Location

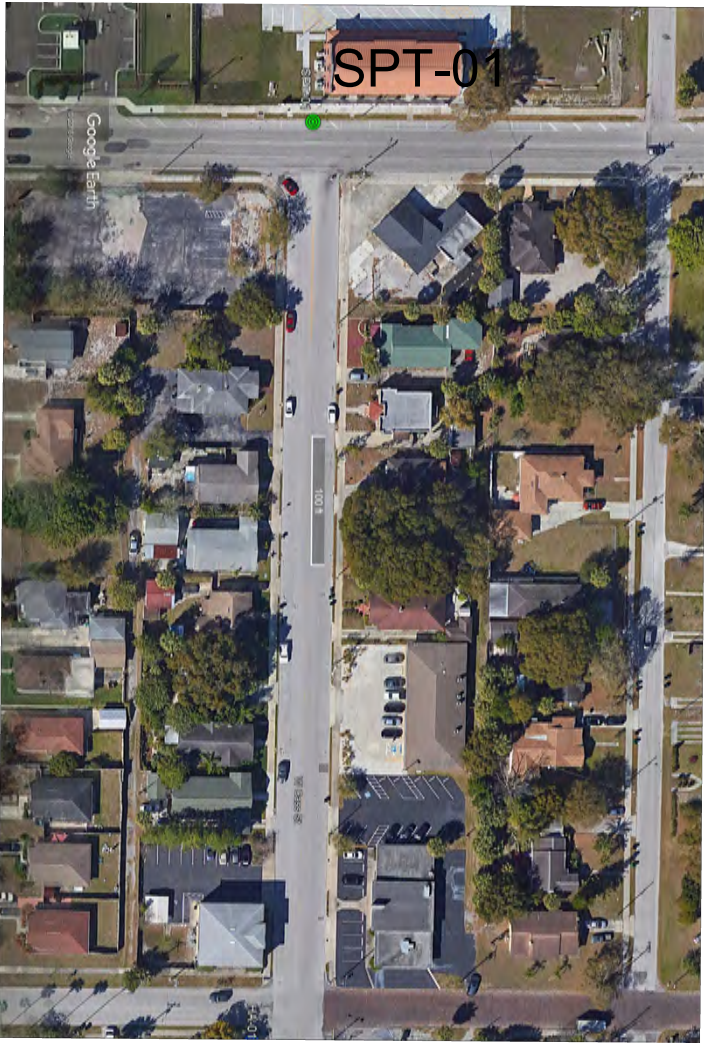
BORING NO.SPT-01  
DATE 5/18/18

WT: 3.0ft.

Boring ID (Depth) (ft)	Moisture Content (%)	Percent Passing No. 200 Sieve (%)	Plastic Limit	Liquid Limit	Plasticity Index	Classification
C-10 (4.5-5)	17.1	21.4	16	28	12	A-2-6
HA-02 (1.5-3.5)	17.1	4.0	-	-	-	A-3
HA-02 (3.5-4.5)	83.0	4.3	NR	NP	NP	A-3 (organic)
SPT-01 (18.5-20)	34.2	38.6	17	42	25	SC
