Site/District Analysis

WALK AUDIT TOOL KIT:

Assessing a community's walkability

Street Name: 3409 W Bay to Bay Blvd

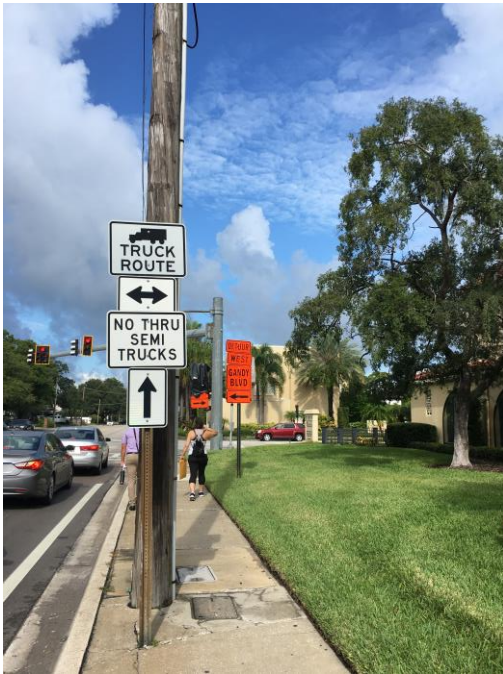
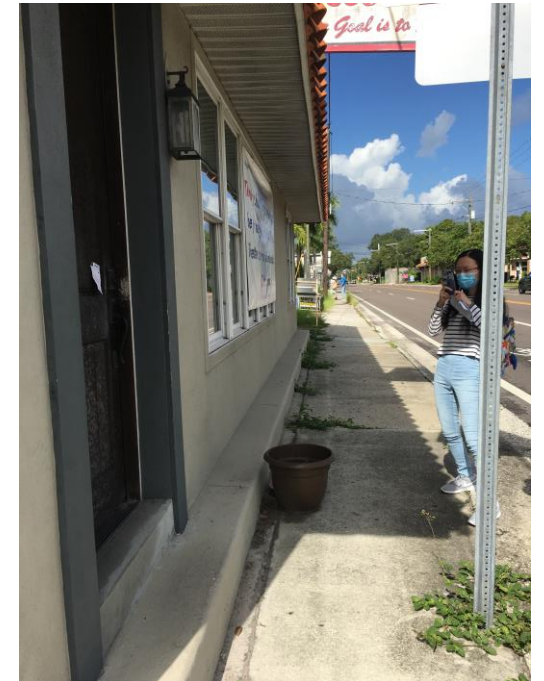
Sidewalk is a bit narrow, especially at the entrance of the store, sometimes only one person can pass through, and the door of some stores is even close to the street. Some sidewalk roads are not connected together.

Other issues and observations: Some sections of the sidewalk are directly pasted to the entrance of the store, and there are obstacles on the sidewalk, which is extremely inconvenient for pedestrians.

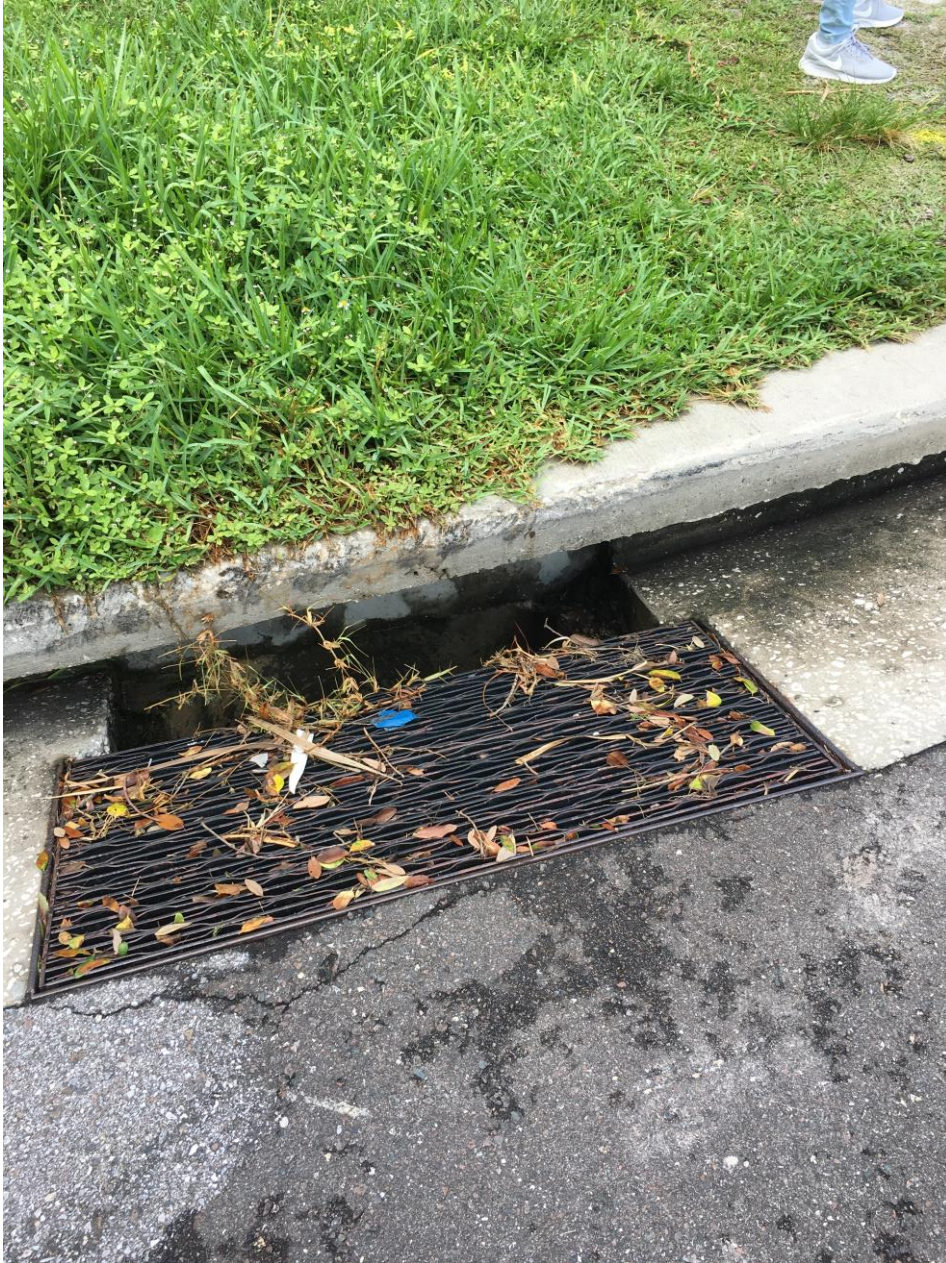
Drainage infrastructure

sewer is not safe and
the gap is too large.

There is a lot of traffic on this street, but the road is a bit narrow. There is too little space for pedestrians. One problem is that the protection of the sewer is not safe and the gap is too large.

Because the speed of the car is very fast and the sidewalk is very close to the road. So it is not very safe, and there is a safety hazard if the water inlet of the sewer is not covered completely.

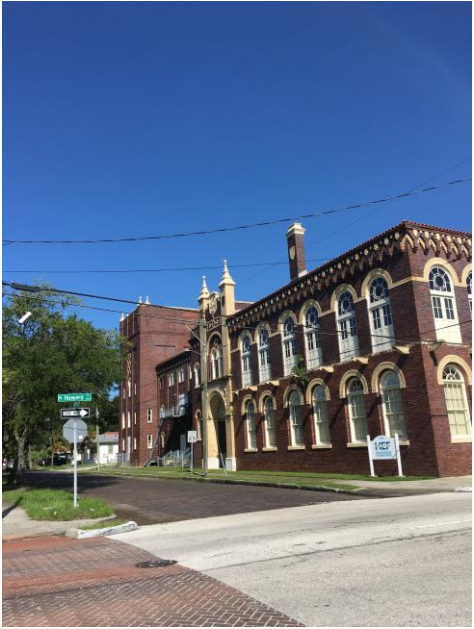
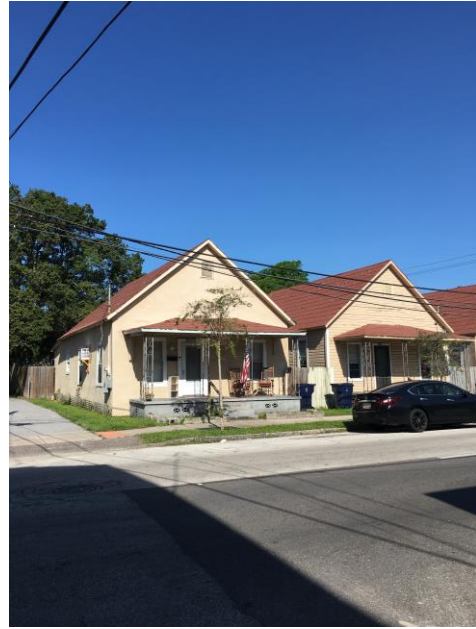
Some buildings are old, and the water from the water pipe flows directly into the sewer through the road.

Most of the buildings on both sides are sealed. The biggest problem is that the sewer is not good, there is too much water on the road, and the rain cannot be dredged in time.

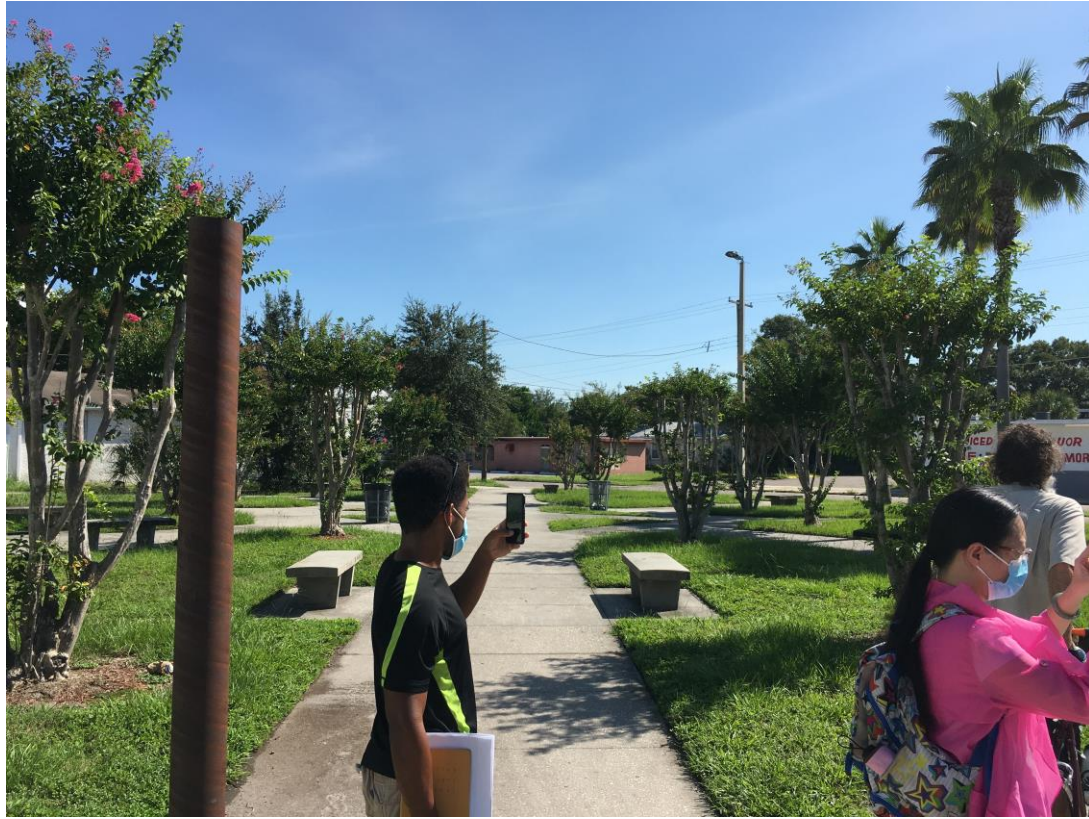
There is a small park here, very simple, without good greenery, on a street corner.

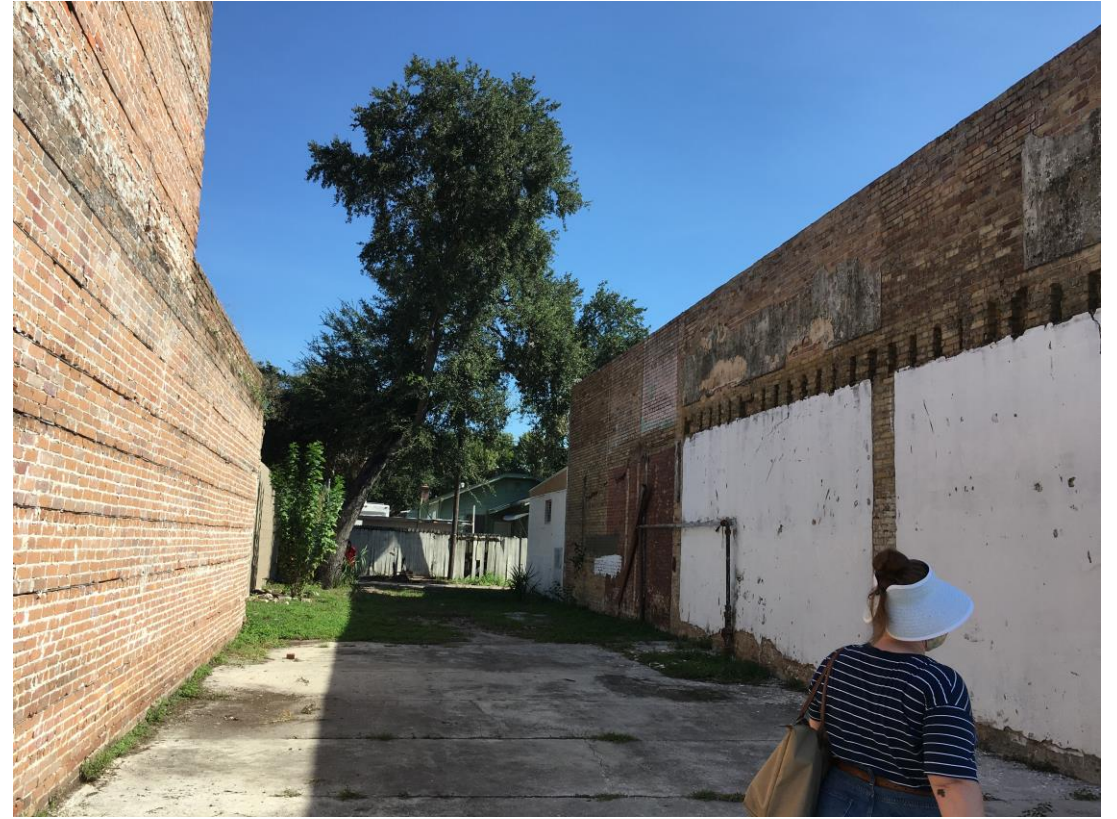
This street has some unused open spaces between the shops.

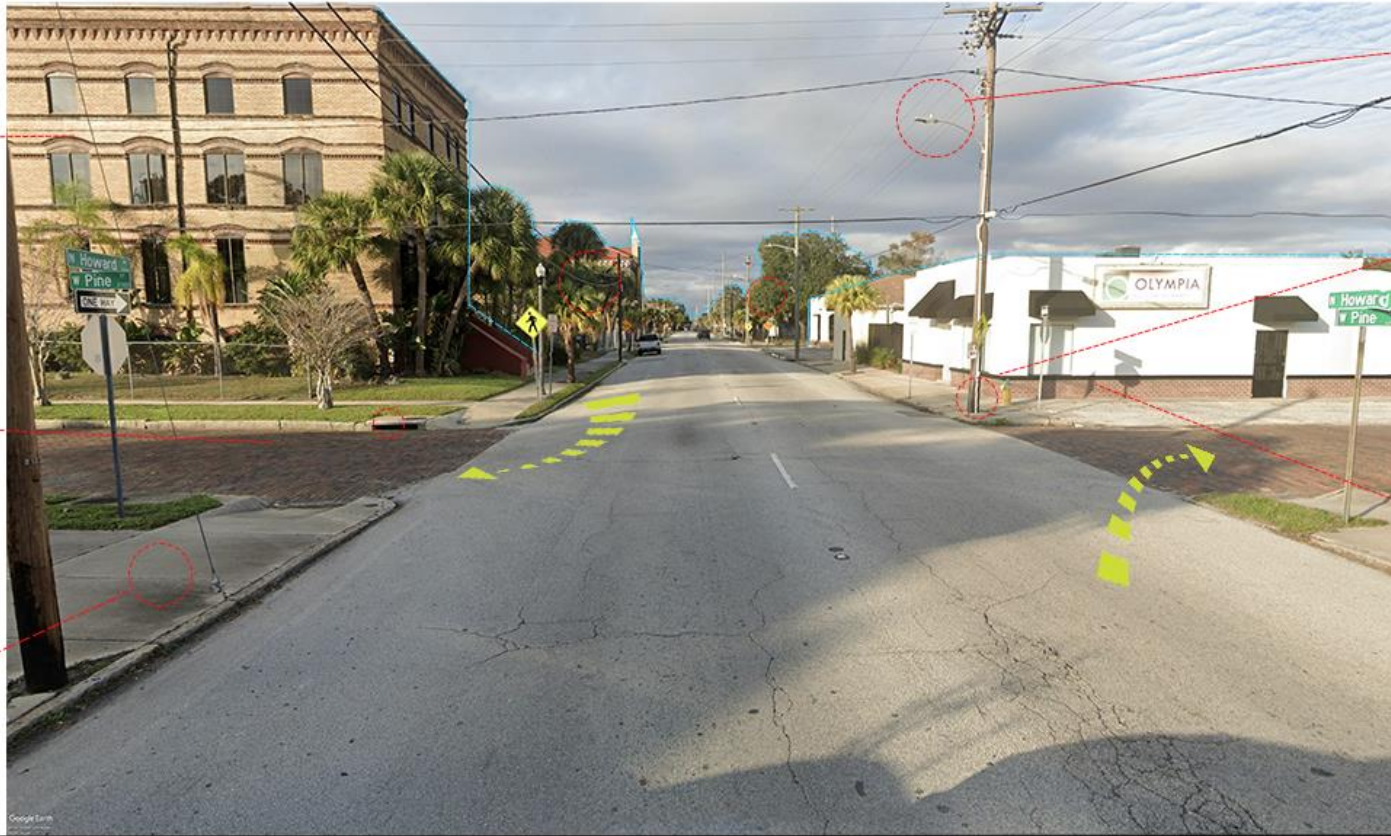
Lighting:*There are few street lights, only one street light for a long distance*

Sidewalk 3'

driving Lane 10'

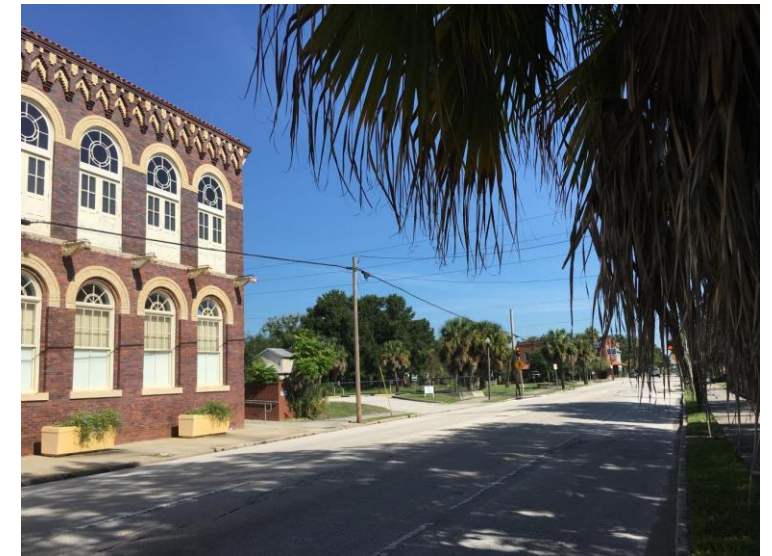
1. **Diversity of uses:** Main street and Howard street mix residential and commercial districts, such as bars, restaurants, cafes and local business districts. This area is located in Tampa downtown, close to the surrounding bustling areas. However, the existing street conditions are inadequate. Due to the age of the street, many places need to be renovated. More street facilities and signs should be added to the streets to guide vehicles and people's activities. Increase the popularity of the street. At the same time, strengthen regional safety, such as increasing safety facilities for night activities. The safety of open spaces is especially important in prosperous areas.

- ① Zoning of commercial streets to make better use of buildings such as coffee shops and restaurants, retail stores and residential areas.
- ② Better use of public areas
- ③ Complete sidewalk
- ④ Speed management
- ⑤ Lighting
- ⑥ Intersection enhancement
- ⑦ Intersection
- ⑧ Traffic transfer

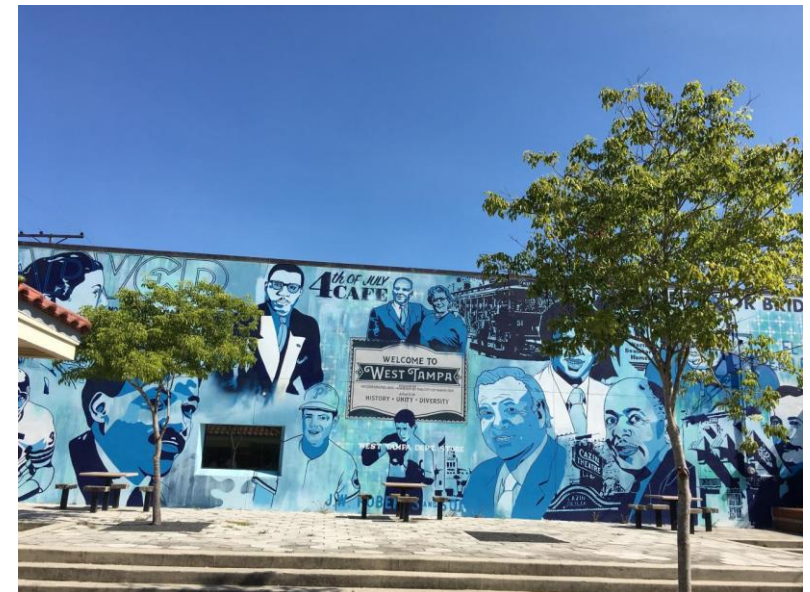
2. Human scale: The building and street planning in the two streets are a bit monotonous, the street buildings are unevenly distributed, and there are many open spaces and incomplete building parts in the commercial area of the street. There are also many abandoned buildings and open spaces. People feel tired when walking and shopping because it takes a long time to walk.

- ① More activity areas can be created in the streets and alleys to increase public space. Use free space to create public areas.
- ② Utilize existing parks and create small public areas in both commercial and residential areas
- ③ Add good children's areas

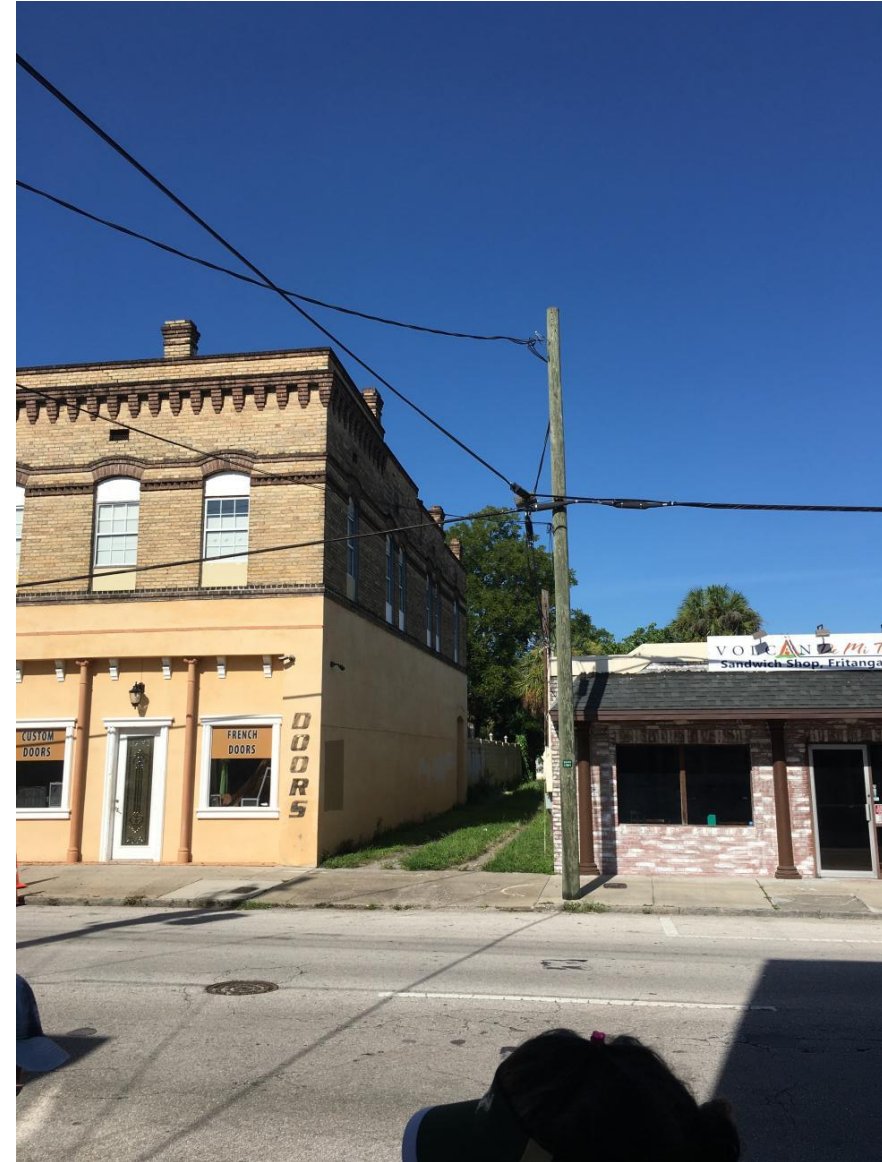
4. Lighting: There is a lack of street lighting in existing street facilities and the distance between street lamps is too long. Can't provide people with lighting safely. It is not possible to move forward efficiently on sidewalks and cyclists. As an indispensable part of the street, lighting should be arranged reasonably.

- ① Add lighting for pedestrians and bicycle lanes
- ② Increased types of street lights at night

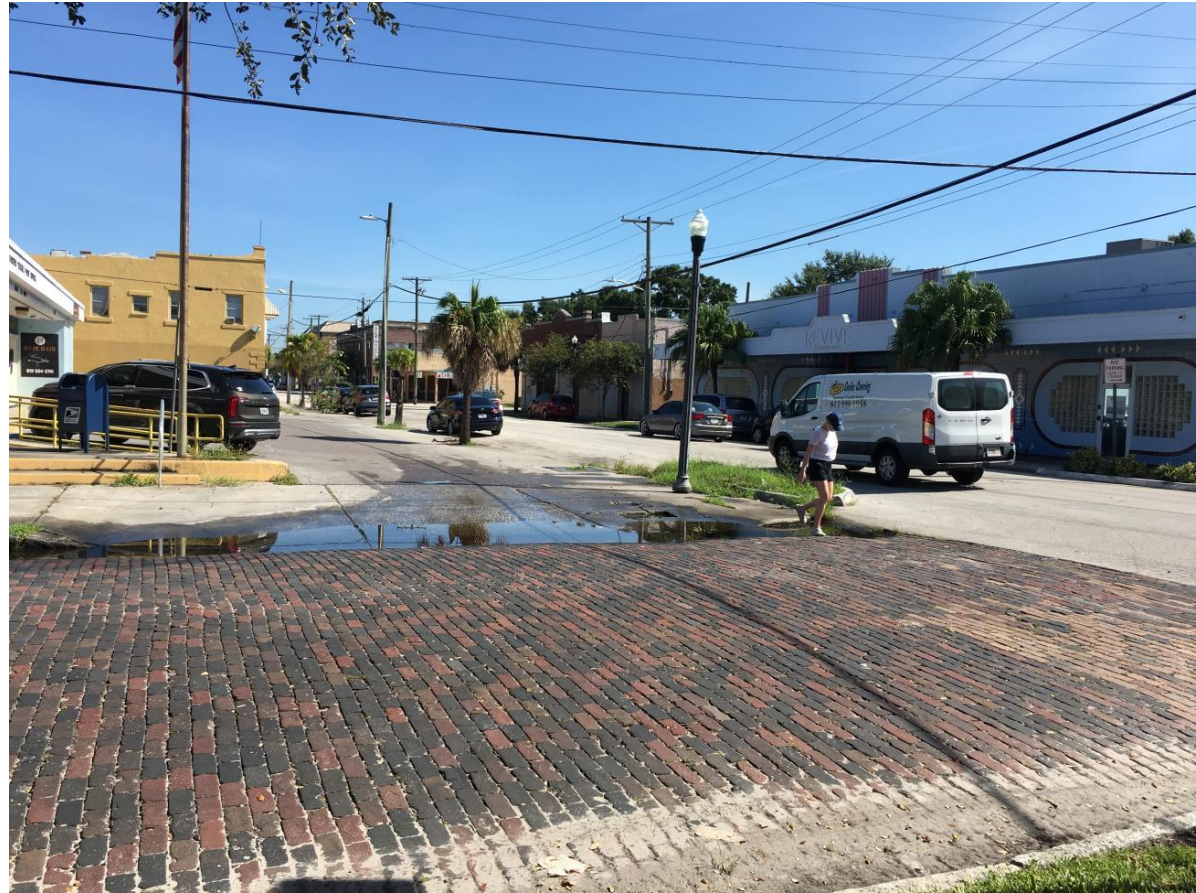
8. Complete streets: Neither Main street nor Howard street has a very complete street setting, lack of public space, and simple facilities in the street. The corresponding street signs are missing. Lack of safe street circulation signs.

- ① Add more sidewalks for pedestrians
- ② Functional zoning of lanes, such as street parking, bicycle lanes, and bus lanes.
- ③ Integrity of street infrastructure.

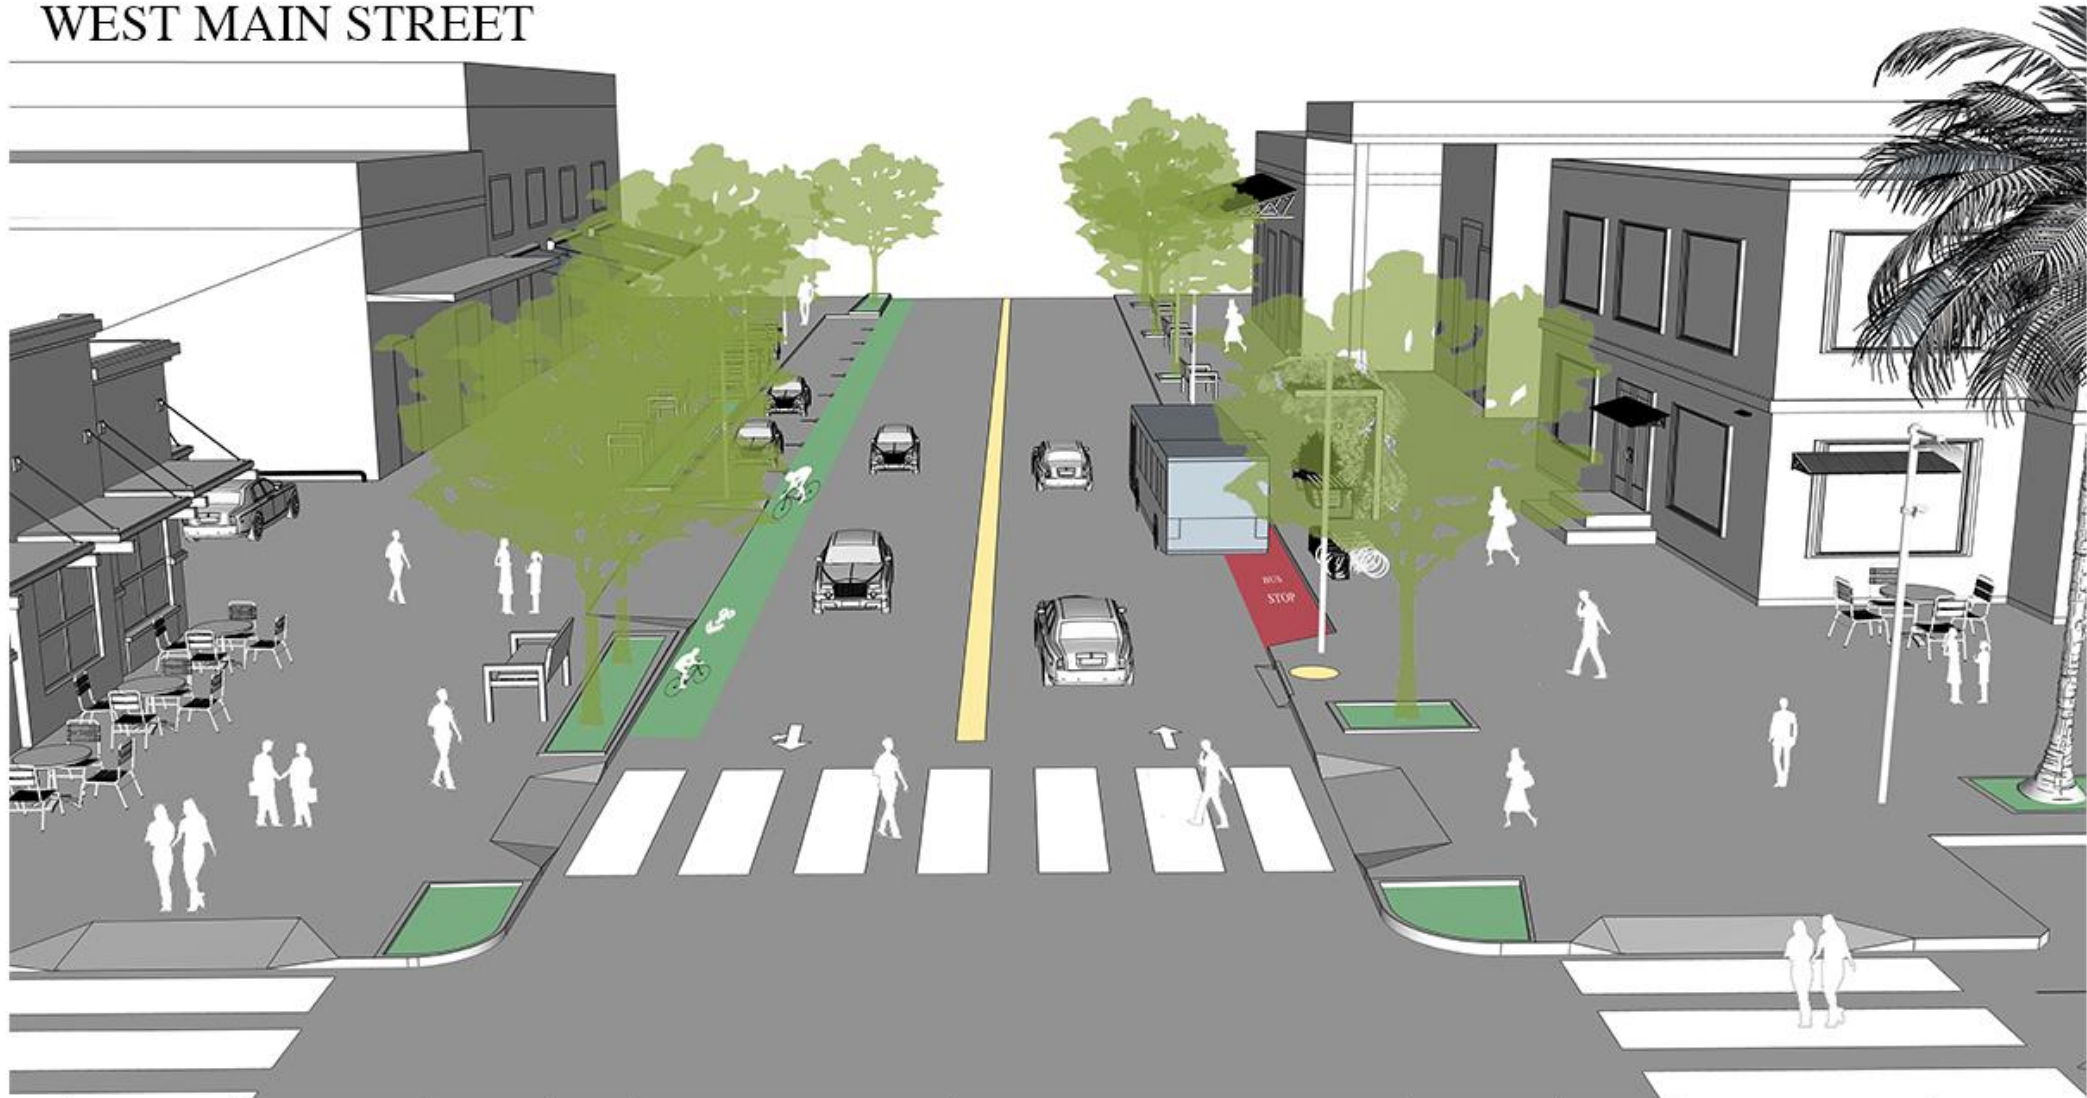
WEST MAIN STREET

6'	6'	6'	8'	5'	11'	11'	8'	6'	6'	6'
frontage zone	pedestrian zone	landscape/furniture zone	Parking zone	bike lane	travel/transit lane	travel/transit lane	Bus lane	landscape	pedestrian zone	frontage zone

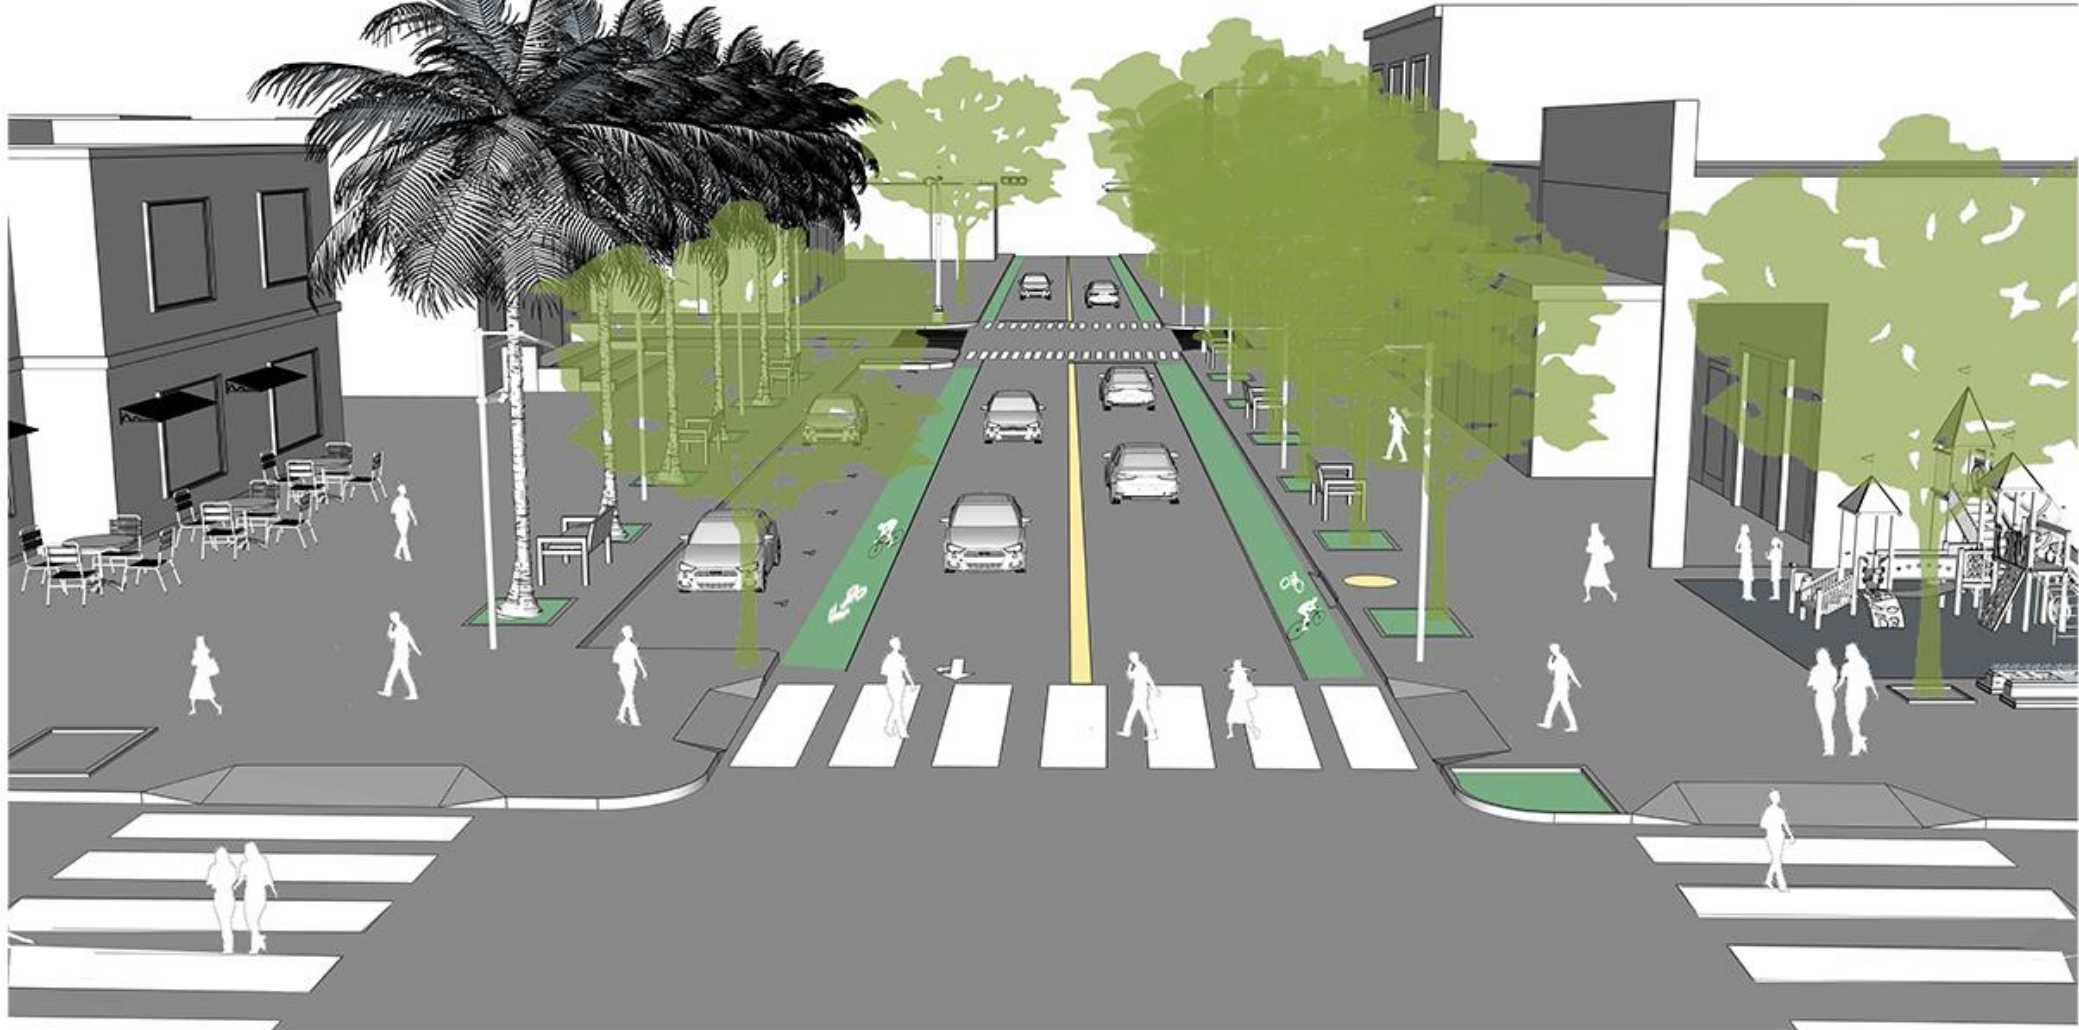
HOWARD STREET

6'	6'	6'	8'	5'	11'	11'	6'	6'	6'	6'
frontage zone	pedestrian zone	landscape/furniture zone	Parking zone	bike lane	travel/transit lane	travel/transit lane	bike lane	landscape	pedestrian zone	frontage zone
