ADDENDUM 4

Contract: 24-C-00032; TPD Howard Avenue Annex Building

## STRUCTURAL ASSESMENT INSPECTION & EVALUATION REPORT

RE: COT Evidence Storage & Impound Lot  
5005 N Howard Ave. Tampa, FL 33601  
Structural Assessment of Existing Facility Building

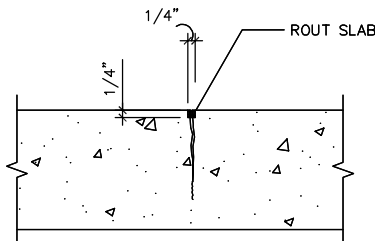
9-004

**Photo 13:** Typical slab on grade cracks

**CRACKS TYPE I**  
(20 MILLS TO 1/4")

1. VEE NOTCH THE SURFACE OF THE CRACK WITH A MECHANICAL ROUTER OR HAND CHIPPING TOOL TO A MAXIMUM WIDTH OF A 1/4". REMOVE LOOSE DEBRIS.
2. REMOVE ALL DUST, LAITANCE, GREASE, CURING COMPOUND, WAXES, IMPREGNATION'S, FOREIGN PARTICLES, EFFLORESCENCE AND OTHER BOND INHIBITING MATERIALS FROM THE SURFACE BY MECHANICAL MEANS, I.E. - SANDBLASTING, HIGH PRESSURE WATER BLASTING, ETC., AS APPROVED BY ENGINEER.
3. SEAL UNDERSIDE OF SLAB IF CRACKS REFLECT THROUGH WITH AN EPOXY GEL.

1. POUR NEAT SIKADUR 35 HI-MOD LV EPOXY RESIN ADHESIVE INTO VEE NOTCHED CRACK. REPLENISH THE RESERVOIR WITH THE MIXED EPOXY RESIN ADHESIVE UNTIL CRACKS HAVE BEEN COMPLETELY FILLED.
2. IF PENETRATION OF ANY CRACK IS IMPOSSIBLE, CONSULT THE ENGINEER.

1. POUR NEAT STO EPOXY BINDER CR633 INTO VEE NOTCHED CRACK. REPLENISH THE RESERVOIR WITH THE MIXED EPOXY RESIN ADHESIVE UNTIL CRACKS HAVE BEEN COMPLETELY FILLED.
2. IF PENETRATION OF ANY CRACK IS IMPOSSIBLE, CONSULT THE ENGINEER.

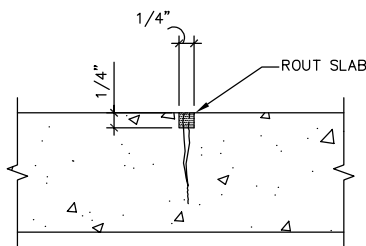
**CRACKS TYPE II**  
(1/4" OR GREATER)

1. VEE NOTCH THE SURFACE OF THE CRACK WITH A MECHANICAL ROUTER OR HAND CHIPPING TOOL TO A MAXIMUM WIDTH OF A 1/2". REMOVE LOOSE DEBRIS.
2. REMOVE ALL DUST, LAITANCE, GREASE, CURING COMPOUND, WAXES, IMPREGNATION'S, FOREIGN PARTICLES, EFFLORESCENCE AND OTHER BOND INHIBITING MATERIALS FROM THE SURFACE BY MECHANICAL MEANS, I.E. - SANDBLASTING, HIGH PRESSURE WATER BLASTING, ETC., AS APPROVED BY ENGINEER.
3. SEAL UNDERSIDE OF SLAB IF CRACKS REFLECT THROUGH.

1. PRIOR TO PRODUCT APPLICATION SUBSTRATE SHOULD BE SATURATED SURFACE DRY (SSD) WITH NO STANDING WATER.
2. POUR NEAT SIKA TOP 111 INTO VEE NOTCHED CRACK. CONTINUE PLACEMENT UNTIL CRACK IS COMPLETELY FILLED.
3. IF PENETRATION OF ANY CRACK IS IMPOSSIBLE, CONSULT THE ENGINEER.

1. FILL CRACK WITH OVEN-DRIED SAND PRIOR TO THE APPLICATION OF THE STO EPOXY BINDER.
2. POUR NEAT STO EPOXY BINDER CR633 INTO VEE NOTCHED CRACK. REPLENISH THE RESERVOIR WITH THE MIXED EPOXY RESIN ADHESIVE UNTIL CRACKS HAVE BEEN COMPLETELY FILLED.
3. IF PENETRATION OF ANY CRACK IS IMPOSSIBLE, CONSULT THE ENGINEER.
