ADDENDUM NO. 1

Contract 14-C-00048; Hillsborough River Dam Walkway Steel Girder and Concrete Repairs

**Subject: Structural Engineering Services
Steel Girder Assessment - Hillsborough River Dam
TWD W.O. 7149
Tampa, Florida**

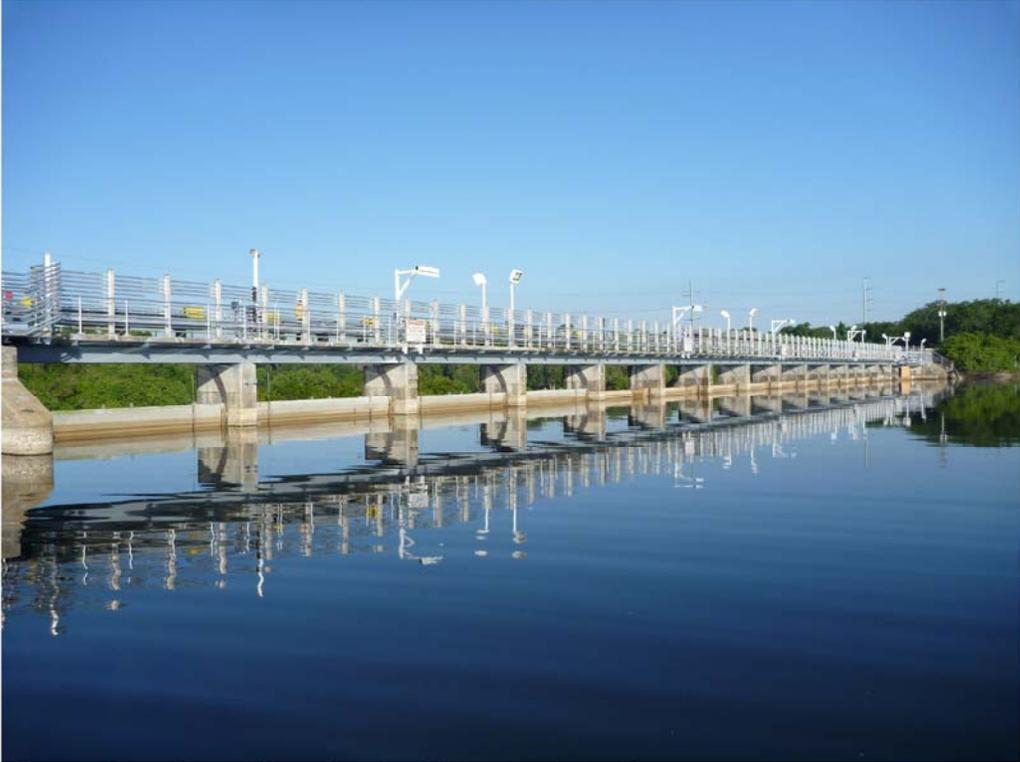
Figure A- 1: East Elevation looking northward

Table A – Dam/Platform Observations	
Conditions Observed	Reference Photos
Overall	
East elevation looking northward	<i>Figure A-1</i>
South End Bay (Concrete Construction)	
Concrete spalling was observed along the bottom portion of the west concrete support beam. The reinforcing steel was exposed.	<i>Figure A-2</i>
Concrete spalling was observed along the bottom portion of the east concrete support beam.	<i>Figure A-3</i>
Bay #1	
Overall 18WF64 east girder view.	<i>Figure A-4</i>
Flange deterioration was observed along the flange section of stringer #3 of the bay. The deterioration was located near the stringer to girder connection point.	<i>Figure A-5</i>
Flange deterioration was observed along the flange section of stringer #5 of the bay. The deterioration was located near the stringer to girder connection point.	<i>Figure A-6</i>
Bay #2	
Flange deterioration was observed along the flange section of stringer #3 of the bay. The deterioration was located near the stringer to girder connection point.	<i>Figure A-7</i>

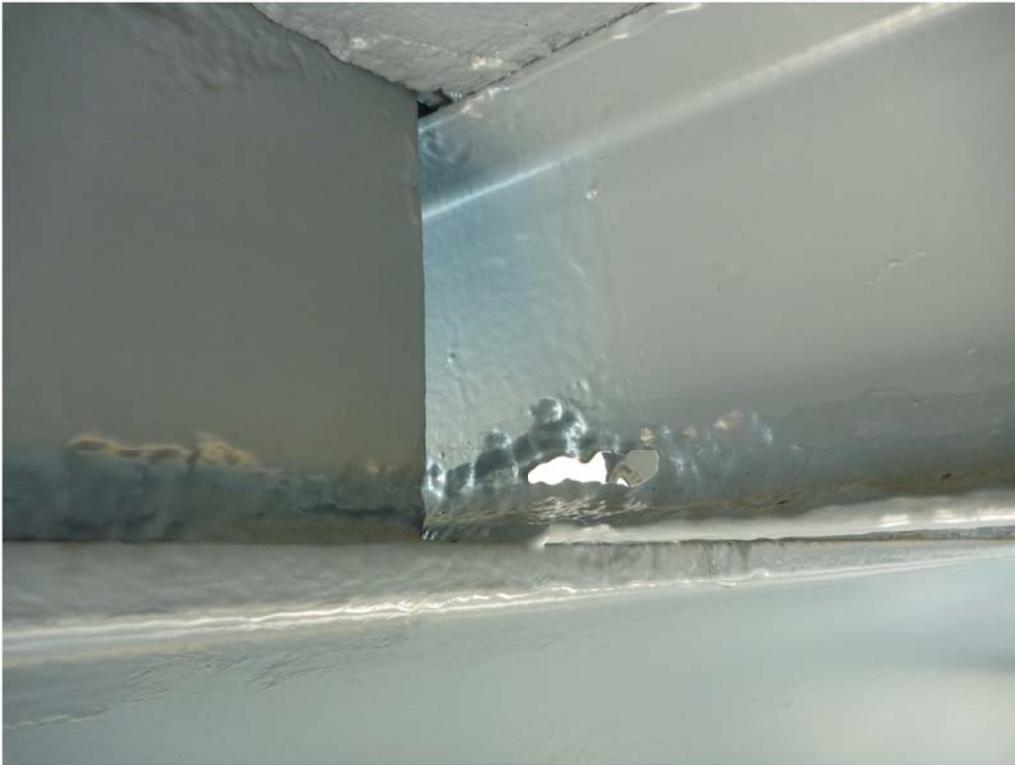
Figure A- 9: Bay #3

Web deterioration was observed along the web section of stringer #1 of the bay. The deterioration was located near the stringer to girder connection point.	<i>Figure A-8</i>
Bay #3	
Web and flange deterioration was observed along the web and flange sections of stringer #3 of the bay. The deterioration was located near the stringer to girder connection point.	<i>Figure A-9</i>
Web deterioration was observed in the west C-channel of the bay, in between stringers #2 and #3. Full thickness section loss was observed.	<i>Figure A-10</i>
Web deterioration was observed in the east C-channel of the bay, in between stringers #2 and #1.	<i>Figure A-11</i>

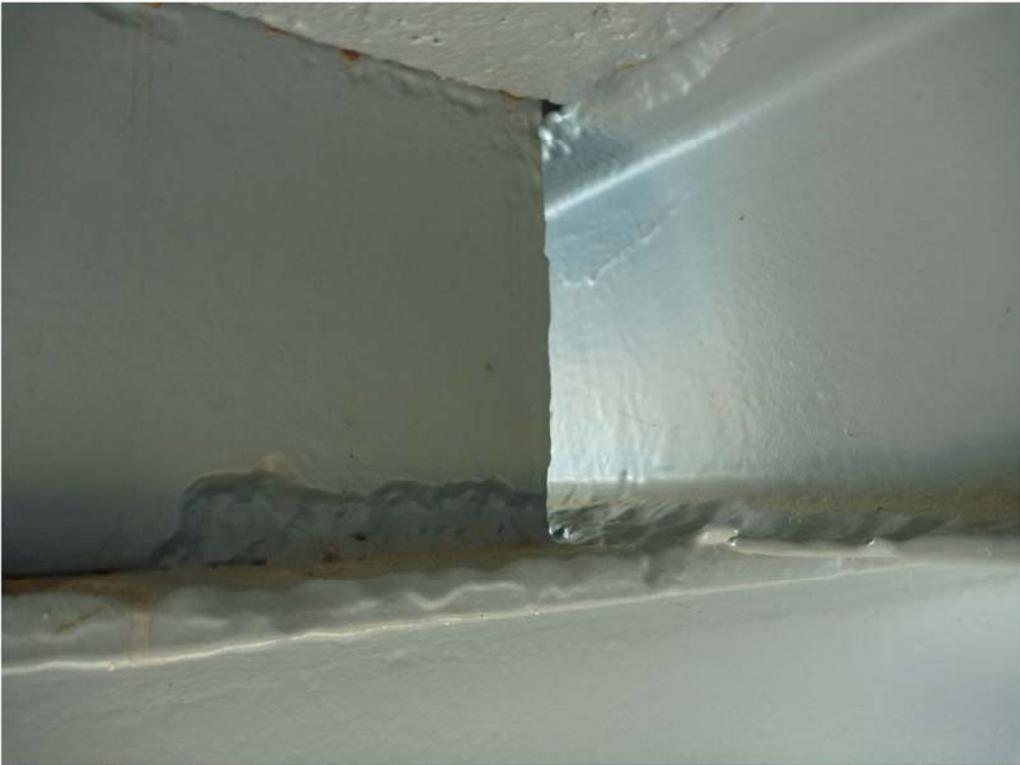
Figure A- 13: Bay #4

Table A – Dam/Platform Observations	
Conditions Observed	Reference Photos
Bay #4	
Web and flange deterioration was observed along the web and flange sections of stringer #4 of the bay. The deterioration was located near the stringer to girder connection point. Full thickness section loss was observed.	<i>Figure A-12</i>
Web deterioration in the east C-channel was observed near stringer #2	<i>Figure A-13</i>
Web and flange deterioration was observed along the web and flange sections of stringer #3 of the bay. The deterioration was located near the stringer to girder connection point. Full thickness section loss was observed.	<i>Figure A-14</i>
Bay #5	
Web and flange deterioration was observed along the web and flange sections of stringer #4 of the bay. The deterioration was located near the stringer to girder connection point. Full thickness section loss was observed.	<i>Figure A-15</i>
Deterioration/Pitting in the girder section was observed along the east girder in between stringer #2 and #3.	<i>Figure A-16</i>

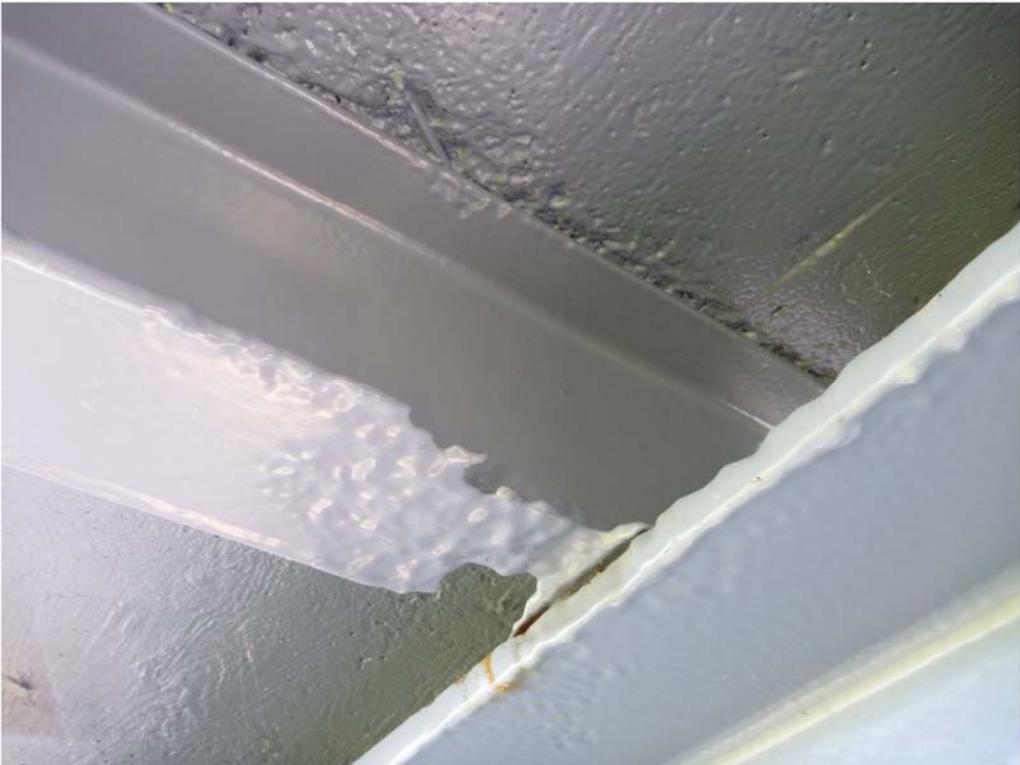
Figure A- 18: Bay #6

Web and flange deterioration was observed along the web and flange sections of stringer #2 of the bay. The deterioration was located near the stringer to girder connection point. Full thickness section loss was observed.	<i>Figure A-17</i>
Bay #6	
Flange deterioration was observed along the flange section of stringer #4 of the bay. The deterioration was located near the stringer to girder connection. Full thickness section loss was observed.	<i>Figure A-18</i>
Deterioration/Pitting was observed along the web section of stringer #3 of the bay.	<i>Figure A-19</i>
Bay #7	
Flange deterioration was observed along the flange section of stringer #4 of the bay. The deterioration was located near the stringer to girder connection. Full thickness section loss was observed.	<i>Figure A-20</i>
Web and flange deterioration was observed along the web and flange sections of stringer #3 of the bay. The deterioration was located near the stringer to girder connection.	<i>Figure A-21</i>

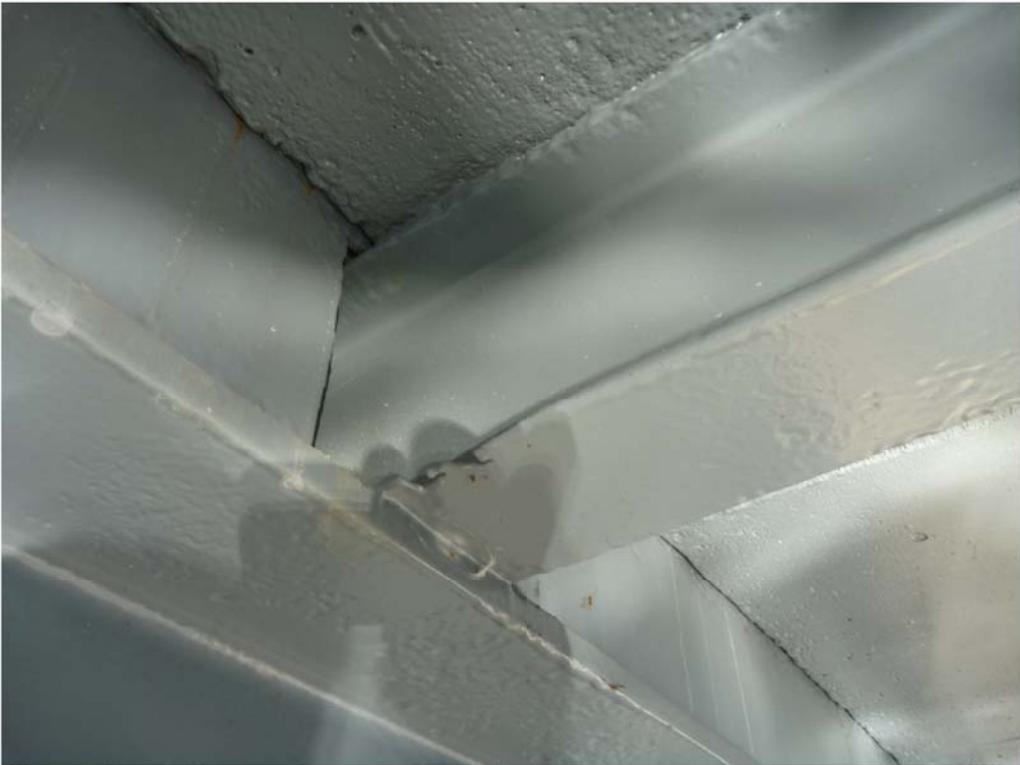
Figure A- 23: Bay #8

Table A – Dam/Platform Observations	
Conditions Observed	Reference Photos
Bay #8	
Web deterioration was observed along the web of stringer #4 and the adjacent C-channel section. Full thickness loss was observed.	<i>Figure A-22</i>
Flange deterioration was observed along the flange of stringer #2 of the bay. The deterioration was located near the stringer to girder connection.	<i>Figure A-23</i>
Bay #9	
Typical girder to concrete pier connection.	<i>Figure A-24</i>
Web and flange deterioration was observed along the web and flange sections of stringer #2 of the bay. Full thickness section loss was observed.	<i>Figure A-25</i>
Flange deterioration was observed along the flange section of stringer #4 of the bay. Full thickness loss was observed.	<i>Figure A-26</i>
Minor web buckling was observed along the bearing end of the girder, adjacent to stringer #5 of the bay.	<i>Figure A-27</i>
Bay #10	
Flange deterioration was observed along the flange section of stringer #4 of the bay. Full thickness loss was observed.	<i>Figure A-28</i>

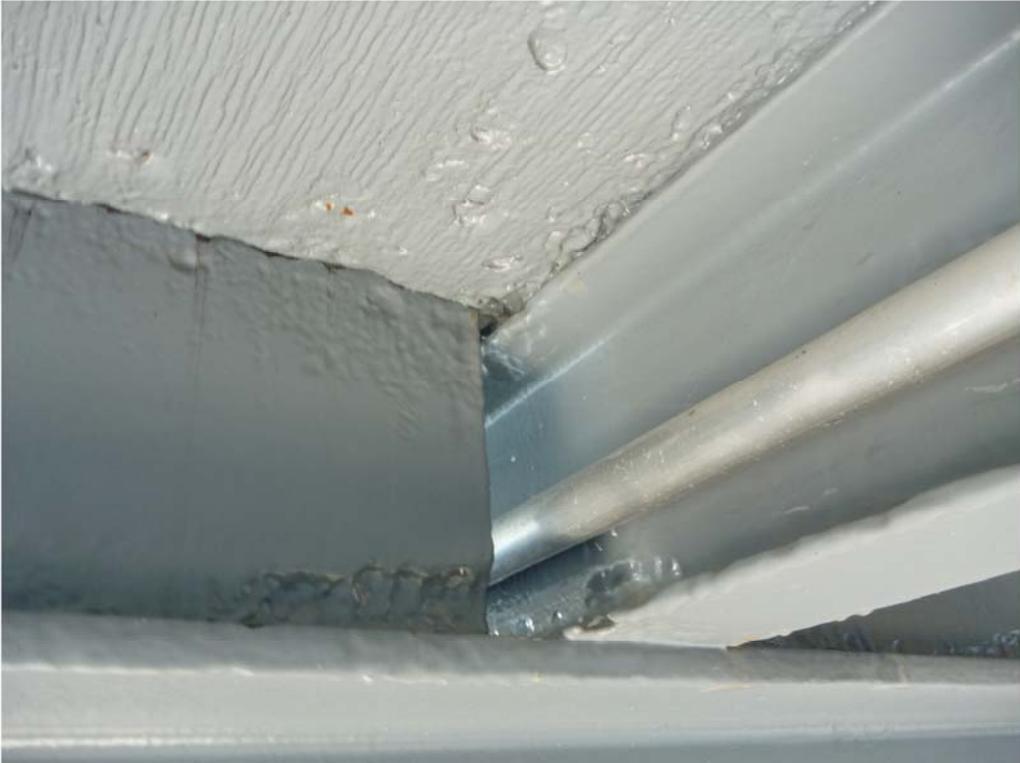
Figure A- 32: Bay #12

Flange deterioration was observed along the flange section of stringer #3 of the bay. Full thickness loss was observed.	<i>Figure A-29</i>
Bay #11	
Flange deterioration was observed along the flange section of stringer #2 of the bay. Full thickness loss was observed.	<i>Figure A-30</i>
Bay #12	
Cracking in the concrete pier was observed below the east base plate. The section was previously repaired.	<i>Figure A-31</i>
Web and flange deterioration was observed along the flange section of stringer #2 and web of the adjacent C-channel.	<i>Figure A-32</i>
Bay #13	
Web and flange deterioration was observed along the flange section of stringer #4 and the web of the adjacent C-channel.	<i>Figure A-33</i>
Flange deterioration was observed along the flange section of stringer #2 of the bay. Full thickness loss was observed.	<i>Figure A-34</i>

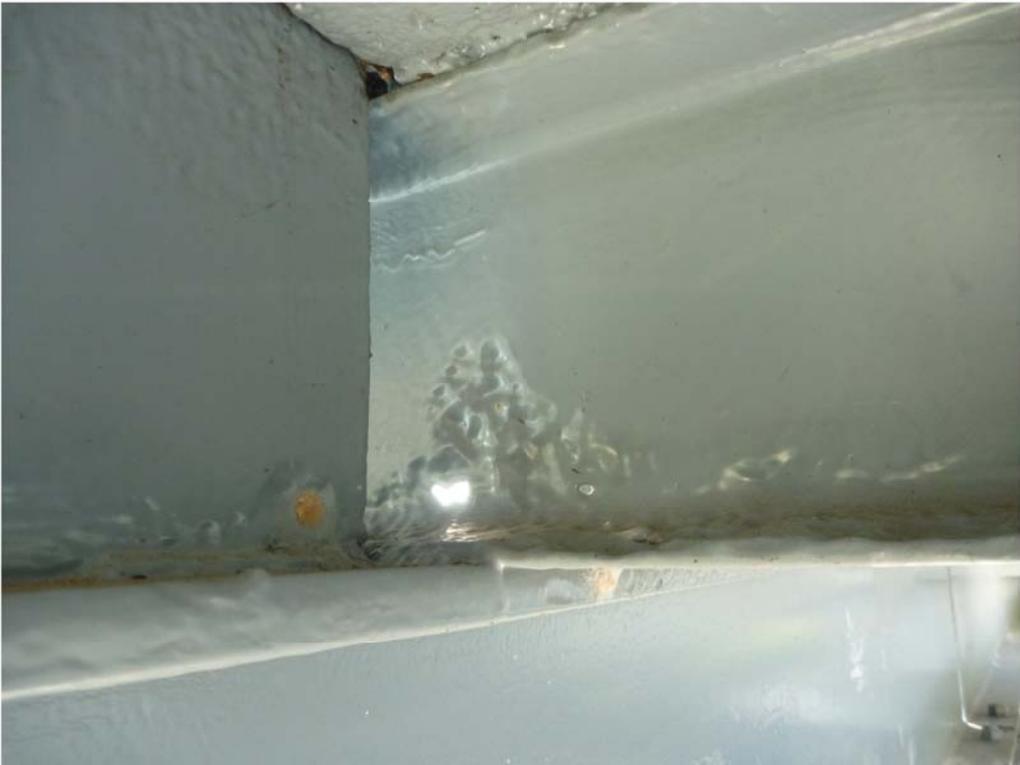
Figure A- 36: Bay #14

Table A – Dam/Platform Observations	
Conditions Observed	Reference Photos
Bay #14	
Concrete deck cracking was observed in the bottom of the concrete deck along the deck edge and edge of the grate hatch angle support.	<i>Figure A-35</i>
Web deterioration was observed along the web section of stringer #2 of the bay. Full thickness loss was observed.	<i>Figure A-36</i>
Bay #15	
Web and flange deterioration was observed along the web and flange sections of stringer #2 of the bay. Full thickness section loss was observed.	<i>Figure A-37</i>
North End Bay (Concrete Construction)	
Concrete spalling was observed along the west deck edge. The spalling was adjacent to a guardrail base connection plate.	<i>Figure A-38</i>
Concrete spalling was observed in the bottom of the concrete deck along the western portion of the bay.	<i>Figure A-39</i>
