El Prado Blvd.

MOBILITY OPPORTUNITIES AND
DEFICIENCIES AUDIT
2020

City of
Tampa
Florida

DECEMBER 2020

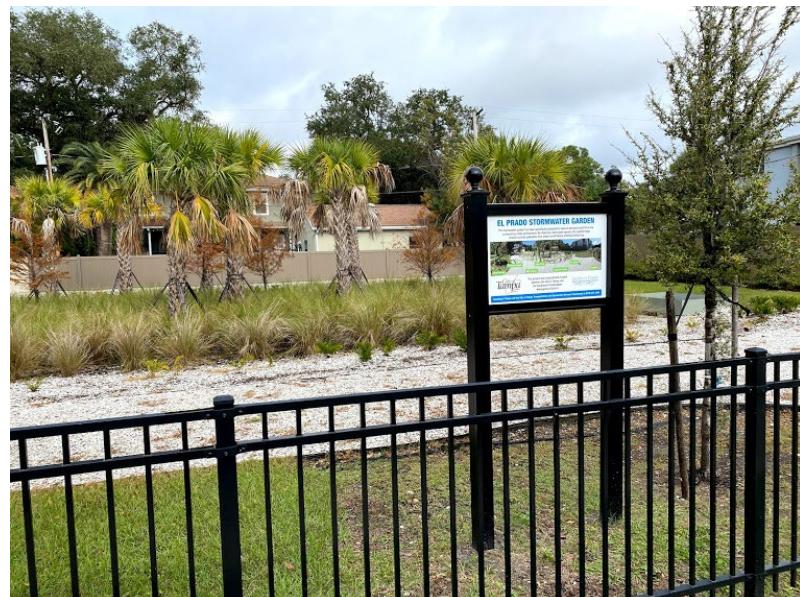
Figure 11: Existing El Prado Stormwater Pond

Landscaping can improve traffic calming and provide a sense of place making the corridor more accessible and inviting to pedestrians and cyclists. Also, amenities, such as bike racks near attractors, can lead to a more successful multimodal network. These components should be considered during design. The City should explore access to the El Prado Stormwater pond.
