Geotechnical Investigation Report

S. Edison Avenue Roadway Improvements City Of Tampa Florida

**Additional Geotechnical Engineering Services
S. Edison Avenue Drainage Improvements
Phase 1
City of Tampa, Florida
MC² Project Number T111413.258**

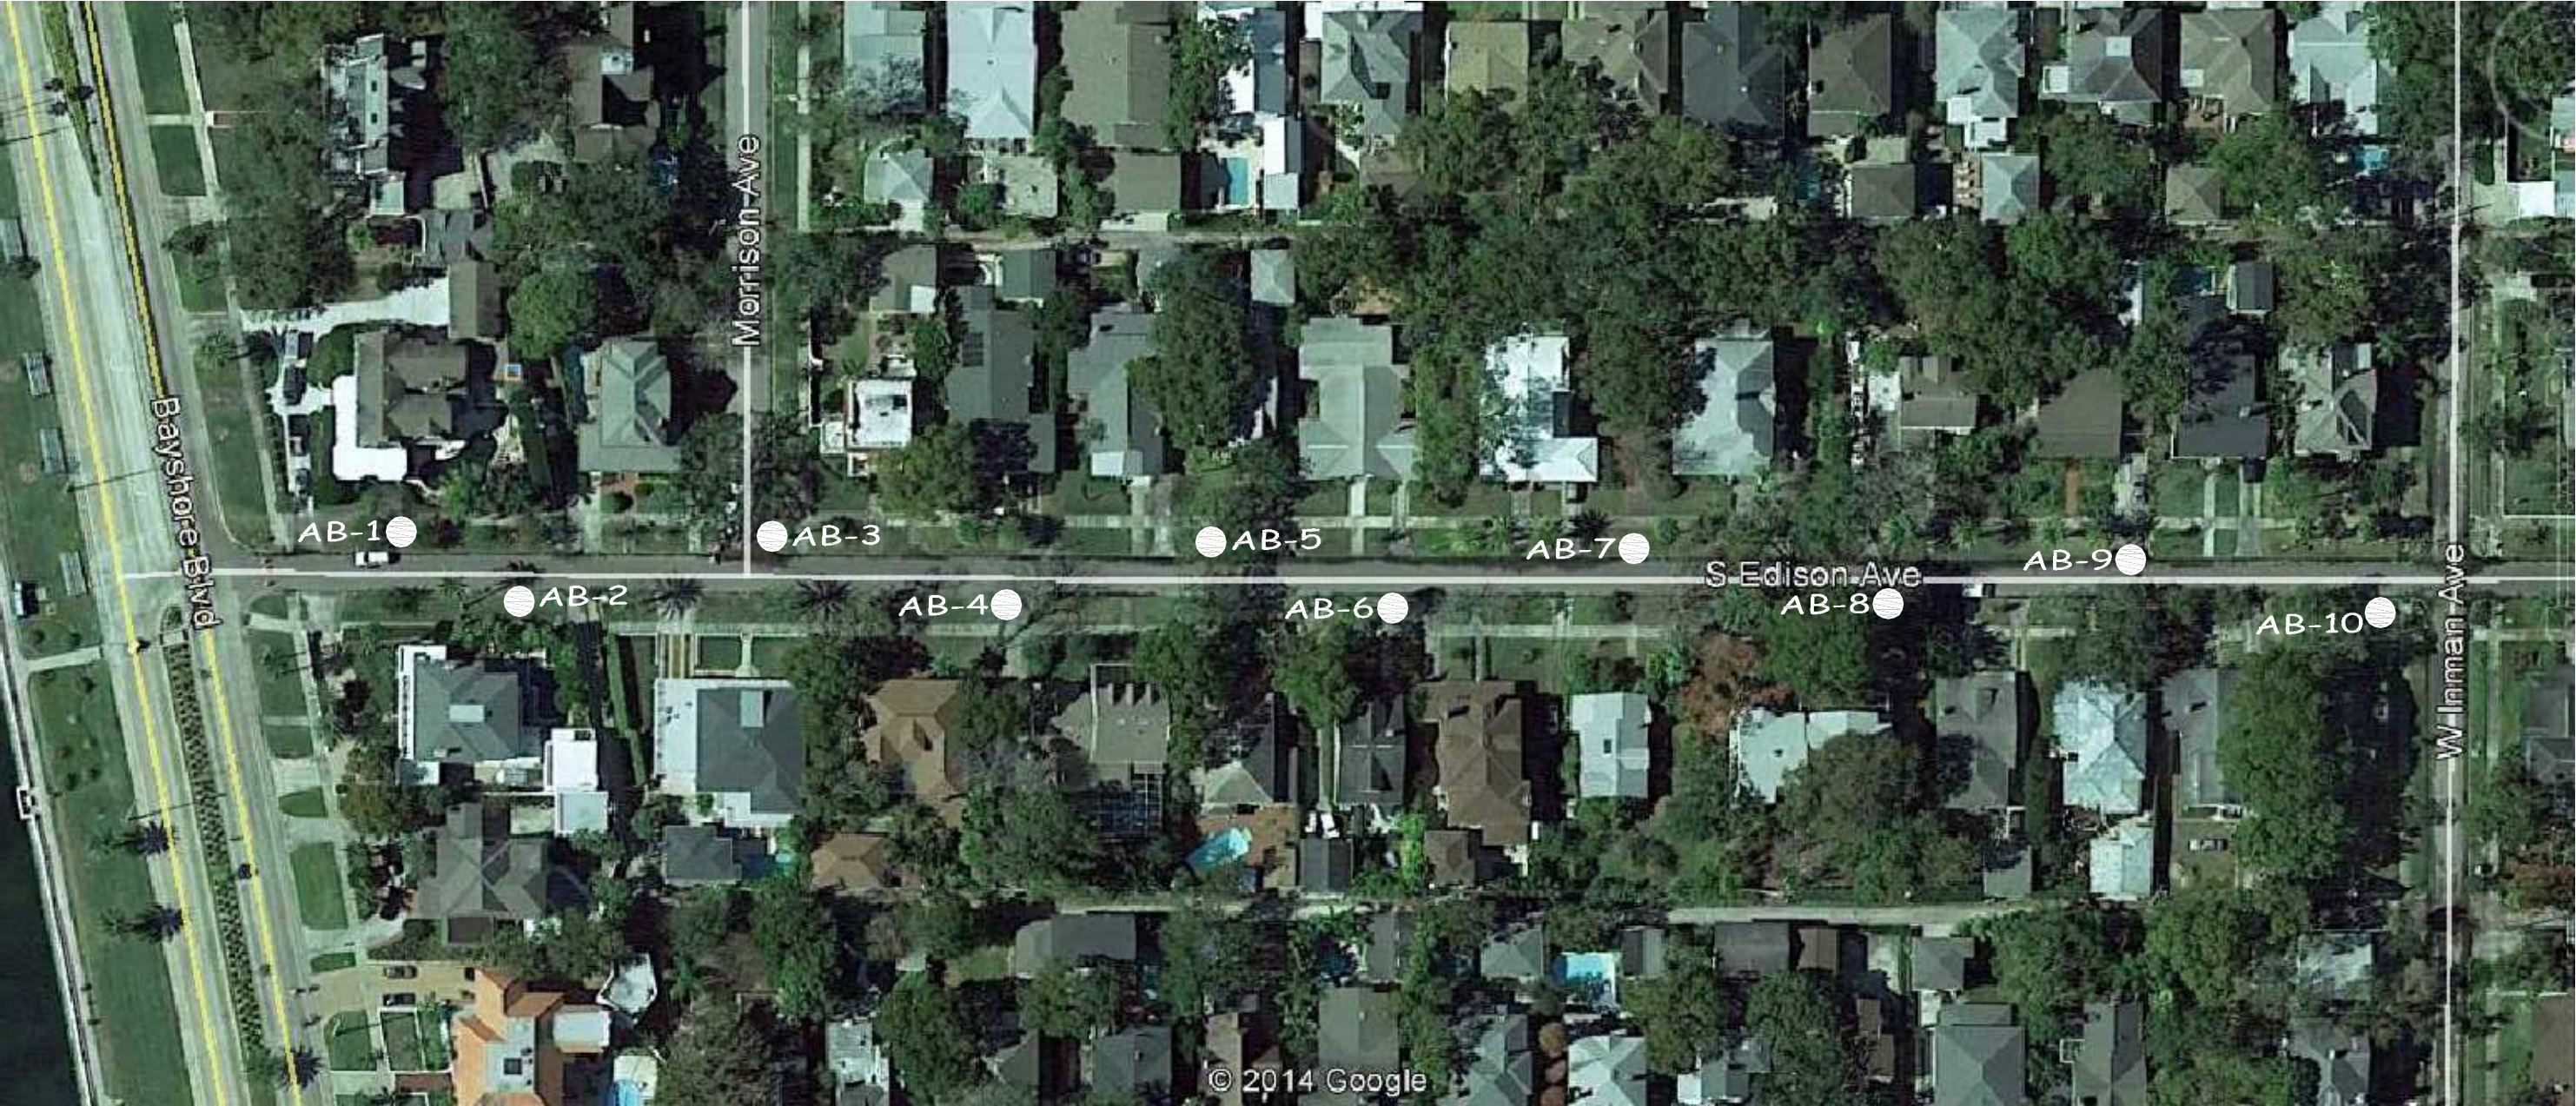
MC² GEOTECHNICAL • ENVIRONMENTAL MATERIALS TESTING	MC SQUARED, INC. Geotechnical Consultants 5808 Breckenridge Parkway, Suite-A Tampa, Florida 33610 Ph:813-623-3399 Fax:813-623-6636	FLORIDA ENGINEERING CERTIFICATE OF AUTHORIZATION No. 9191 WILLIAM P. ROVIRA IV, P.E. FLORIDA LICENSE No. 74586	NAME			DATE	BORING LOCATION PLAN		PROJECT NO.	SHEET NO.
											DESIGNED BY:	IR	01/15	S. Edison Avenue (Phase 1) Roadway Improvements City Of Tampa, Florida	T111413.258	1		
											DRAWN BY:	IR	01/15					
											CHECKED BY:	RN	01/15					
											SUPERVISED BY:

The locations of the 10 auger borings were selected by **MC²** to evaluate the variation of soil conditions along the proposed underdrain alignment. The site plan indicating the approximate boring locations is presented in **Sheet 1** in the **Appendix** of this report.
