PALMETTO BEACH SEAWALL FEASIBILITY MEMO

For the City of Tampa

September 19, 2023

The goal of this scope of work is to develop a Preliminary Feasibility Report (PFR) that includes conceptual drawings for a permittable and constructible design of the coastline area. The conceptual design is focused on the seawall and adjacent public right-of-way at South Bermuda Boulevard. Prior to embarking on the technical design of these elements, a feasibility analysis will determine if all regulatory and City criteria can be met to execute the project, and to identify other site issues that may impact desired projects.

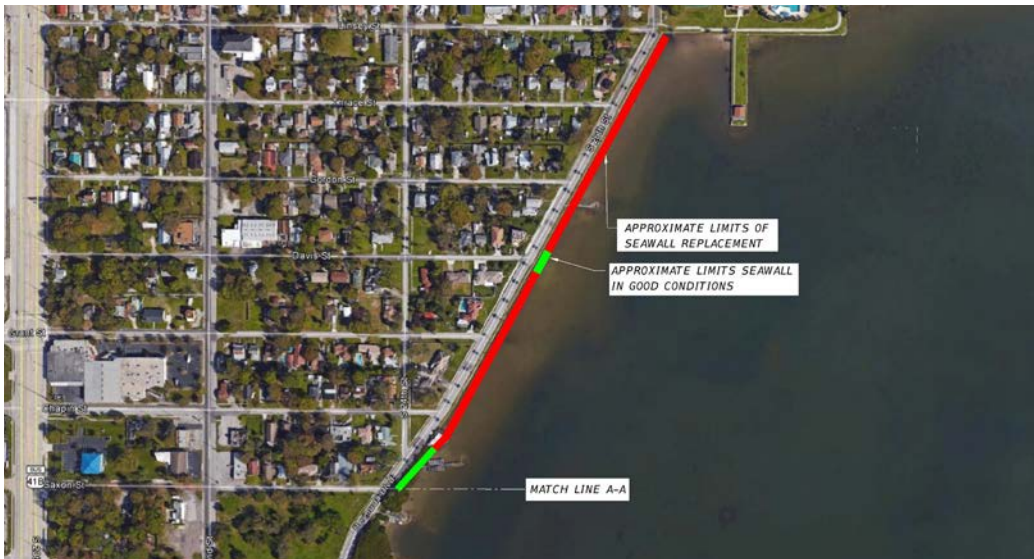
Option 1

Two concepts were proposed for the Bermuda Boulevard right of way, to enhance pedestrian, cycling, and green infrastructure. Both concepts were designed to be at or near the elevation of the existing grade, with one option having 10' lanes and the other 12' lanes. Both options included tree wells on the seawall side of the road to collect stormwater.

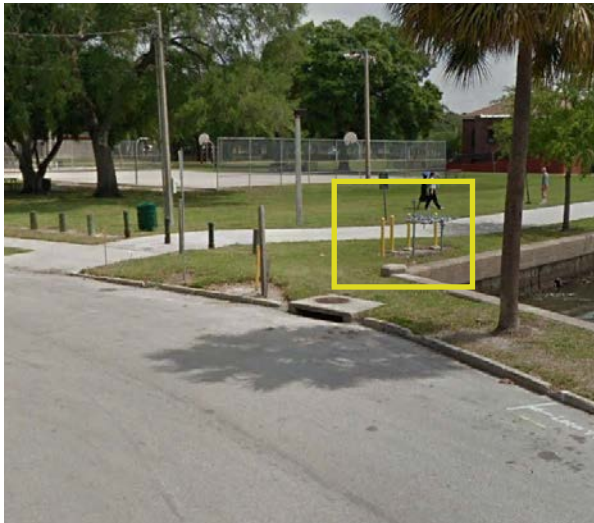
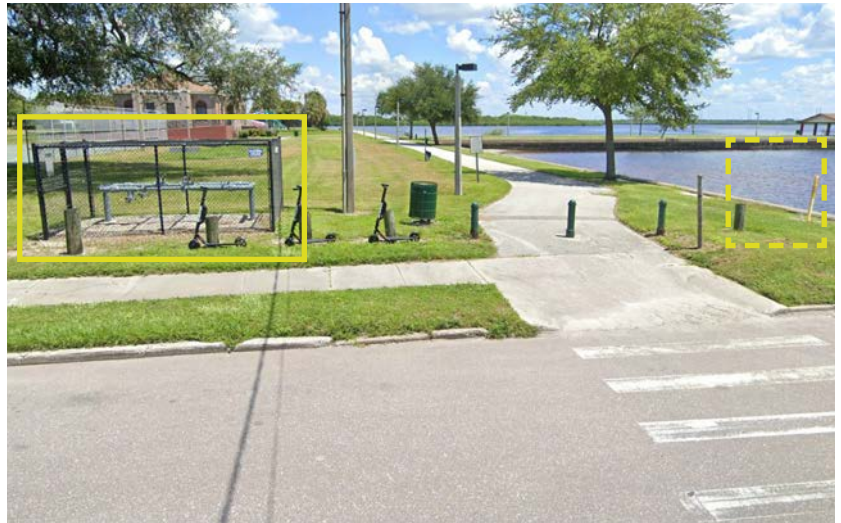
Gas infrastructure at the corner of 26th and Lindsey, showing before and after. Images taken from Google street view.

The 2018 report suggests that TECO wanted to install a 4” to 8” gas main along Bermuda Boulevard. This appears to be completed, but is unverified - a surface meter at the corner of 26th and Lindsey streets has been renovated and moved (see images below).

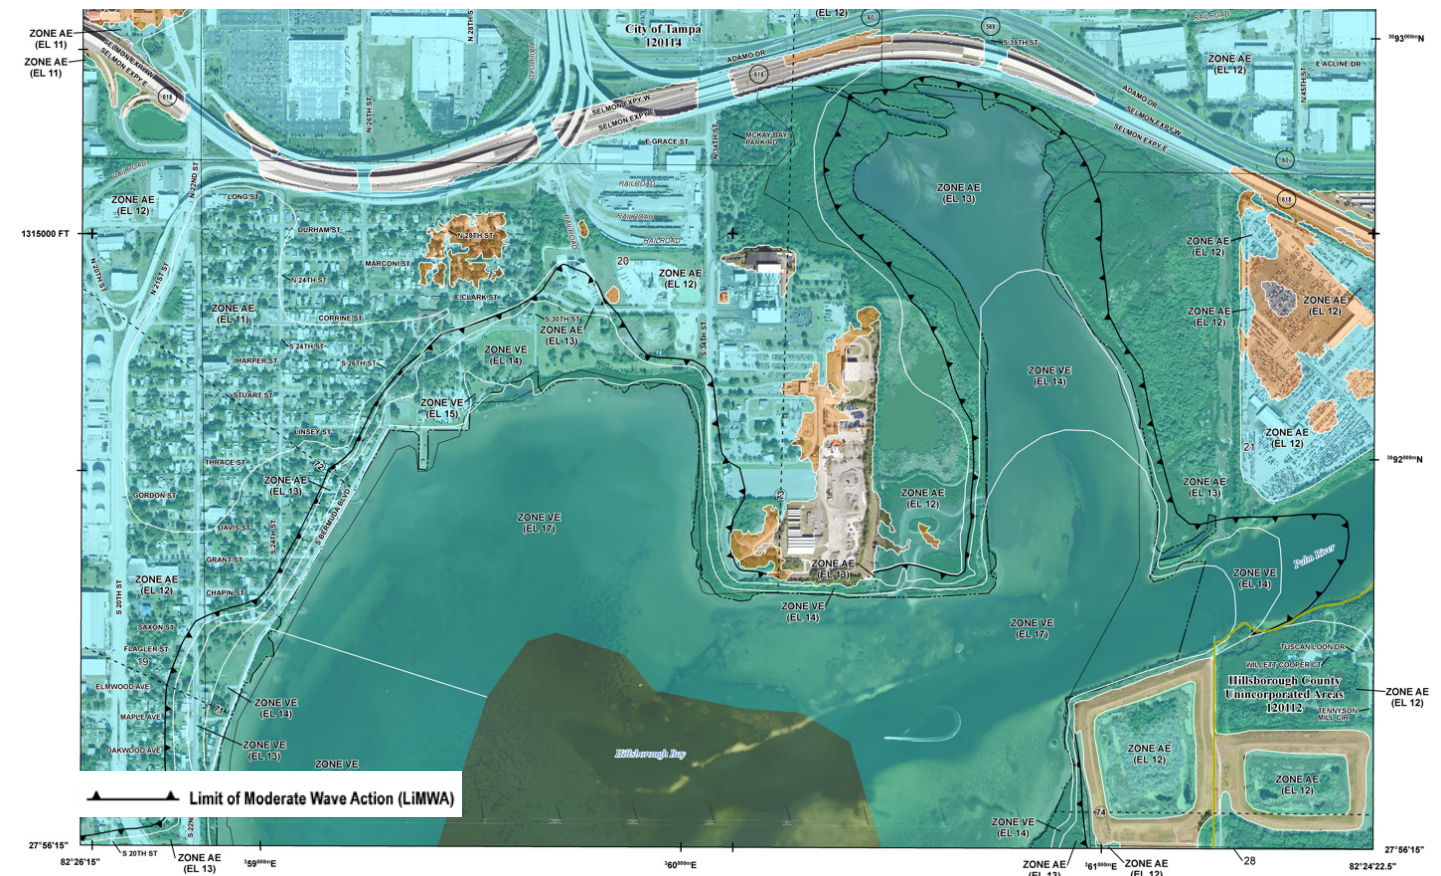
Map showing FEMA Flood Zones and the LIMWA line for Palmetto Beach

One of the neighborhood’s most significant challenges is its susceptibility to flooding and storm surge inundation. The newly released Flood Insurance Rate Maps designate almost the entire neighborhood as a Flood Zone AE. Near the shoreline of Bermuda Boulevard there are areas within the Limit of Moderate Wave Action (LIMWA), which specifies a reduced velocity zone, with similar requirements as “V” zones. V, or velocity, zones signify danger to wave run-up. The base flood elevation in Palmetto Beach ranges from 11 to 14’ NAVD88.

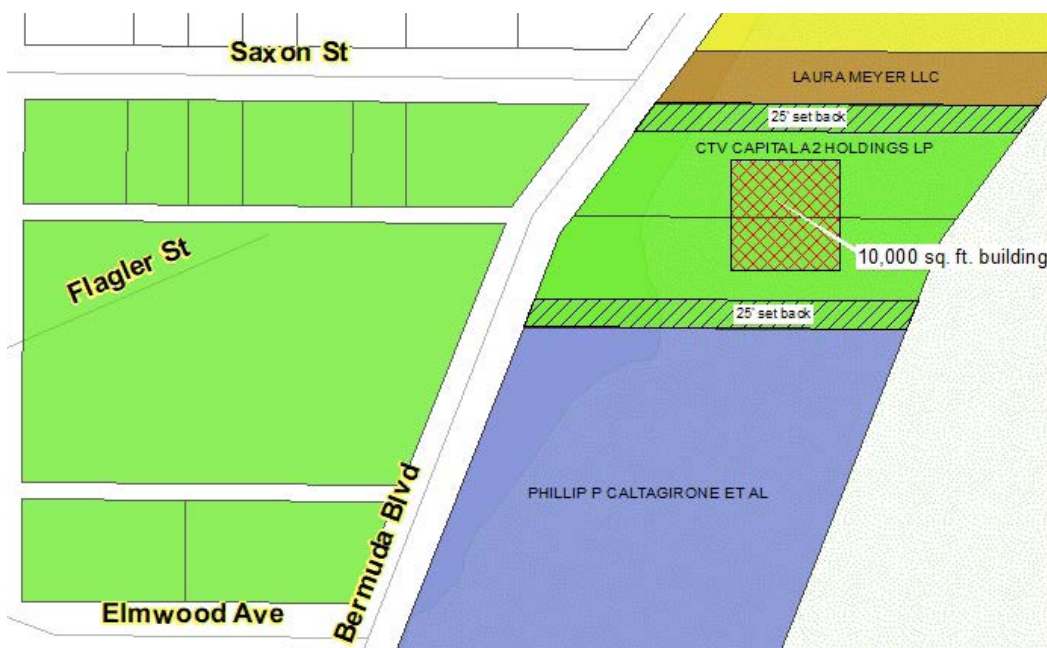
The submerged Hevia properties are now owned by CTV Capital Holdings (Green).
The image above shows Quit Claim Deed Restrictions (Crosshatching).

The Quit Claim Deed Exhibit A further states that "No structure shall be placed closer than 25' to the north property line of Lot 33 nor closer than 25' to the south property line of Lot 34, nor shall there be constructed within the said setback lines more than 10,000 square feet of actual physical dock construction nor more than two (2) separate structures. These setback lines and square footage restrictions shall be appurtenant to and shall run with the land and may be enforced by the Tampa Port Authority or any public entity owing the surrounding sovereign lands any interest therein."

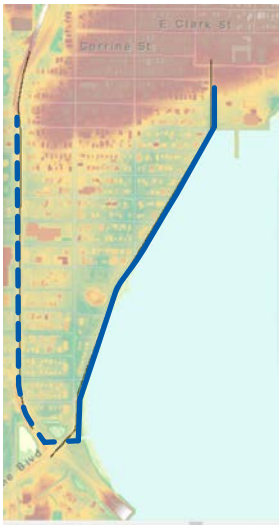
The drawing to the right shows the potential for continuous perimeter protection for the Palmetto Beach community at elevation 6', shown by the red line. A seawall along Bermuda Boulevard could tie into road and park grades to create a basin. Areas in orange are below elevation 6', which would be the limit of protection. Additional study to relieve the 'basin' condition from stormwater accumulation need to be performed. A pump or pumps may be required.

Elevation 6' is shown in red, representing potential tie-in locations for a seawall constructed to meet that elevation. Most of 20th Street, the north-south road at the west of the community, is already at elevation 6'.

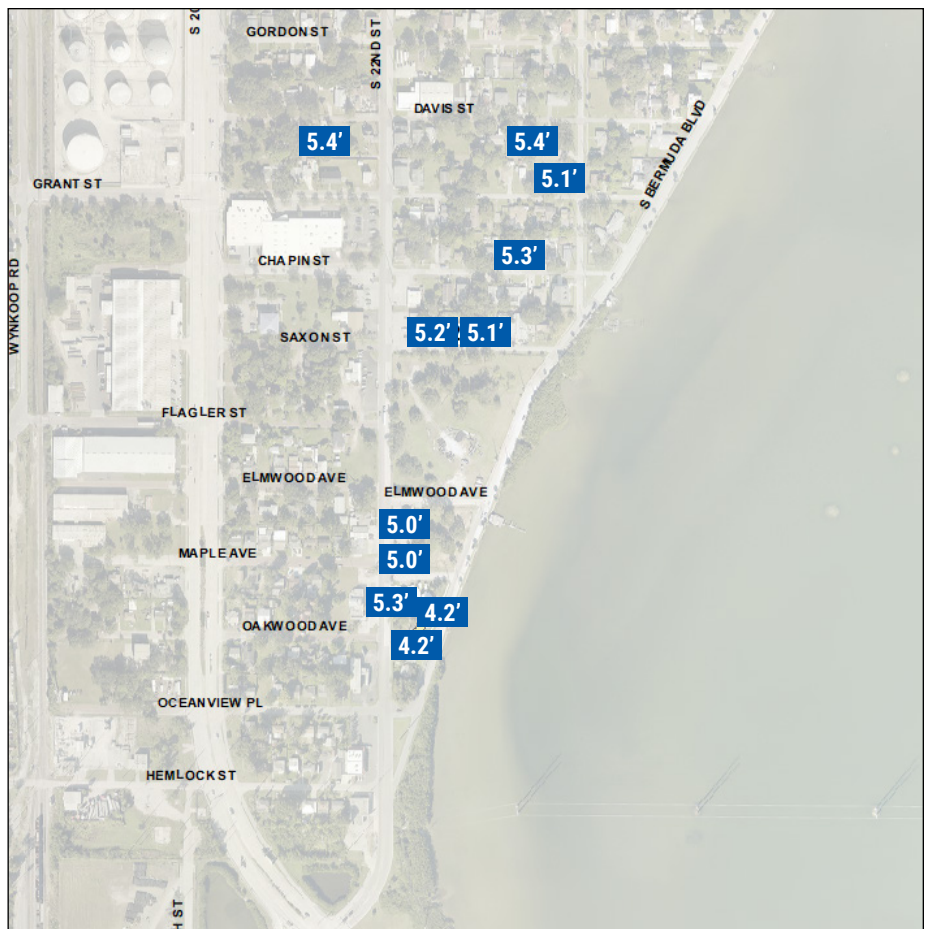
The 10 lowest structures and their elevations are shown in the diagram to the right. These elevations were formulated using the best available LIDAR data and need to be field-verified.

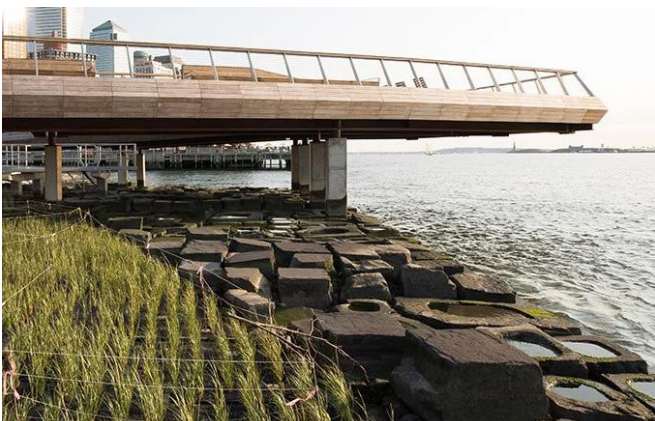
Concrete reef coastline example using EConcrete at
Pier 26, New York City, NY

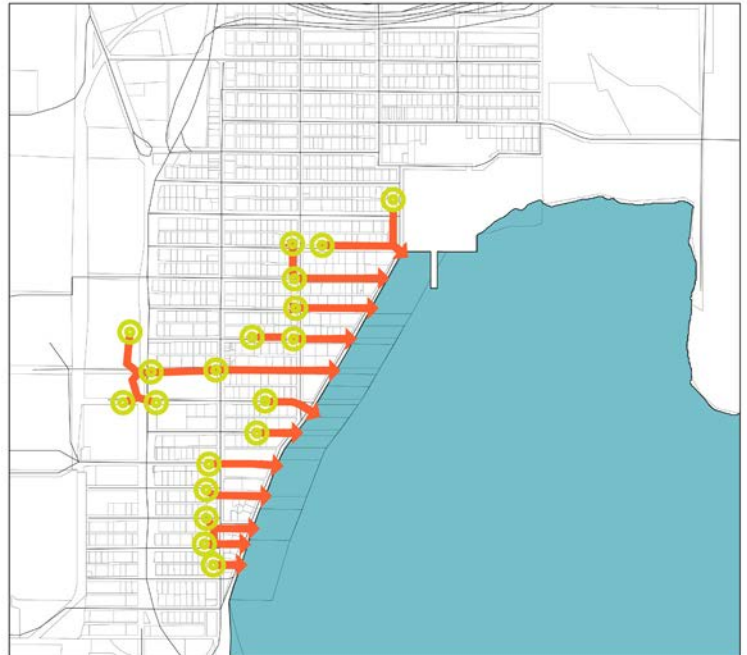
Image: Existing storm drains (yellow) and outfalls (orange arrows).

There are 12 outfall penetrations in the Bermuda Boulevard seawall, which are noted with red arrows (wall locations are highlighted in yellow).
