PALMETTO BEACH SEAWALL FEASIBILITY MEMO

For the City of Tampa

September 19, 2023

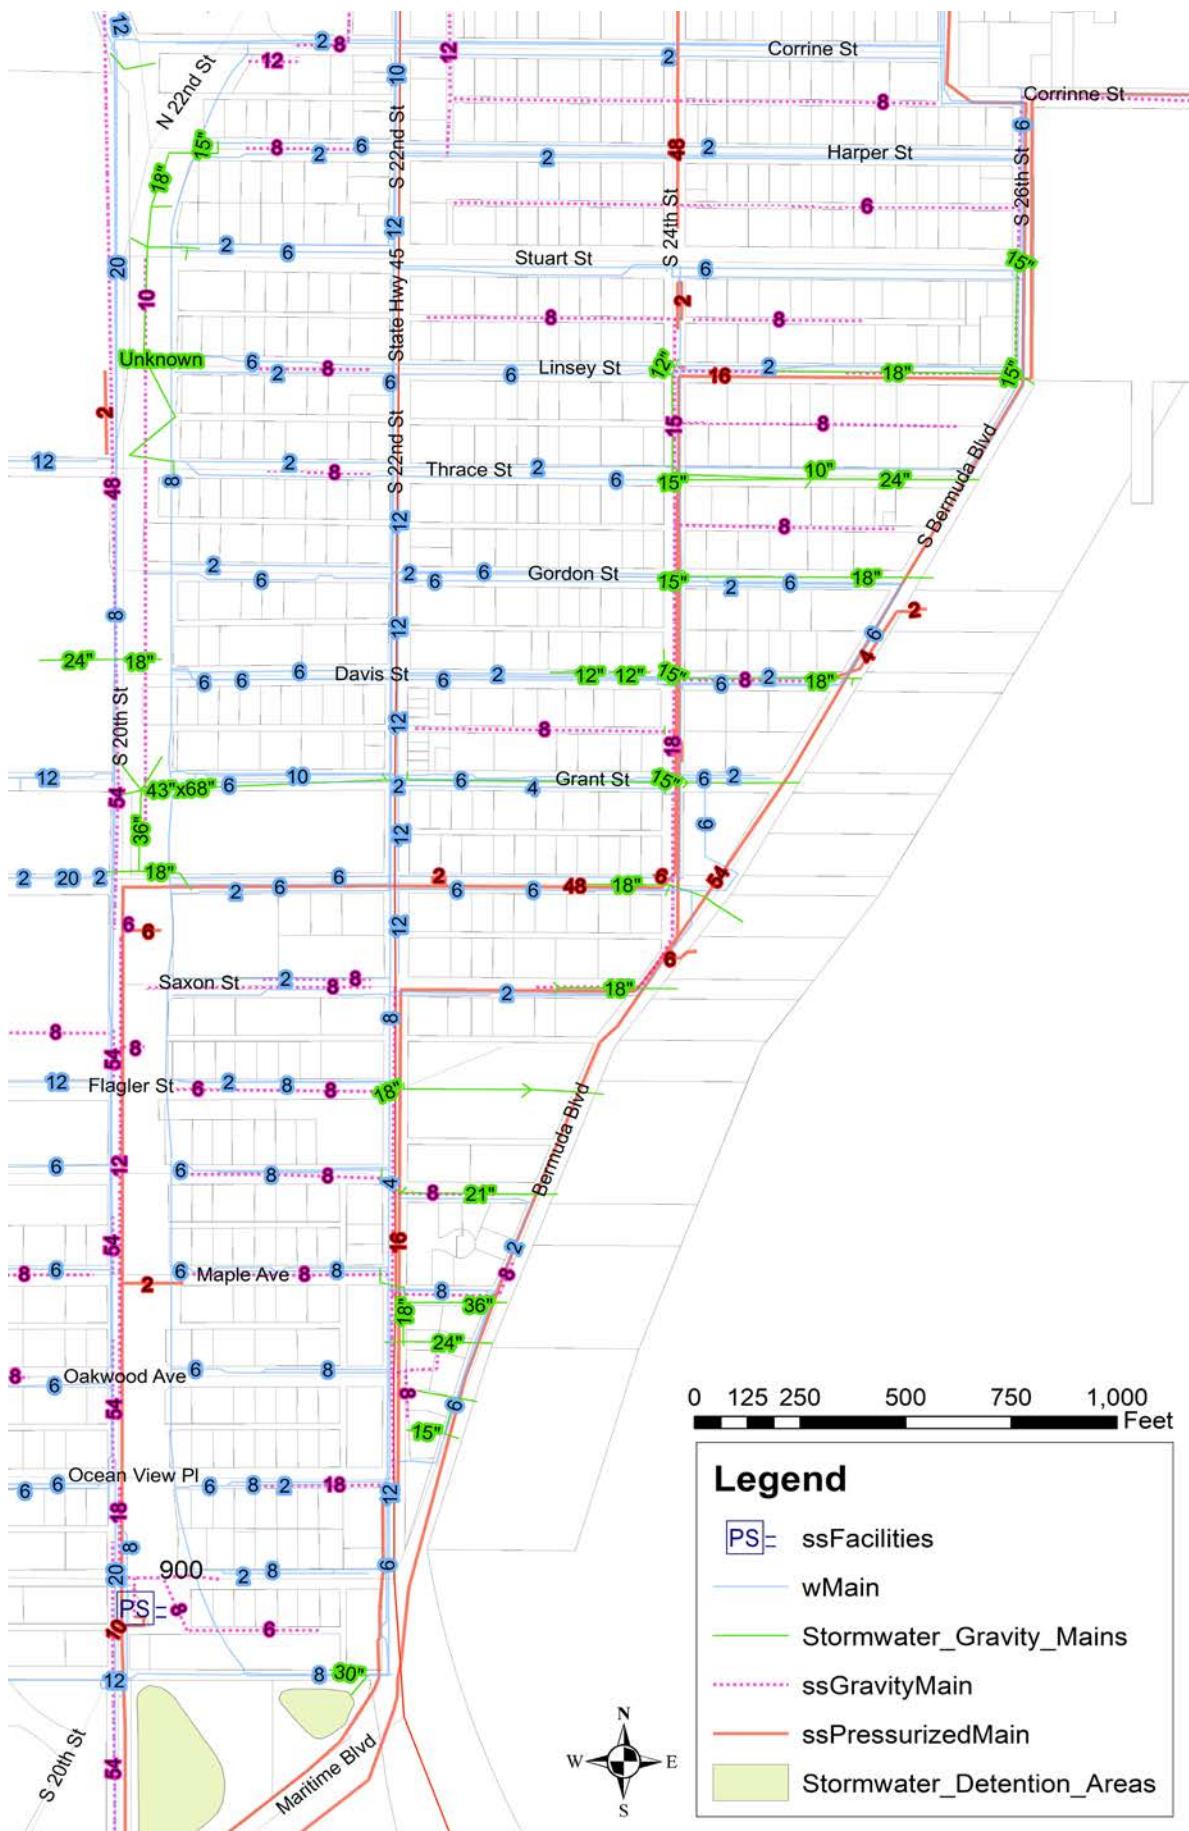
Utilities Map for Palmetto Beach

All potable lines that run along Bermuda Boulevard service properties to the west. There are 6" ductile iron potable lines running along Bermuda Boulevard between Oceanview Place and Elmwood Avenue, Saxon Street and Chapin Street, Chapin Street toward Grant Street, two between Davis Street and Gordon Street, and midway between Gordon Street and Lindsey Street. There is also a 2" cast iron potable line running along Bermuda Boulevard between Oceanview Place and Elmwood

Avenue. It is reasonable that several sections of water main would need to be connected for improved “looped” service especially if fire protection is a major concern.

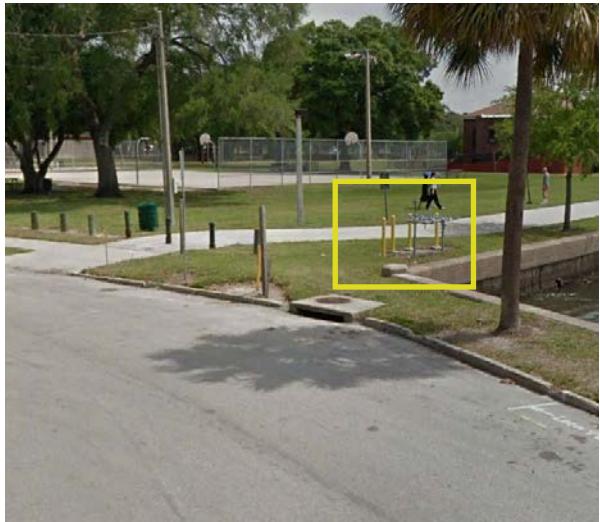
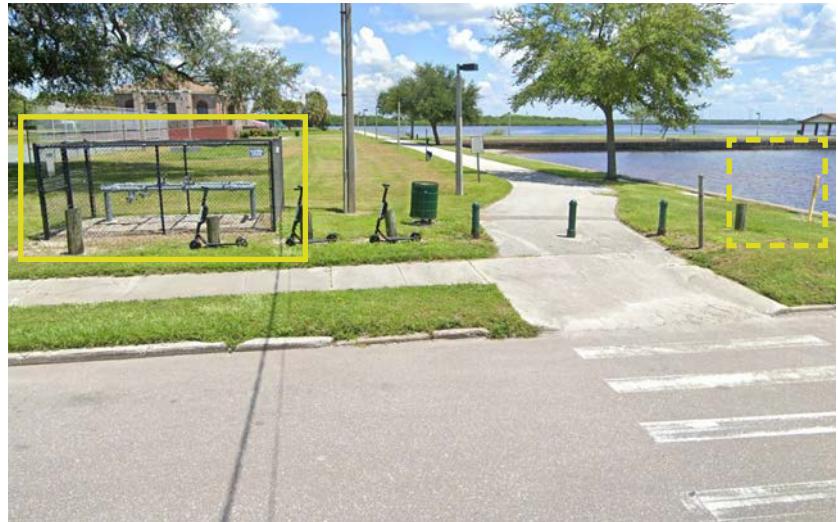
Gas infrastructure at the corner of 26th and Lindsey, showing before and after. Images taken from Google street view.

The 2018 report suggests that TECO wanted to install a 4" to 8" gas main along Bermuda Boulevard. This appears to be completed, but is unverified - a surface meter at the corner of 26th and Lindsey streets has been renovated and moved (see images below).

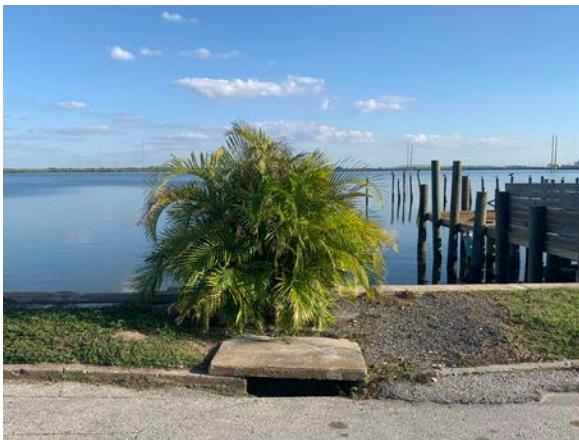
Inlet leading directly to McKay Bay

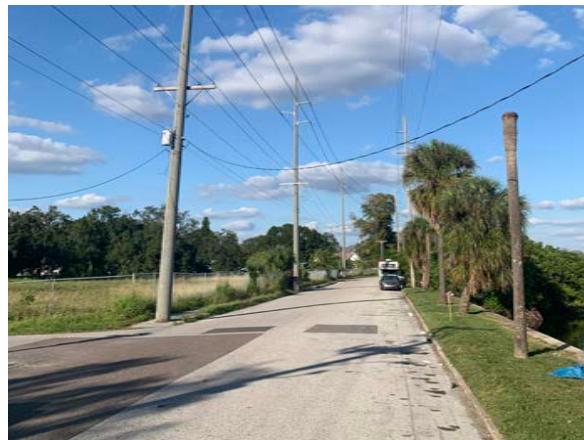
The Bermuda Boulevard roadway, adjacent to the seawall

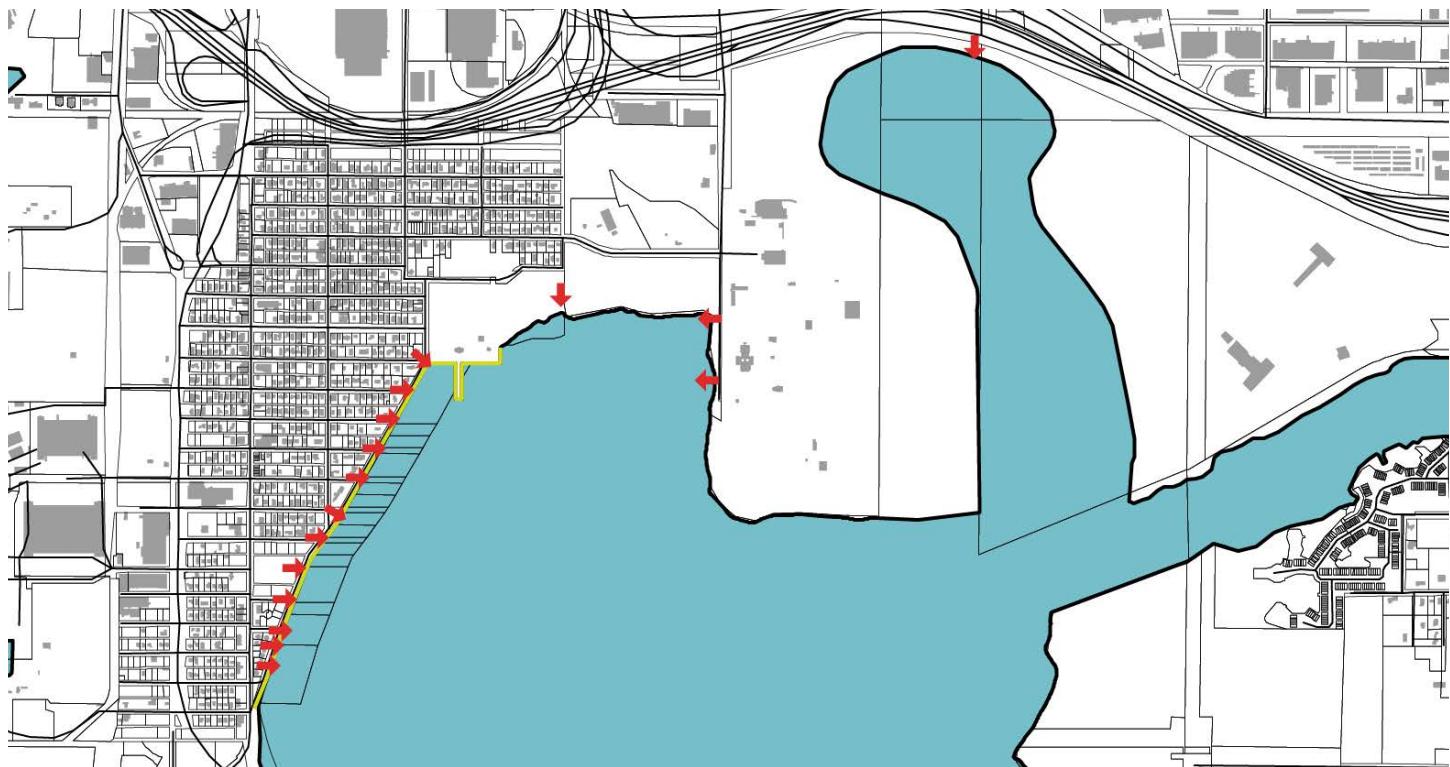
There are 12 outfall penetrations in the Bermuda Boulevard seawall, which are noted with red arrows (wall locations are highlighted in yellow).

Physical Factors and Connections: The seawall is connected to multiple stormwater pipes, which have outfalls along the face of the wall.

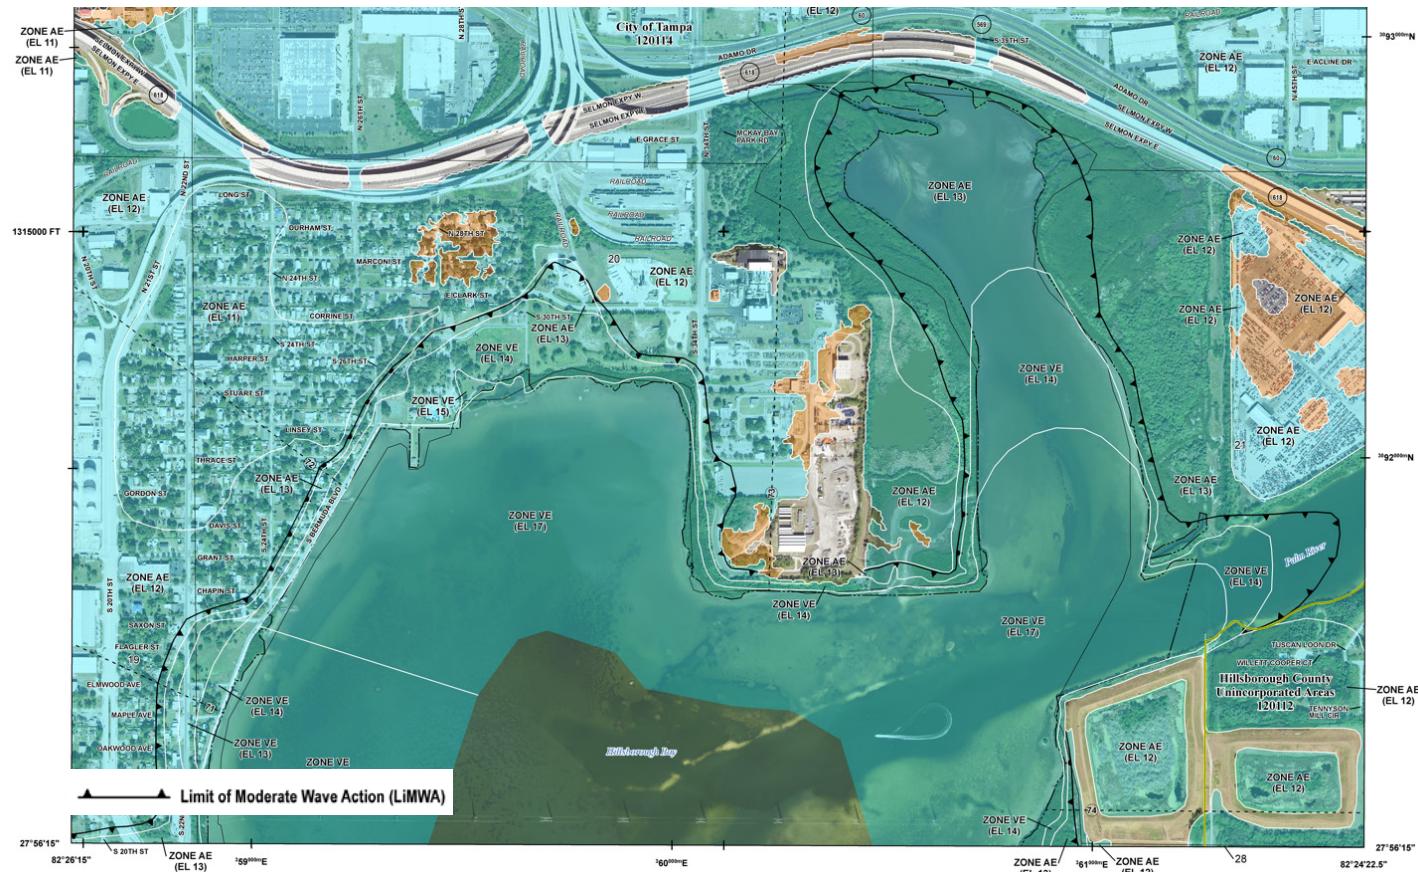
The area was studied for its vulnerability to sea level rise in the 2021 Regulatory Approach to Sea Level Rise project. Outcomes are shown in the image below.

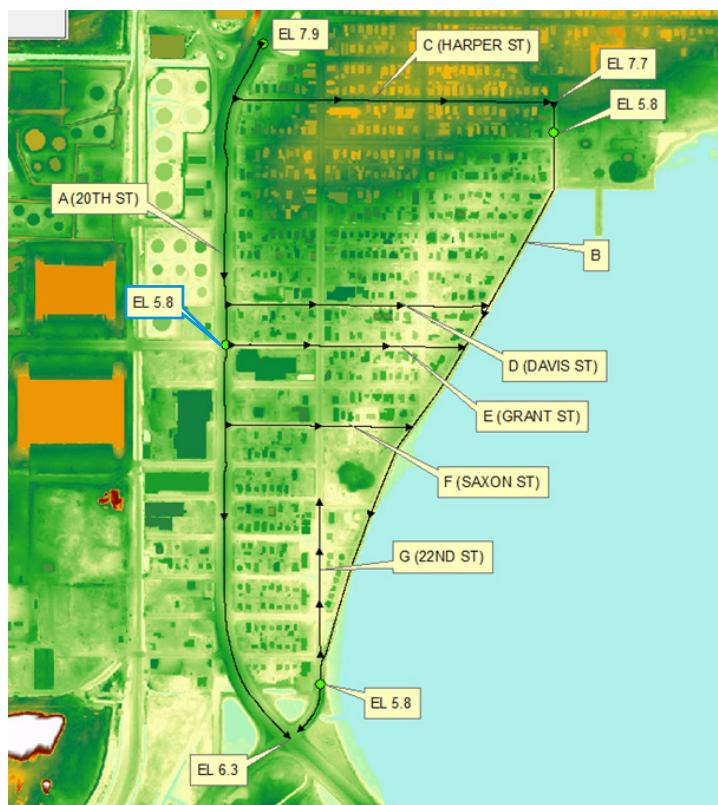
Section A: 20th Street

Seawall and topographic elevations were studied to evaluate potential protection levels, from coastal surge. The lowest elevations along 20th Street, a major boundary for the area, is at approximately 5.8' NAVD88, with a consistent low elevation of about 6'. On the eastern edge, the centerline for Bermuda Boulevard ranges between elevation 3.2 to about 6.2 NAVD88. This does not account for the lowest points in the roadway, since the gutter at the edge of the street is lower, but provides a general sense of elevations.

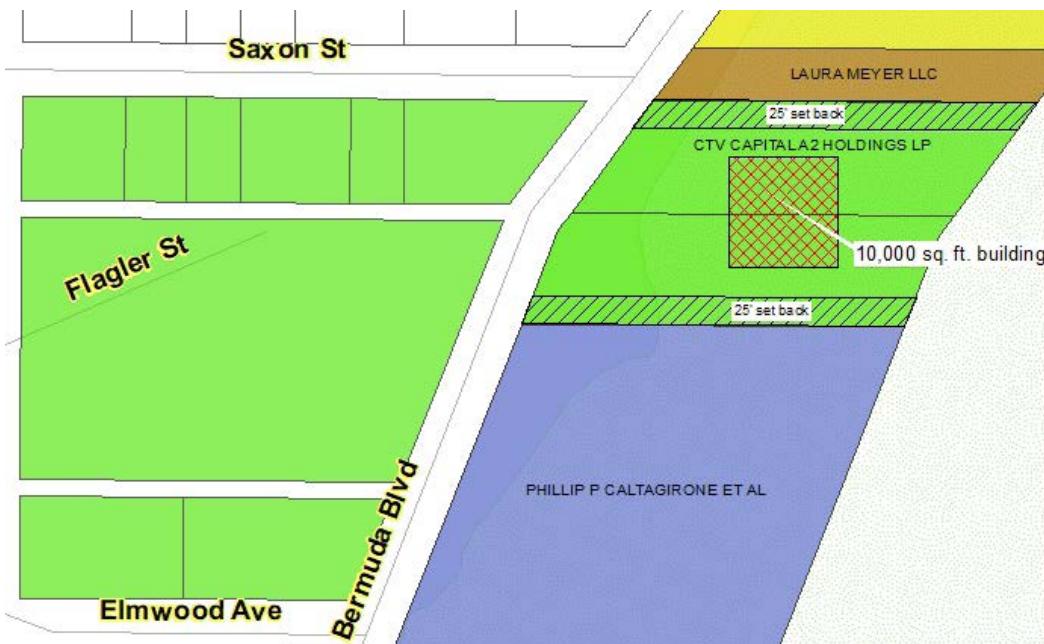
The submerged Hevia properties are now owned by CTV Capital Holdings (Green).
 The image above shows Quit Claim Deed Restrictions (Crosshatching).

The Quit Claim Deed Exhibit A further states that "No structure shall be placed closer than 25' to the north property line of Lot 33 nor closer than 25' to the south property line of Lot 34, nor shall there be constructed within the said setback lines more than 10,000 square feet of actual physical dock construction nor more than two (2) separate structures. These setback lines and square footage restrictions shall be appurtenant to and shall run with the land and may be enforced by the Tampa Port Authority or any public entity owing the surrounding sovereign lands any interest therein."

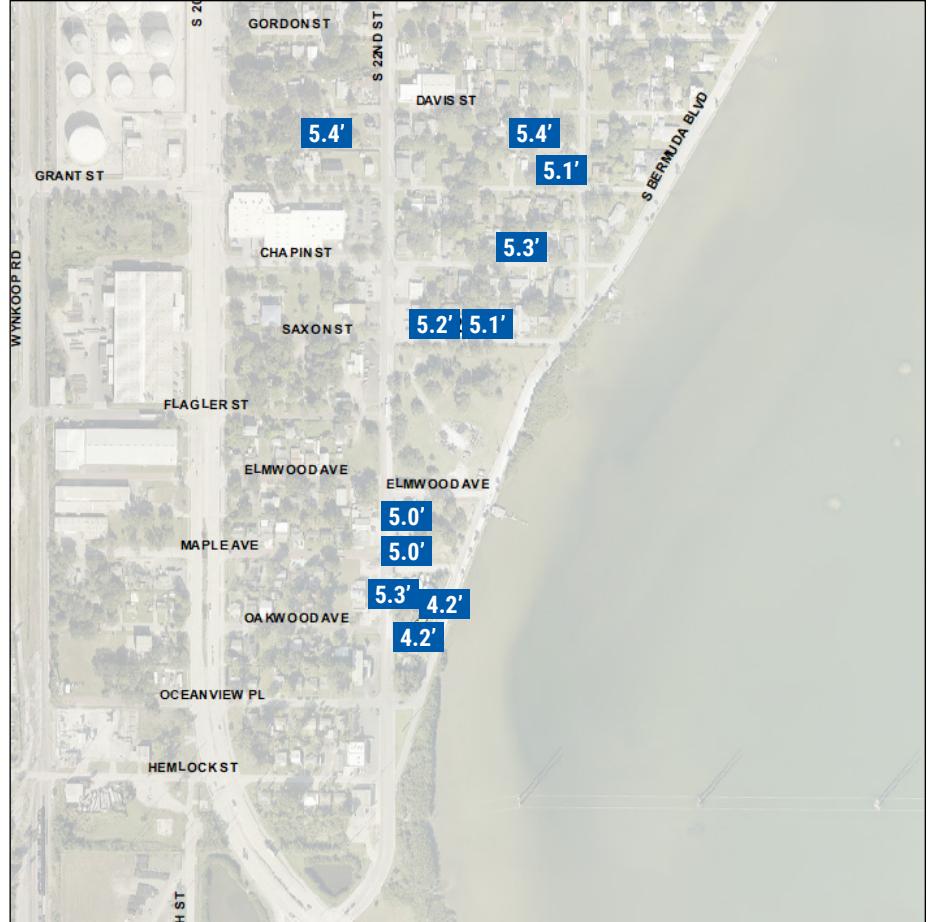
The 10 lowest structures and their elevations are shown in the diagram to the right. These elevations were formulated using the best available LIDAR data and need to be field-verified.

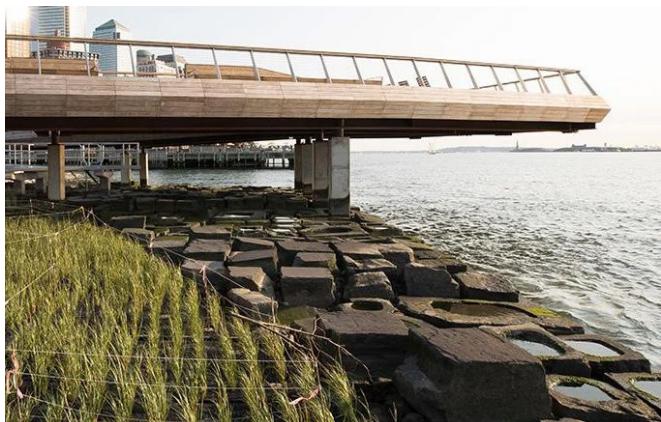
Concrete reef coastline example using ECOConcrete at
Pier 26, New York City, NY

On the seaward side of the seawall, there is potential to include living shoreline elements such as rip rap or ECOConcrete reef structures to create habitat and wave energy dissipation. These elements would be easier to include on properties owned by the City, where previous permits had allowed up to 8' of living shoreline material to be added. These materials could also be incorporated into privately owned submerged properties if an easement was created - for example a utilities easement - that continued the owners construction development rights while benefiting habitat and creating additional erosion protection for the seawall.

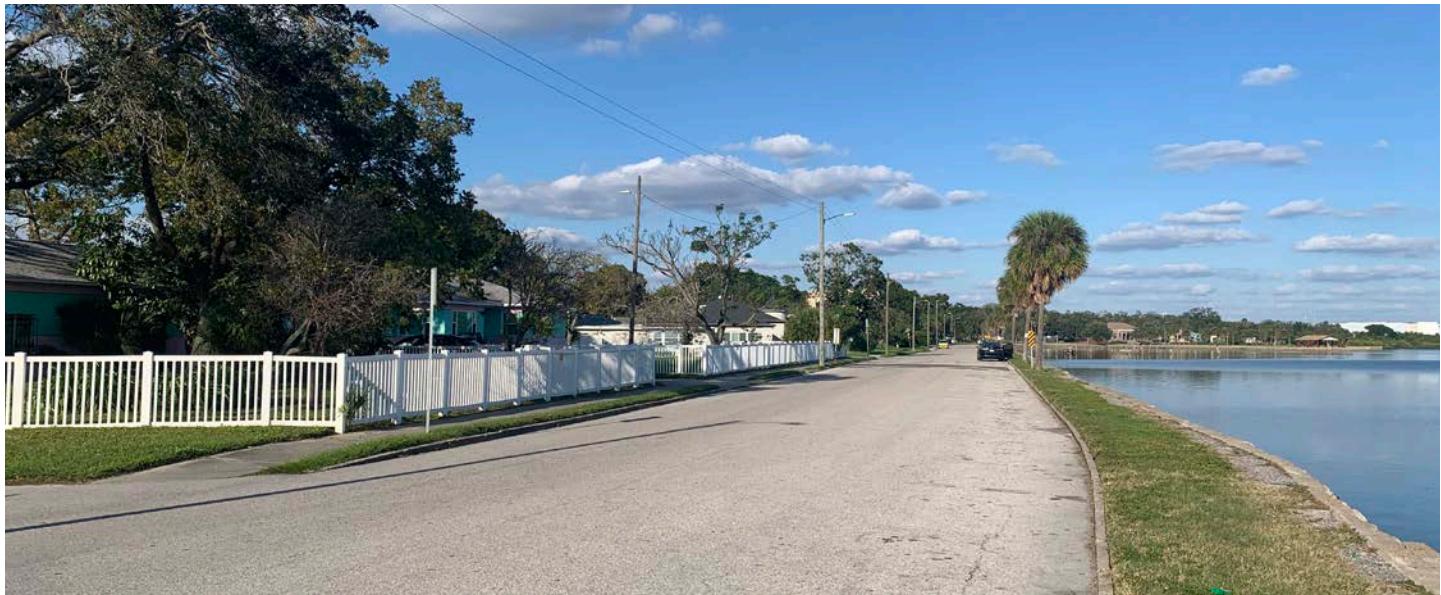
EXISTING CONDITIONS

The existing roadway and right of way space is approximately 40 feet, on average, from the back of seawall to the curb on the other side of the street. The road is generally 32' wide, is crowned, and includes a few stormwater inlets along the corridor. The pavement is in poor condition. There is a grass vegetated area, approximately 8' wide, between the curb and seawall, with occasional cabbage palms, and overhead wires along the west side of the road. South of 24th Street the utility wire masts are much larger in size, whereas north of 24th Street they are only used to provide power to individual street lights. This street is not supposed to be used by heavy trucks, although the neighborhood has complained that they occasionally use the road.

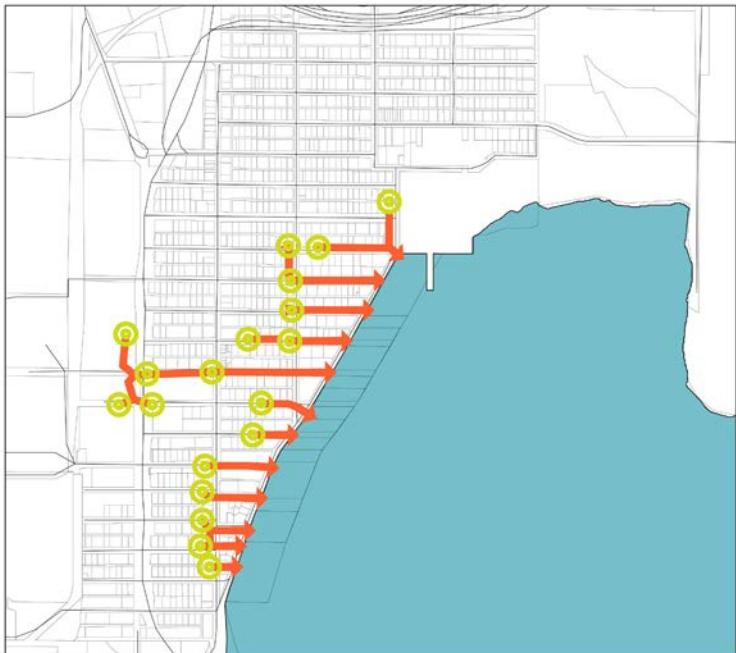
Image: Existing storm drains (yellow) and outfalls (orange arrows).

Manifolding the pipe system would require street excavation and replacement of pipes, inlets, and access structures. New pipes, placed in the City's right of way, would create connections between existing pipes. New inlets may be necessary. A trunk line would be established, including a sediment 'drop out' structure, such as a baffle box, if the water table would allow. The number of outfalls would be reduced. At each outflow a tidal gate valve would be included.
