**RFQ: 15-C-00017**  
**OLD CITY HALL EXTERIOR RENOVATIONS**  
**DESIGN-BUILD SERVICES**

**DESIGN CRITERIA PACKAGE**

CITY OF TAMPA

December 12, 2014

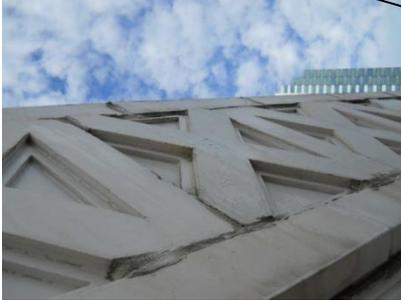
Chalking / flaking paint finish  
on terra-cotta face and mortar  
joints

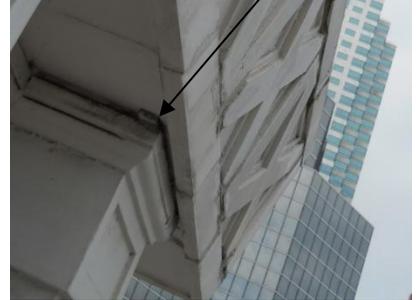
**U14**

Original wood shim. No  
mortar in joint

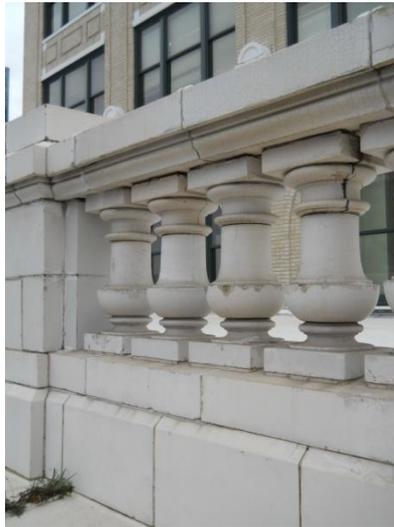
**I8**

Ballusters in varying degrees of deterioration.

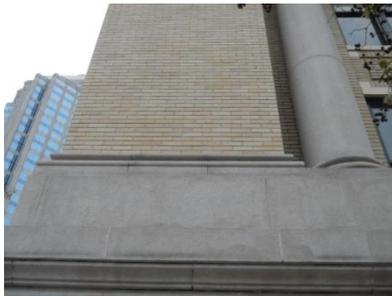
**D19**

Severely deflected granite head.

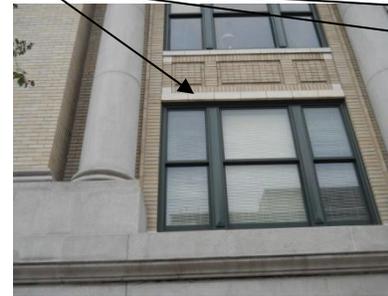
**D12**

Granite joints deteriorated, typical.

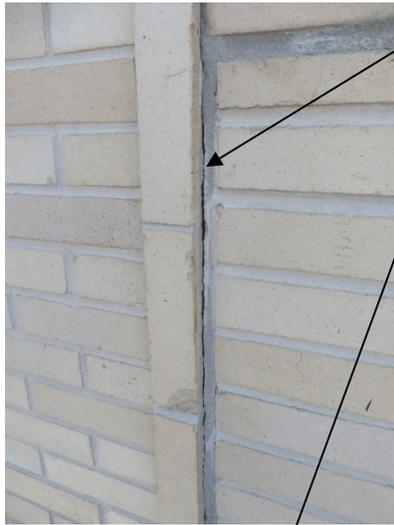
Vertical crack along brick band

Incorrect brick replacement color / texture

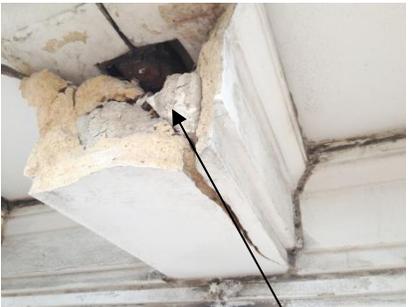
**H12**

Severely cracked soffit panel (this has subsequently been removed)

Failed terra-cotta dentil molding

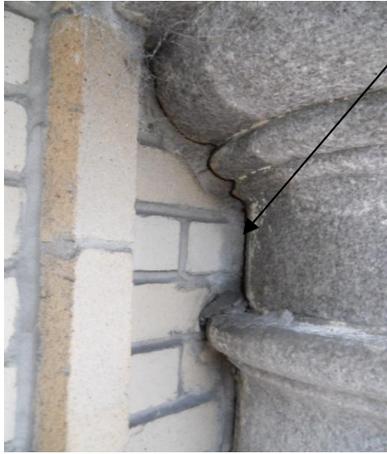
**H16**

Granite column moving away from the building face

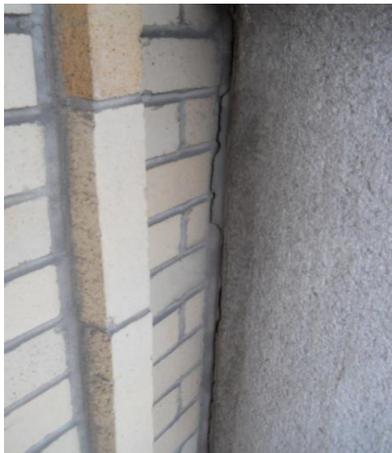
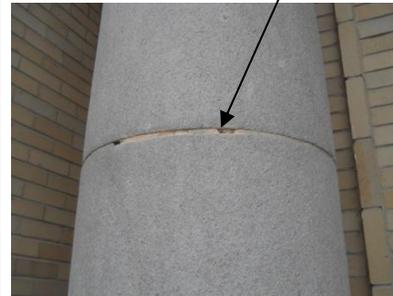
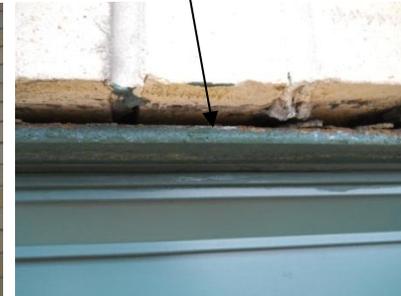
Deteriorated granite joint  
Deteriorated steel lintel.

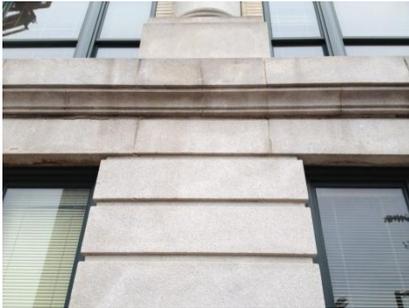
**B14**

Spalled granite

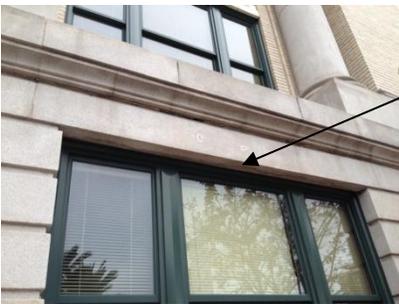
**C4**

Deflecting granite head

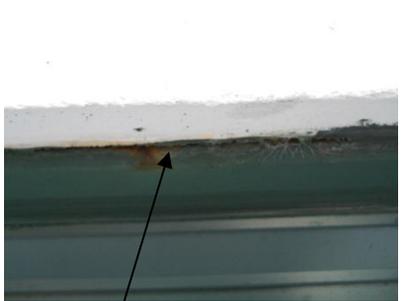
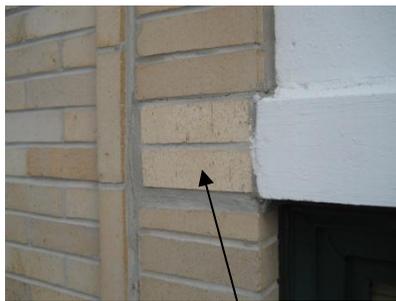
Deteriorated steel  
lintel.

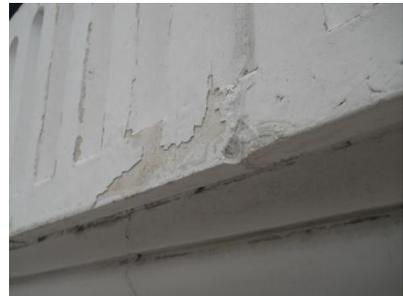
**K10**

Terra-cotta banding replaced with resinous casting

Inappropriate use of a gypsum filler material

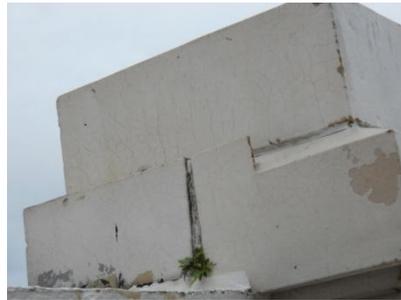
**I3**

Vegetation growth indicating failing joints.
